Profile/Photo Observation Report

Date:	09/17/2021	Weather:		Coding:	PACP 7.0
Pipe Length (ft):	203.0	Owner:	City of Hobart	Pre Clean:	Light Cleaning
P.O.#:	YES502259	Surveyor:	S. Bucklin	PSR:	P-503-053-054
Customer:	City of Hobart	Clean Date:	08/24/2021	Shape:	C

Street:	North Guyer Street	Flow Control:	Not Controlled
City:	Hobart, IN	Year Renewed:	
Location:	Easement/Right of Way	Tape/Media #:	
Purpose:	Routine Assessment	Dia/Height:	10"
Use:	Sanitary Sewage Pipe	Material:	VCP
Drain Area:		Lining:	None
Category:	NA		
Comment:			
Location Details:		Direction of Survey:	Upstream
US MH:	M-503-053	DS MH:	M-503-054
		Total Length Surveyed (ft):	145.2

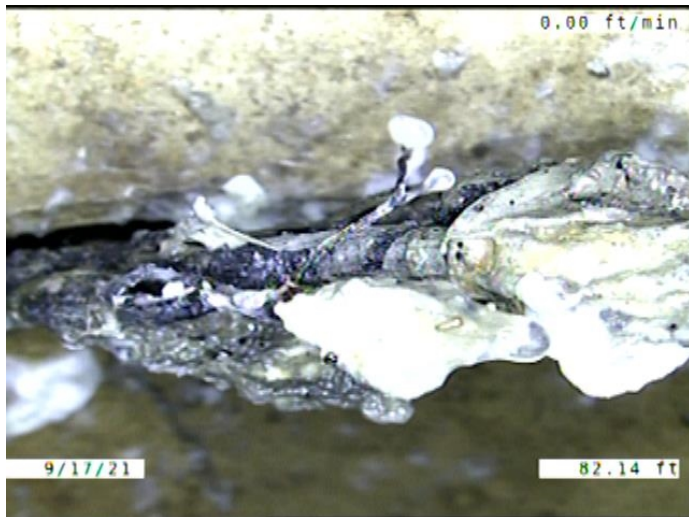
Code: **RMJ**
 Description: **Roots Medium Joint**

Distance (ft): **82.1**
 Structural Grade: **0**
 O&M Grade: **3**
 Clock Start/From: **9**
 Clock To: **3**
 1st Value:
 2nd Value:
 Value Percent: **5.000**
 Continuous Index:
 Within 8" of Joint: **YES**
 Remarks:

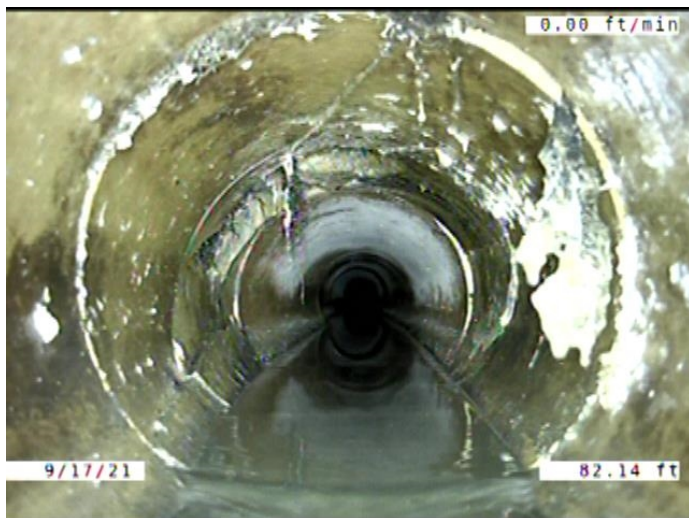
Code: **FM**
 Description: **Fracture Multiple**

Distance (ft): **82.1**
 Structural Grade: **4**
 O&M Grade: **0**
 Clock Start/From: **12**
 Clock To: **12**
 1st Value:
 2nd Value:
 Value Percent:
 Continuous Index:
 Within 8" of Joint: **YES**
 Remarks:

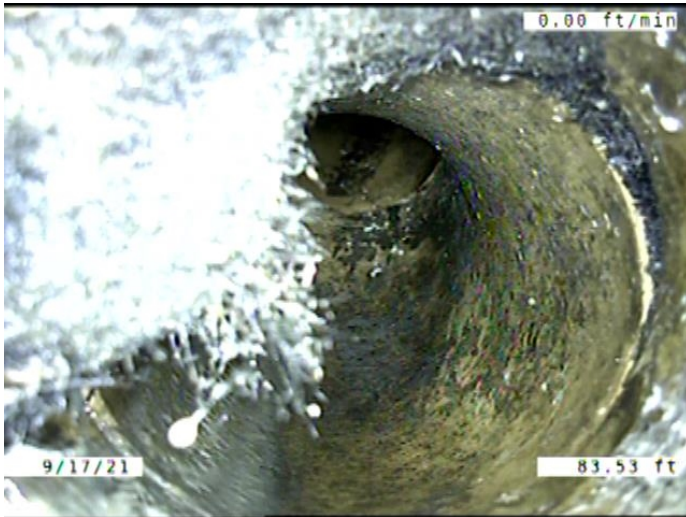
Code: **TFD**
 Description: **Tap Factory Defective**

Distance (ft): **83.5**
 Structural Grade: **0**
 O&M Grade: **3**
 Clock Start/From: **11**
 Clock To:
 1st Value: **4.000**
 2nd Value:
 Value Percent:
 Continuous Index:
 Within 8" of Joint: **YES**
 Remarks: **Defective**

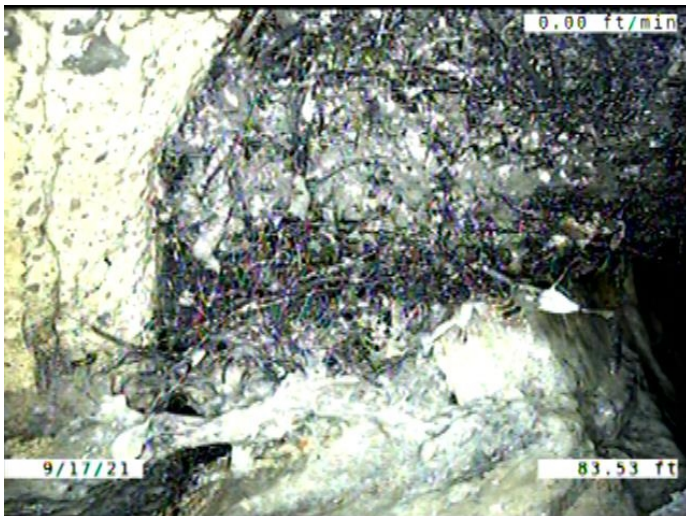
Code: **RFL**
 Description: **Roots Fine Lateral**

Distance (ft): **83.5**
 Structural Grade: **0**
 O&M Grade: **1**
 Clock Start/From: **10**
 Clock To: **12**
 1st Value:
 2nd Value:
 Value Percent:
 Continuous Index:
 Within 8" of Joint: **NO**
 Remarks:
