Profile/Photo Observation Report

Street:	North Guyer Street	Flow Control:	Not Controlled
City:	Hobart, IN	Year Renewed:	
Location:	Easement/Right of Way	Tape/Media #:	
Purpose:	Routine Assessment	Dia/Height:	10"
Use:	Sanitary Sewage Pipe	Material:	VCP
Drain Area:		Lining:	None
Category:	NA		
Comment:

Location Details:		Direction of Survey:	Downstream
US MH:	M-503-053	DS MH:	M-503-054
		Total Length Surveyed (ft):	76.1

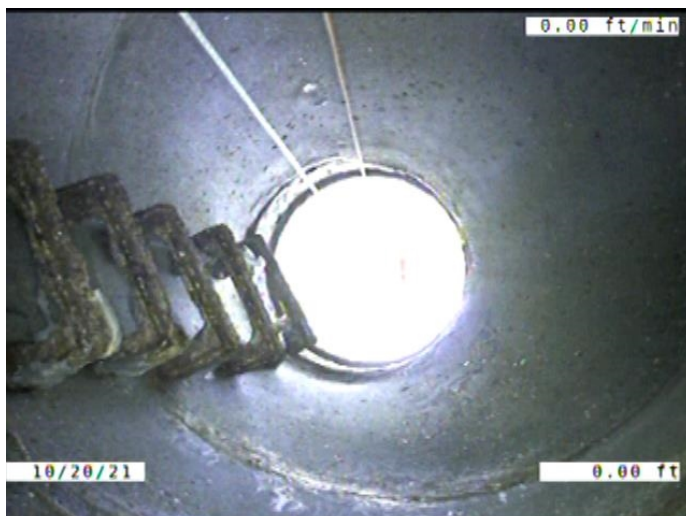
Code: **AMH**
 Description: **Manhole**

Distance (ft): **.0**
 Structural Grade: **0**
 O&M Grade: **0**
 Clock Start/From:
 Clock To:
 1st Value:
 2nd Value:
 Value Percent:
 Continuous Index:
 Within 8" of Joint: **NO**
 Remarks: **M-503-053**

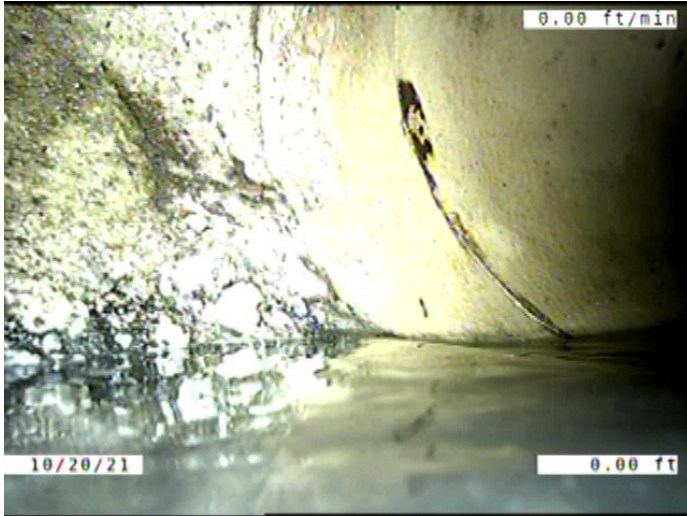
Code: **MWL**
Description: **Miscellaneous Water Level**

Distance (ft): **.0**
Structural Grade: **0**
O&M Grade: **0**
Clock Start/From:
Clock To:
1st Value:
2nd Value:
Value Percent: **5.000**
Continuous Index:
Within 8" of Joint: **NO**
Remarks:

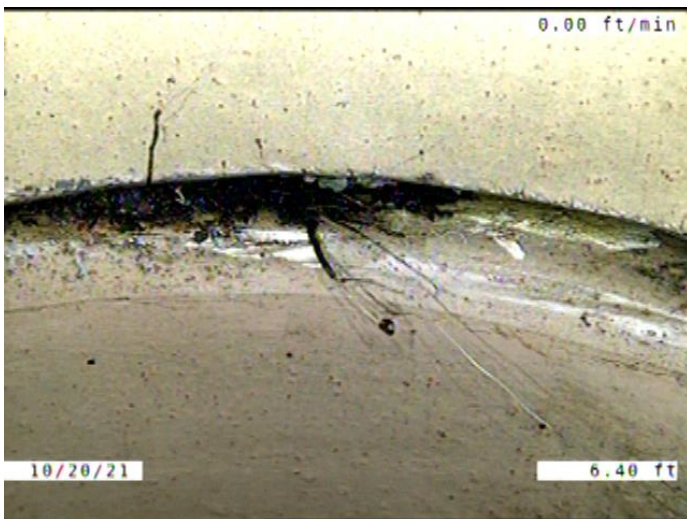
Code: **RFJ**
Description: **Roots Fine Joint**

Distance (ft): **6.4**
Structural Grade: **0**
O&M Grade: **1**
Clock Start/From: **2**
Clock To: **3**
1st Value:
2nd Value:
Value Percent:
Continuous Index:
Within 8" of Joint: **YES**
Remarks:

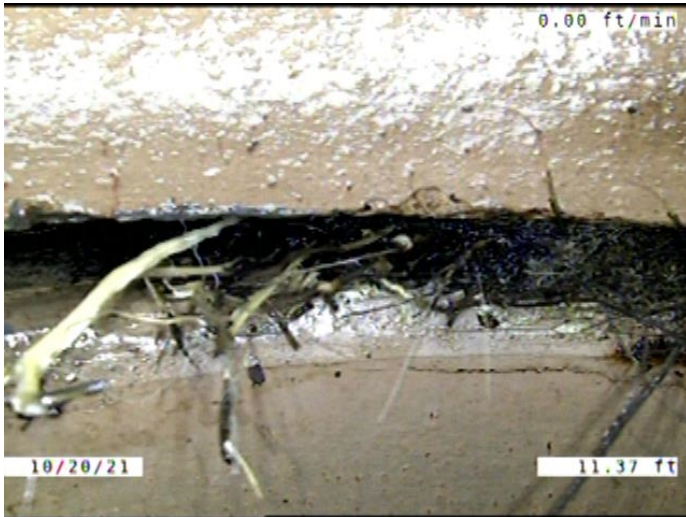
Code: **RFJ**
 Description: **Roots Fine Joint**

Distance (ft): **11.4**
 Structural Grade: **0**
 O&M Grade: **1**
 Clock Start/From: **9**
 Clock To: **4**
 1st Value:
 2nd Value:
 Value Percent:
 Continuous Index: **S01**
 Within 8" of Joint: **YES**
 Remarks:

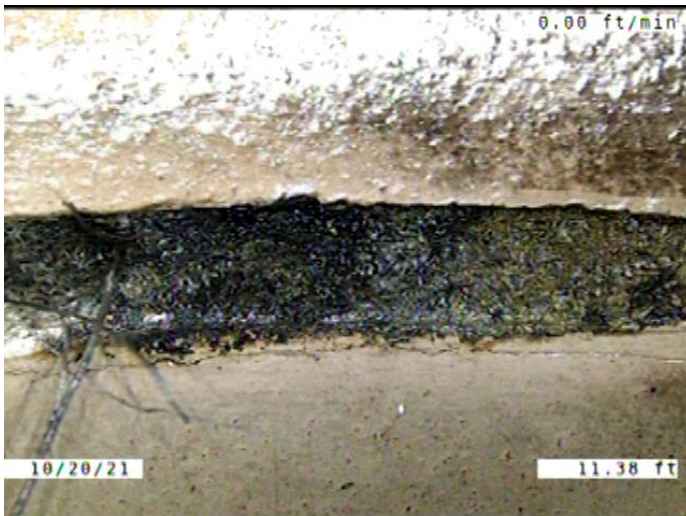
Code: **CS**
 Description: **Crack Spiral**

Distance (ft): **11.4**
 Structural Grade: **2**
 O&M Grade: **0**
 Clock Start/From: **8**
 Clock To: **4**
 1st Value:
 2nd Value:
 Value Percent:
 Continuous Index:
 Within 8" of Joint: **YES**
 Remarks:

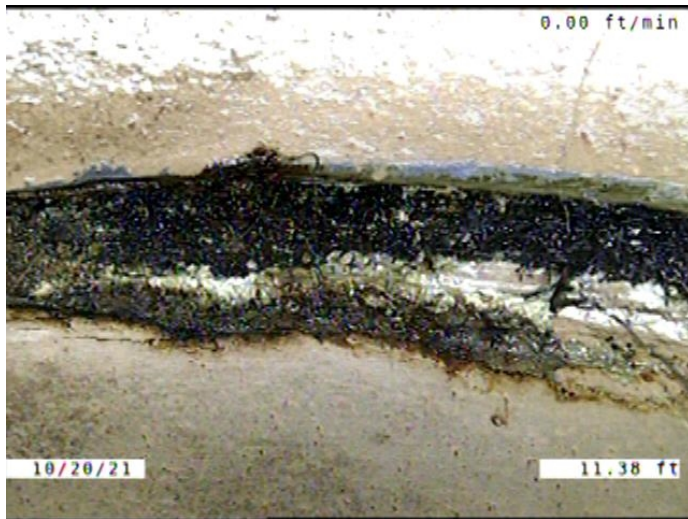
Code: **DAE**
 Description: **Deposits Attached Encrustation**

Distance (ft): **11.4**
 Structural Grade: **0**
 O&M Grade: **2**
 Clock Start/From: **8**
 Clock To: **4**
 1st Value:
 2nd Value:
 Value Percent: **5.000**
 Continuous Index:
 Within 8" of Joint: **YES**
 Remarks:

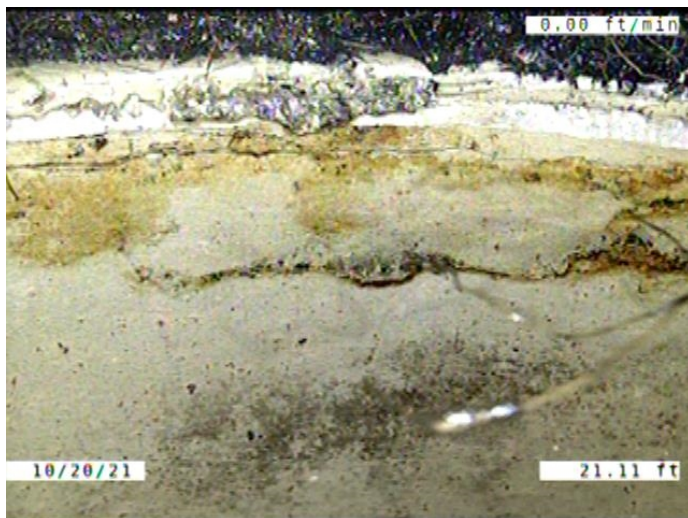
Code: **ISB**
 Description: **Infiltration Stain Barrel**

Distance (ft): **21.1**
 Structural Grade: **0**
 O&M Grade: **1**
 Clock Start/From: **9**
 Clock To: **3**
 1st Value:
 2nd Value:
 Value Percent:
 Continuous Index:
 Within 8" of Joint: **YES**
 Remarks:

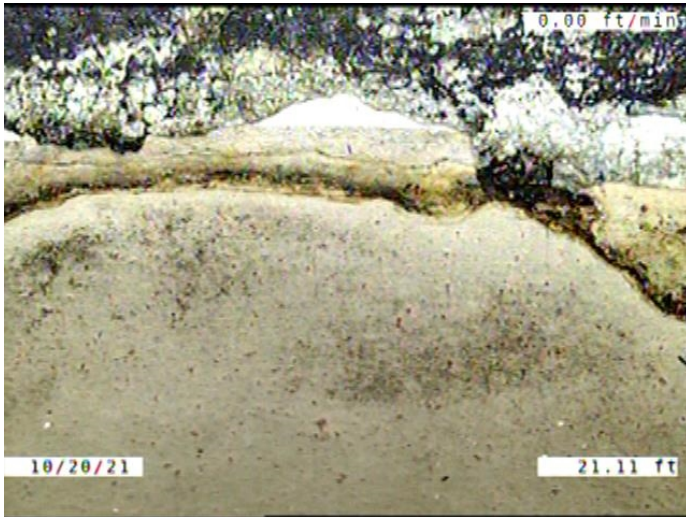
Code: **CS**
 Description: **Crack Spiral**

Distance (ft): **21.1**
 Structural Grade: **2**
 O&M Grade: **0**
 Clock Start/From: **12**
 Clock To: **12**
 1st Value:
 2nd Value:
 Value Percent:
 Continuous Index:
 Within 8" of Joint: **YES**
 Remarks:

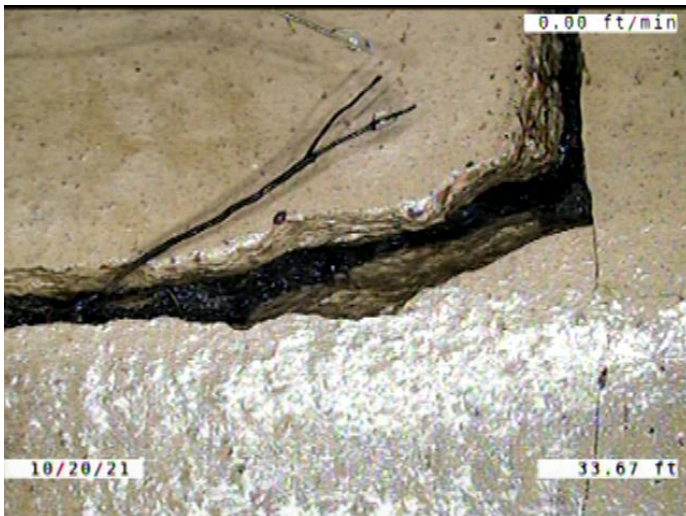
Code: **B**
 Description: **Broken**

Distance (ft): **33.7**
 Structural Grade: **4**
 O&M Grade: **0**
 Clock Start/From: **12**
 Clock To: **12**
 1st Value:
 2nd Value:
 Value Percent:
 Continuous Index:
 Within 8" of Joint: **YES**
 Remarks:

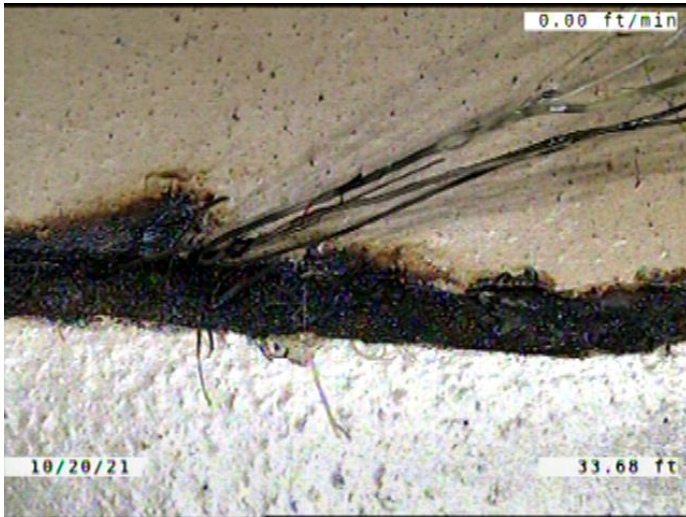
Code: **RFB**
Description: **Roots Fine Barrel**

Distance (ft): **33.7**
Structural Grade: **0**
O&M Grade: **2**
Clock Start/From: **8**
Clock To: **4**
1st Value:
2nd Value:
Value Percent:
Continuous Index:
Within 8" of Joint: **NO**
Remarks:

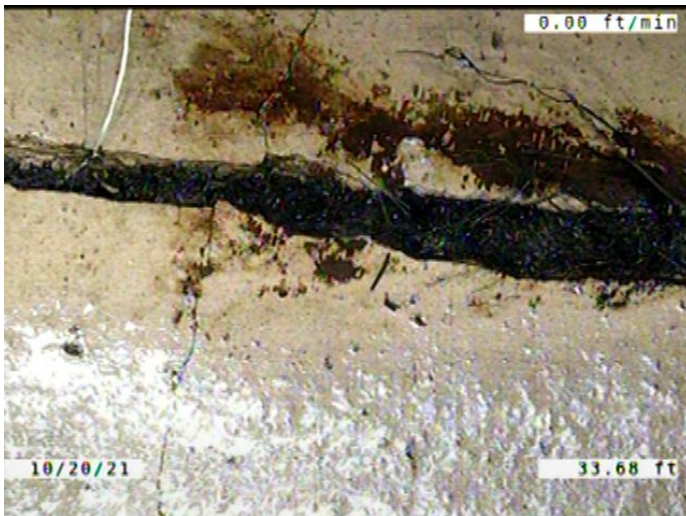
Code: **ISB**
Description: **Infiltration Stain Barrel**

Distance (ft): **33.7**
Structural Grade: **0**
O&M Grade: **1**
Clock Start/From: **9**
Clock To: **3**
1st Value:
2nd Value:
Value Percent:
Continuous Index:
Within 8" of Joint: **YES**
Remarks:

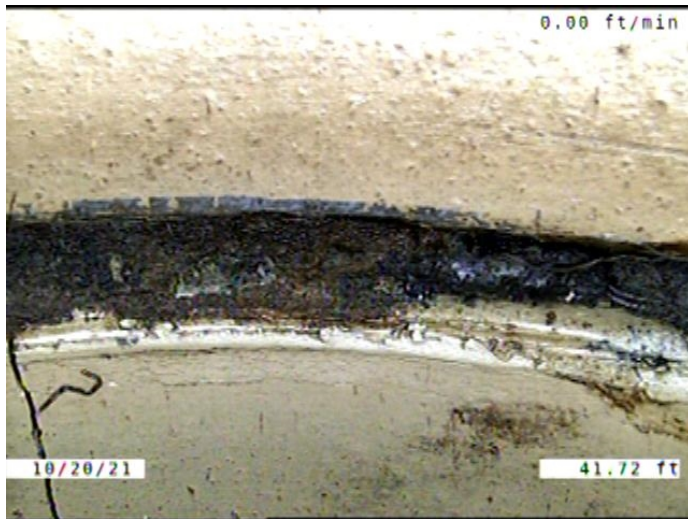
Code: **DAE**
 Description: **Deposits Attached Encrustation**

Distance (ft): **41.7**
 Structural Grade: **0**
 O&M Grade: **2**
 Clock Start/From: **9**
 Clock To: **2**
 1st Value:
 2nd Value:
 Value Percent: **5.000**
 Continuous Index:
 Within 8" of Joint: **YES**
 Remarks:

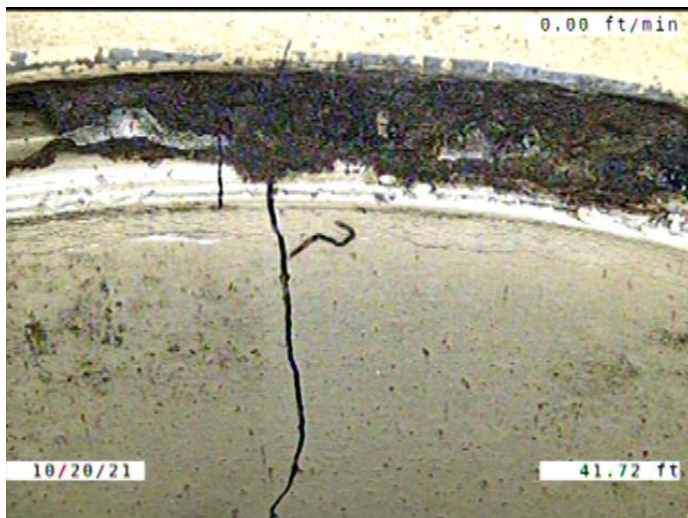
Code: **FS**
 Description: **Fracture Spiral**

Distance (ft): **41.7**
 Structural Grade: **3**
 O&M Grade: **0**
 Clock Start/From: **12**
 Clock To: **1**
 1st Value:
 2nd Value:
 Value Percent:
 Continuous Index: **S02**
 Within 8" of Joint: **YES**
 Remarks:

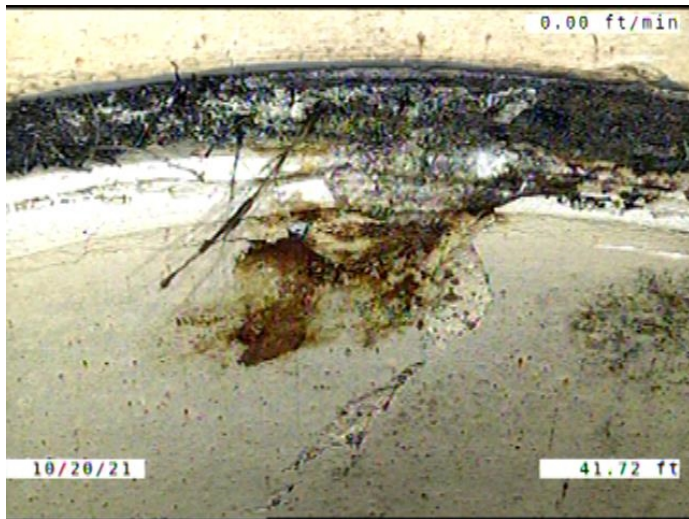
Code: **CS**
 Description: **Crack Spiral**

Distance (ft): **41.7**
 Structural Grade: **2**
 O&M Grade: **0**
 Clock Start/From: **12**
 Clock To: **12**
 1st Value:
 2nd Value:
 Value Percent:
 Continuous Index:
 Within 8" of Joint: **YES**
 Remarks:

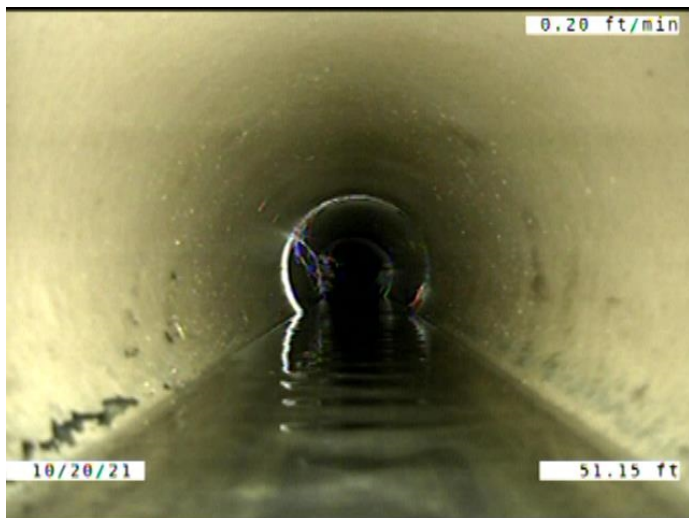
Code: **FS**
 Description: **Fracture Spiral**

Distance (ft): **51.2**
 Structural Grade: **3**
 O&M Grade: **0**
 Clock Start/From: **12**
 Clock To: **1**
 1st Value:
 2nd Value:
 Value Percent:
 Continuous Index: **F02**
 Within 8" of Joint: **YES**
 Remarks:

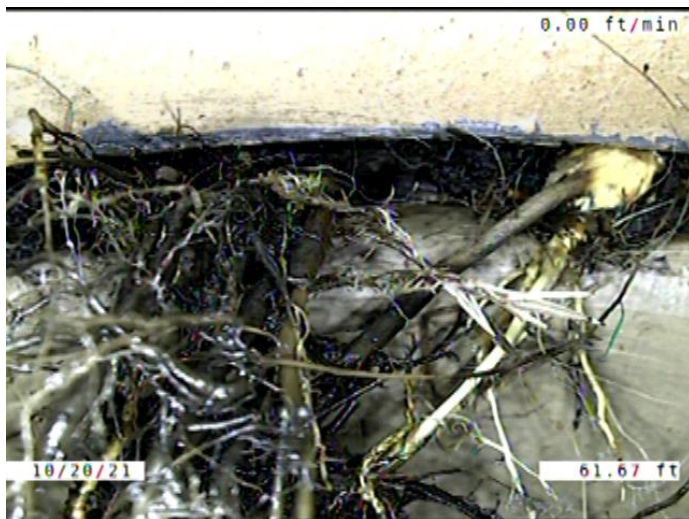
Code: **RMJ**
 Description: **Roots Medium Joint**

Distance (ft): **61.7**
 Structural Grade: **0**
 O&M Grade: **3**
 Clock Start/From: **8**
 Clock To: **4**
 1st Value:
 2nd Value:
 Value Percent: **5.000**
 Continuous Index:
 Within 8" of Joint: **YES**
 Remarks:

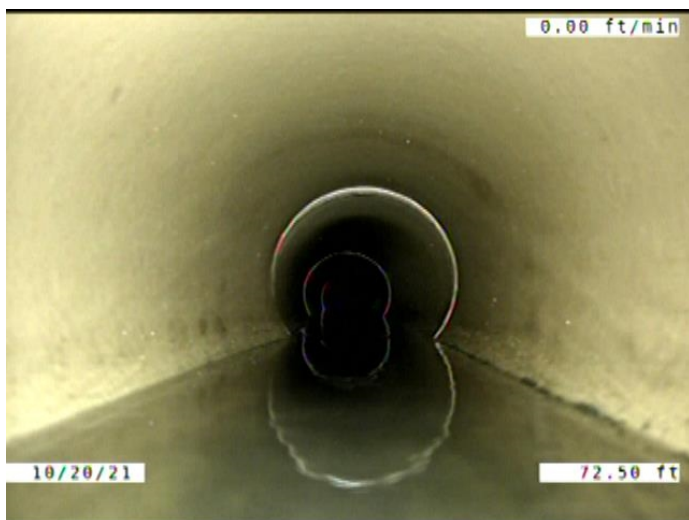
Code: **RFJ**
 Description: **Roots Fine Joint**

Distance (ft): **72.5**
 Structural Grade: **0**
 O&M Grade: **1**
 Clock Start/From: **9**
 Clock To: **4**
 1st Value:
 2nd Value:
 Value Percent:
 Continuous Index: **F01**
 Within 8" of Joint: **YES**
 Remarks:

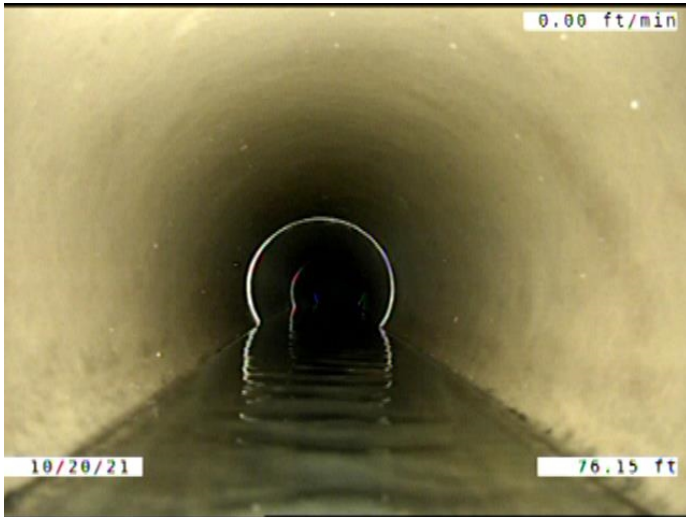
Code:	MSA
Description:	Miscellaneous Survey Abandoned
Distance (ft):	76.1
Structural Grade:	0
O&M Grade:	0
Clock Start/From:	
Clock To:	
1st Value:	
2nd Value:	
Value Percent:	
Continuous Index:	
Within 8" of Joint:	NO
Remarks:	MAKE IT TO THE POINT OF OVERLAP. REVERSAL COMPLETE
