## Profile/Photo Observation Report

Date:	<b>10/20/2021</b>	Weather:		Coding:	<b>PACP 7.0</b>
Pipe Length (ft):	<b>203.0</b>	Owner:	<b>City of Hobart</b>	Pre Clean:	<b>Heavy Cleaning</b>
P.O.#:	<b>YES502259</b>	Surveyor:	<b>S. Bucklin</b>	PSR:	<b>P-503-053-054</b>
Customer:	<b>City of Hobart</b>	Clean Date:	<b>08/24/2021</b>	Shape:	<b>C</b>

Street:	<b>North Guyer Street</b>	Flow Control:	<b>Not Controlled</b>
City:	<b>Hobart, IN</b>	Year Renewed:	
Location:	<b>Easement/Right of Way</b>	Tape/Media #:	
Purpose:	<b>Routine Assessment</b>	Dia/Height:	<b>10"</b>
Use:	<b>Sanitary Sewage Pipe</b>	Material:	<b>VCP</b>
Drain Area:		Lining:	<b>None</b>
Category:	<b>NA</b>		
Comment:

Location Details:		Direction of Survey:	<b>Downstream</b>
US MH:	<b>M-503-053</b>	DS MH:	<b>M-503-054</b>
		Total Length Surveyed (ft):	<b>76.1</b>

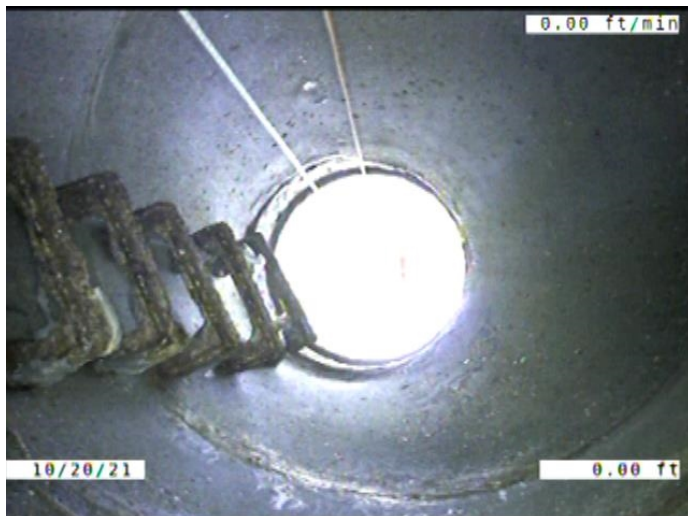
Code: **AMH**  
 Description: **Manhole**

Distance (ft): **.0**  
 Structural Grade: **0**  
 O&M Grade: **0**  
 Clock Start/From:  
 Clock To:  
 1st Value:  
 2nd Value:  
 Value Percent:  
 Continuous Index:  
 Within 8" of Joint: **NO**  
 Remarks: **M-503-053**

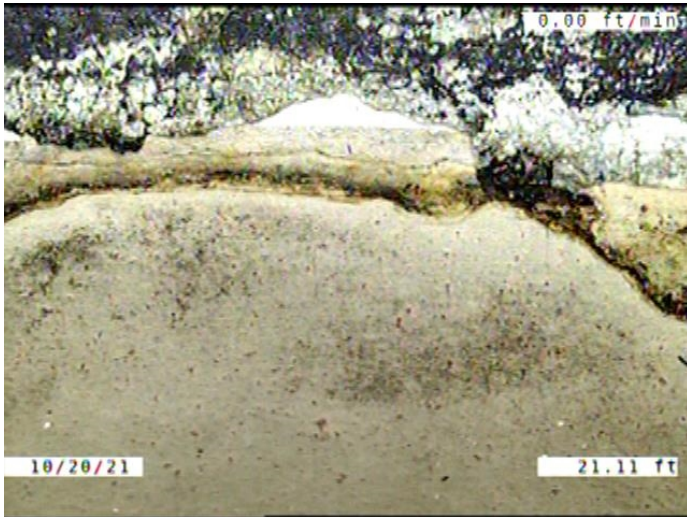
Code: **CS**  
 Description: **Crack Spiral**

Distance (ft): **21.1**  
 Structural Grade: **2**  
 O&M Grade: **0**  
 Clock Start/From: **12**  
 Clock To: **12**  
 1st Value:  
 2nd Value:  
 Value Percent:  
 Continuous Index:  
 Within 8" of Joint: **YES**  
 Remarks:

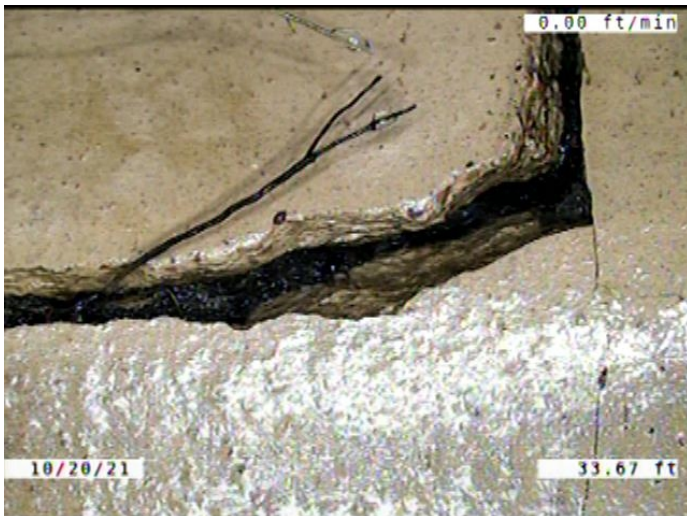
Code: **B**  
 Description: **Broken**

Distance (ft): **33.7**  
 Structural Grade: **4**  
 O&M Grade: **0**  
 Clock Start/From: **12**  
 Clock To: **12**  
 1st Value:  
 2nd Value:  
 Value Percent:  
 Continuous Index:  
 Within 8" of Joint: **YES**  
 Remarks:

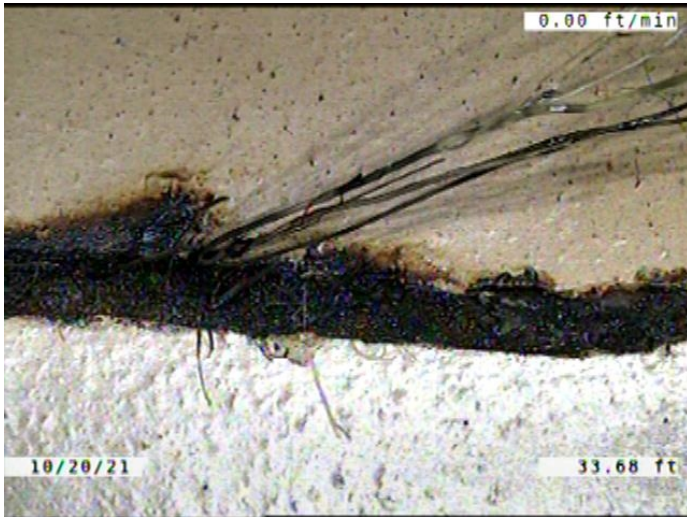
Code: **RFB**  
 Description: **Roots Fine Barrel**

Distance (ft): **33.7**  
 Structural Grade: **0**  
 O&M Grade: **2**  
 Clock Start/From: **8**  
 Clock To: **4**  
 1st Value:  
 2nd Value:  
 Value Percent:  
 Continuous Index:  
 Within 8" of Joint: **NO**  
 Remarks:

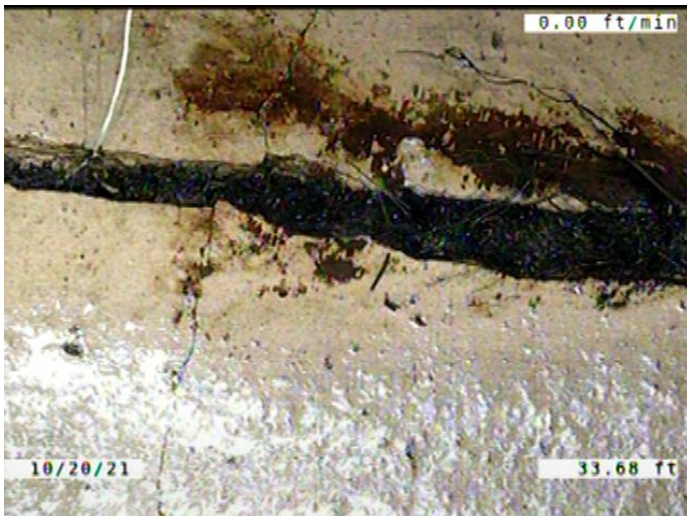
Code: **ISB**  
 Description: **Infiltration Stain Barrel**

Distance (ft): **33.7**  
 Structural Grade: **0**  
 O&M Grade: **1**  
 Clock Start/From: **9**  
 Clock To: **3**  
 1st Value:  
 2nd Value:  
 Value Percent:  
 Continuous Index:  
 Within 8" of Joint: **YES**  
 Remarks:

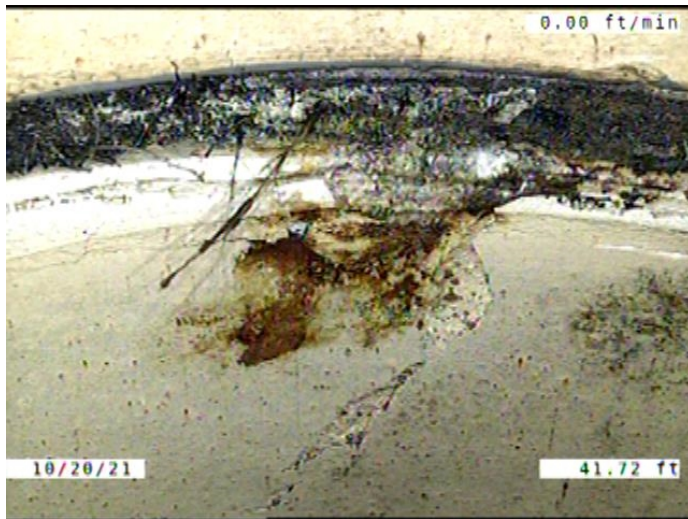
Code: **CS**  
 Description: **Crack Spiral**

Distance (ft): **41.7**  
 Structural Grade: **2**  
 O&M Grade: **0**  
 Clock Start/From: **12**  
 Clock To: **12**  
 1st Value:  
 2nd Value:  
 Value Percent:  
 Continuous Index:  
 Within 8" of Joint: **YES**  
 Remarks:

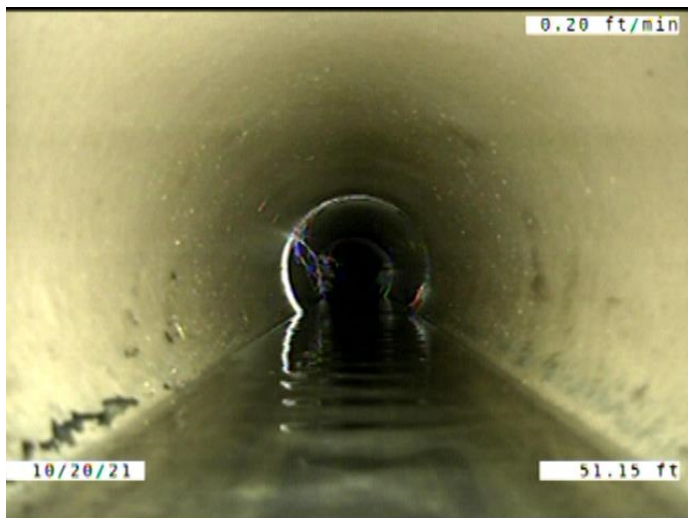
Code: **FS**  
 Description: **Fracture Spiral**

Distance (ft): **51.2**  
 Structural Grade: **3**  
 O&M Grade: **0**  
 Clock Start/From: **12**  
 Clock To: **1**  
 1st Value:  
 2nd Value:  
 Value Percent:  
 Continuous Index: **F02**  
 Within 8" of Joint: **YES**  
 Remarks:
