## Profile/Photo Observation Report

Street:	<b>N GUYER ST</b>	Flow Control:	<b>Not Controlled</b>
City:	<b>Hobart, IN</b>	Year Renewed:	
Location:	<b>Other</b>	Tape/Media #:	
Purpose:	<b>Not Known</b>	Dia/Height:	<b>10"</b>
Use:	<b>Sanitary</b>	Material:	<b>VCP</b>
Drain Area:	<b>NA</b>	Lining:	
Category:	<b>NA</b>		
Comment:

Location Details:		Direction of Survey:	<b>Downstream</b>
US MH:	<b>M-503-054</b>	DS MH:	<b>M-503-055</b>
		Total Length Surveyed (ft):	<b>54.8</b>

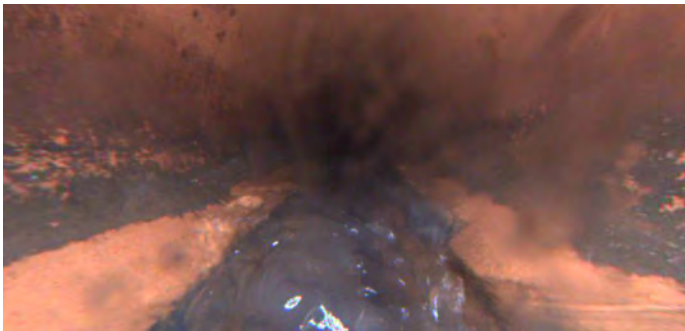
Code: **AMH**  
Description: **Manhole**

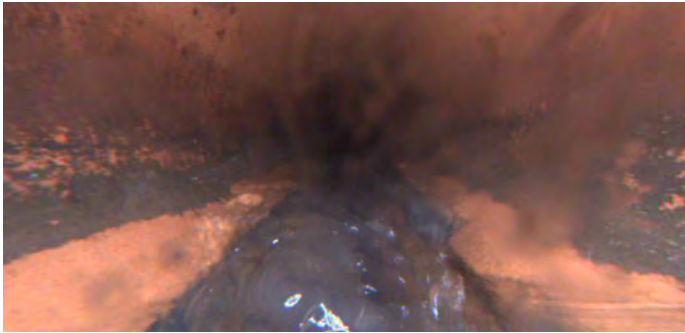
Code:	<b>MWL</b>
Description:	<b>Water Level</b>

Distance (ft):	<b>.0</b>
Structural Grade:	<b>0</b>
O&M Grade:	<b>0</b>
Clock Start/From:	
Clock To:	
1st Value:	
2nd Value:	
Value Percent:	<b>10.000</b>
Continuous Index:	
Within 8" of Joint:	<b>NO</b>
Remarks:

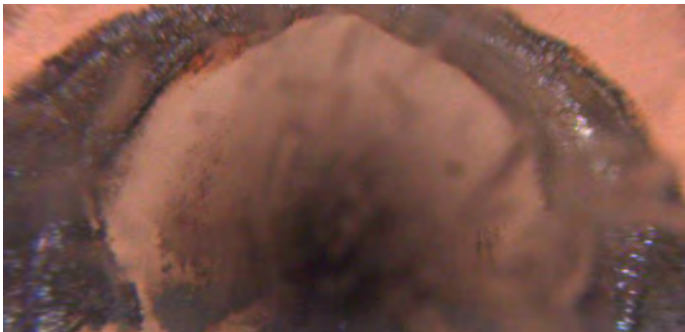
Code:	<b>IW</b>
Description:	<b>Infil Weeper</b>

Distance (ft):	<b>3.3</b>
Structural Grade:	<b>0</b>
O&M Grade:	<b>2</b>
Clock Start/From:	<b>8</b>
Clock To:	<b>4</b>
1st Value:	
2nd Value:	
Value Percent:	
Continuous Index:	
Within 8" of Joint:	<b>YES</b>
Remarks:

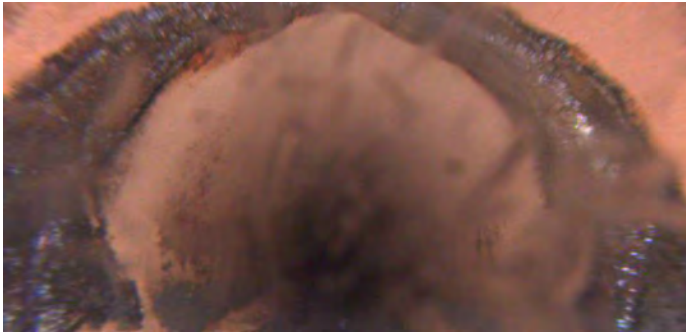
Code:	<b>DAE</b>
Description:	<b>Deposits Attached Encrustation</b>

Distance (ft):	<b>3.3</b>
Structural Grade:	<b>0</b>
O&M Grade:	<b>2</b>
Clock Start/From:	<b>8</b>
Clock To:	<b>4</b>
1st Value:	
2nd Value:	
Value Percent:	<b>5.000</b>
Continuous Index:	
Within 8" of Joint:	<b>YES</b>
Remarks:

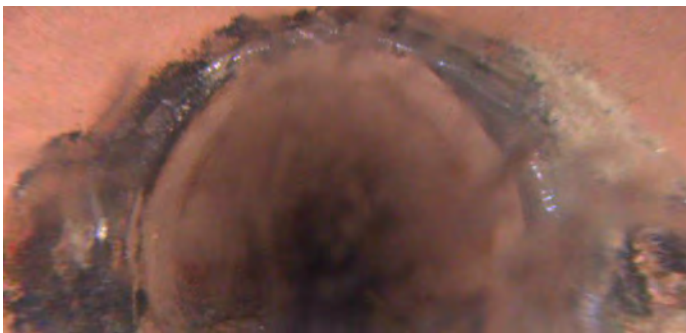
Code:	<b>IW</b>
Description:	<b>Infil Weeper</b>

Distance (ft):	<b>18.2</b>
Structural Grade:	<b>0</b>
O&M Grade:	<b>2</b>
Clock Start/From:	<b>8</b>
Clock To:	<b>4</b>
1st Value:	
2nd Value:	
Value Percent:	
Continuous Index:	<b>S01</b>
Within 8" of Joint:	<b>YES</b>
Remarks:

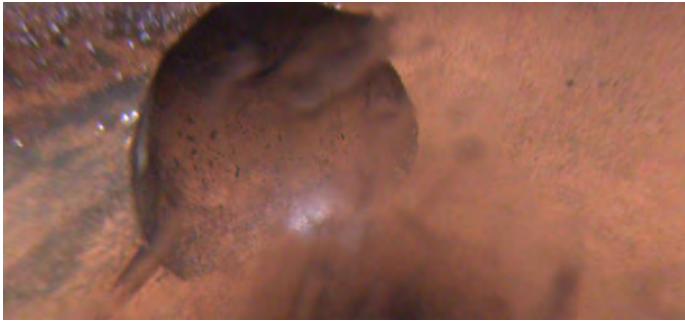
Code: **TFA**  
Description: **Tap Factory Active**

Distance (ft): **34.2**  
Structural Grade: **0**  
O&M Grade: **0**  
Clock Start/From: **11**  
Clock To:  
1st Value: **4.000**  
2nd Value:  
Value Percent:  
Continuous Index:  
Within 8" of Joint:  
Remarks:

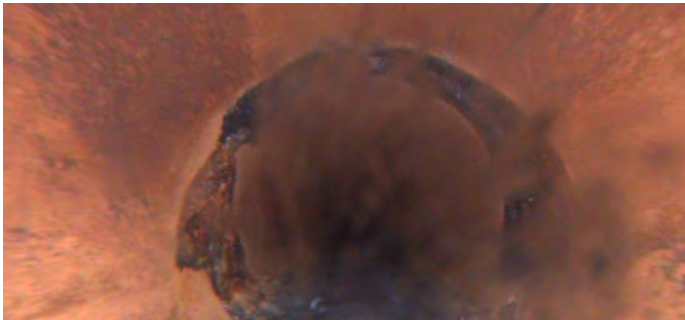
Code: **DAE**  
Description: **Deposits Attached Encrustation**

Distance (ft): **35.3**  
Structural Grade: **0**  
O&M Grade: **2**  
Clock Start/From: **8**  
Clock To: **4**  
1st Value:  
2nd Value:  
Value Percent: **5.000**  
Continuous Index:  
Within 8" of Joint: **YES**  
Remarks:

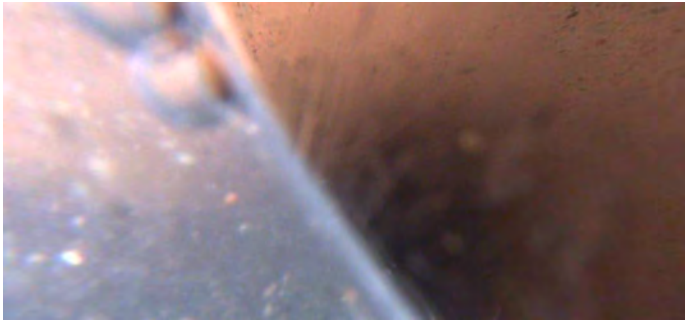
Code: **MWL**  
Description: **Water Level**

Distance (ft): **54.8**  
Structural Grade: **0**  
O&M Grade: **0**  
Clock Start/From:  
Clock To:  
1st Value:  
2nd Value:  
Value Percent: **40.000**  
Continuous Index:  
Within 8" of Joint: **NO**  
Remarks:

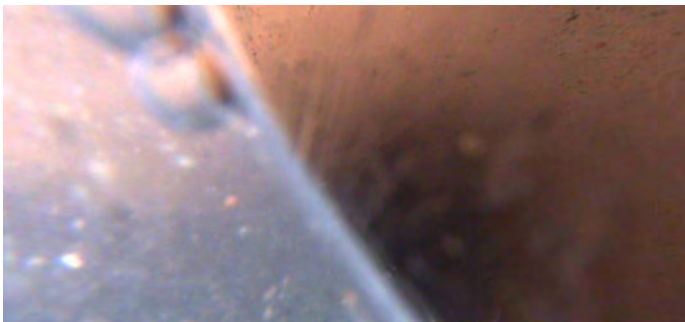
Code: **MSA**  
Description: **Abandoned Survey**

Distance (ft): **54.8**  
Structural Grade: **0**  
O&M Grade: **0**  
Clock Start/From:  
Clock To:  
1st Value:  
2nd Value:  
Value Percent:  
Continuous Index:  
Within 8" of Joint: **NO**  
Remarks: **overturned**

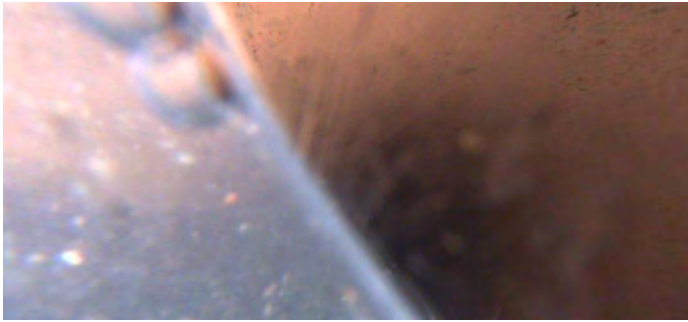
Code:	<b>IW</b>
Description:	<b>Infil Weeper</b>
Distance (ft):	<b>54.8</b>
Structural Grade:	<b>0</b>
O&M Grade:	<b>2</b>
Clock Start/From:	<b>8</b>
Clock To:	<b>4</b>
1st Value:	
2nd Value:	
Value Percent:	
Continuous Index:	<b>F01</b>
Within 8" of Joint:	<b>YES</b>
Remarks:
