## Profile/Photo Observation Report

Street:	<b>N GUYER ST</b>	Flow Control:	<b>Not Controlled</b>
City:	<b>Hobart, IN</b>	Year Renewed:	
Location:	<b>Other</b>	Tape/Media #:	
Purpose:	<b>Not Known</b>	Dia/Height:	<b>10"</b>
Use:	<b>Sanitary</b>	Material:	<b>VCP</b>
Drain Area:	<b>NA</b>	Lining:	
Category:	<b>NA</b>		
Comment:

Location Details:		Direction of Survey:	<b>Upstream</b>
US MH:	<b>M-503-054</b>	DS MH:	<b>M-503-055</b>
		Total Length Surveyed (ft):	<b>6.1</b>

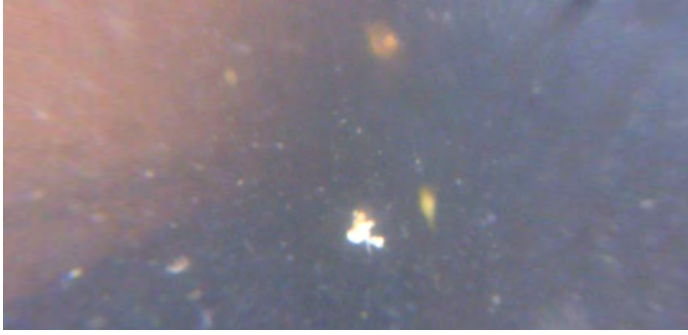
Code:	<b>MSA</b>
Description:	<b>Abandoned Survey</b>
Distance (ft):	<b>6.1</b>
Structural Grade:	<b>0</b>
O&M Grade:	<b>0</b>
Clock Start/From:	
Clock To:	
1st Value:	
2nd Value:	
Value Percent:	
Continuous Index:	
Within 8" of Joint:	<b>NO</b>
Remarks:	<b>MCU</b>
