Profile/Photo Observation Report

Street:	W 40th ave	Flow Control:	Not Controlled
City:	Hobart, IN	Year Renewed:	
Location:	Other	Tape/Media #:	
Purpose:	Not Known	Dia/Height:	10"
Use:	Sanitary	Material:	VCP
Drain Area:	NA	Lining:	
Category:	NA		
Comment:

Location Details:		Direction of Survey:	Upstream
US MH:	M-503-054	DS MH:	M-503-055
		Total Length Surveyed (ft):	6.1

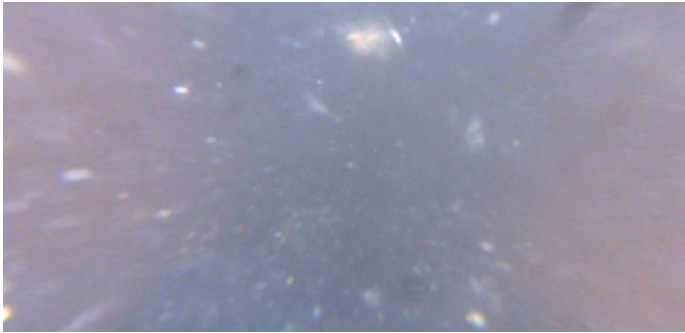
Code:	MWL
Description:	Water Level

Distance (ft):	.0
Structural Grade:	0
O&M Grade:	0
Clock Start/From:	
Clock To:	
1st Value:	
2nd Value:	
Value Percent:	100.000
Continuous Index:	
Within 8" of Joint:	NO
Remarks:

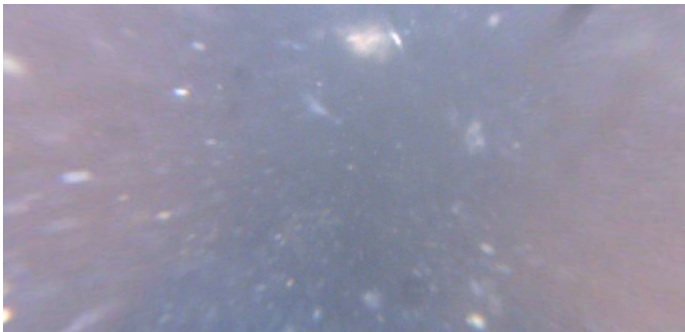
Code:	MCU
Description:	Camera Underwater

Distance (ft):	.0
Structural Grade:	0
O&M Grade:	4
Clock Start/From:	
Clock To:	
1st Value:	
2nd Value:	
Value Percent:	
Continuous Index:	
Within 8" of Joint:	NO
Remarks:

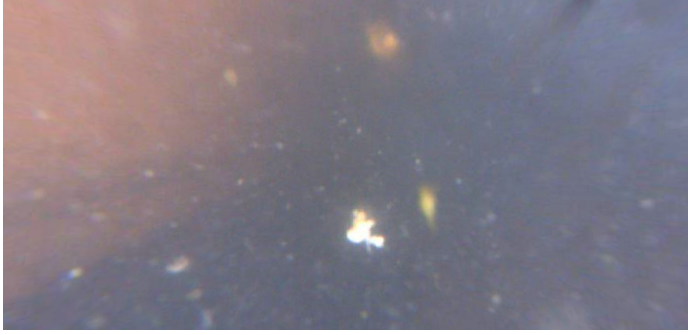
Code:	MSA
Description:	Abandoned Survey
Distance (ft):	6.1
Structural Grade:	0
O&M Grade:	0
Clock Start/From:	
Clock To:	
1st Value:	
2nd Value:	
Value Percent:	
Continuous Index:	
Within 8" of Joint:	NO
Remarks:	MCU
