Profile/Photo Observation Report

Date:	09/17/2021	Weather:		Coding:	PACP 7.0
Pipe Length (ft):	256.6	Owner:	City of Hobart	Pre Clean:	Heavy Cleaning
P.O.#:	YES502259	Surveyor:	S. Bucklin	PSR:	P-503-054-055
Customer:	City of Hobart	Clean Date:	08/24/2021	Shape:	C

Street:	North Guyer Street	Flow Control:	Not Controlled
City:	Hobart, IN	Year Renewed:	
Location:	Local rural streets with light traffic, t	Tape/Media #:	
Purpose:	Routine Assessment	Dia/Height:	10"
Use:	Sanitary Sewage Pipe	Material:	VCP
Drain Area:		Lining:	None
Category:	NA		
Comment:			
Location Details:		Direction of Survey:	Downstream
US MH:	M-503-054	DS MH:	M-503-055
		Total Length Surveyed (ft):	256.6

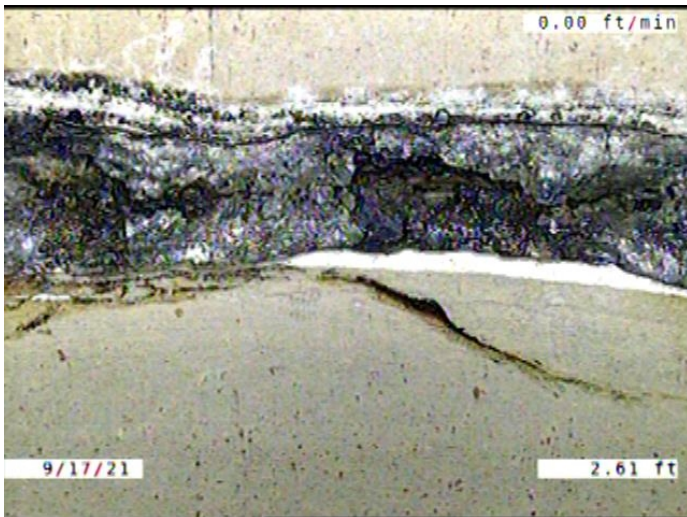
Code: **DAE**
Description: **Deposits Attached Encrustation**

Distance (ft): **2.6**
Structural Grade: **0**
O&M Grade: **2**
Clock Start/From: **7**
Clock To: **5**
1st Value:
2nd Value:
Value Percent: **5.000**
Continuous Index:
Within 8" of Joint: **YES**
Remarks:

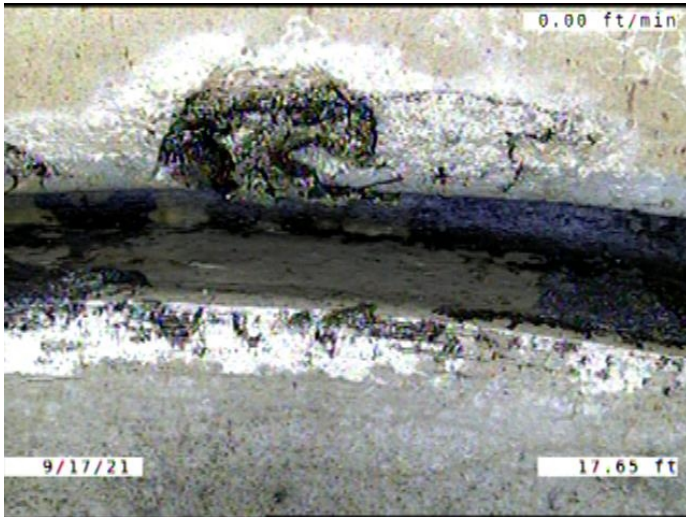
Code: **DAE**
Description: **Deposits Attached Encrustation**

Distance (ft): **17.6**
Structural Grade: **0**
O&M Grade: **2**
Clock Start/From: **8**
Clock To: **4**
1st Value:
2nd Value:
Value Percent: **5.000**
Continuous Index:
Within 8" of Joint: **YES**
Remarks:

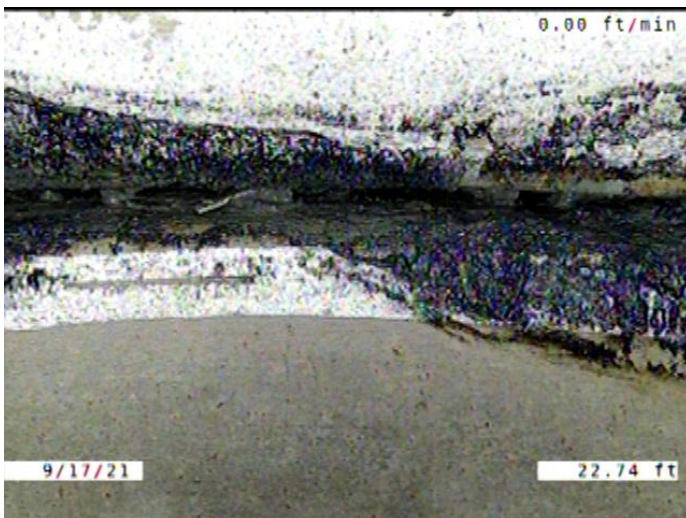
Code: **DAE**
Description: **Deposits Attached Encrustation**

Distance (ft): **22.7**
Structural Grade: **0**
O&M Grade: **2**
Clock Start/From: **8**
Clock To: **4**
1st Value:
2nd Value:
Value Percent: **5.000**
Continuous Index: **S01**
Within 8" of Joint: **YES**
Remarks:

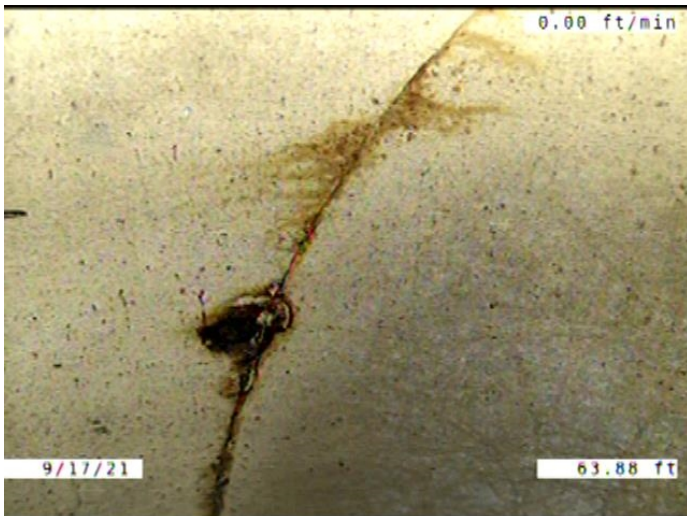
Code: **CS**
 Description: **Crack Spiral**

Distance (ft): **63.9**
 Structural Grade: **2**
 O&M Grade: **0**
 Clock Start/From: **11**
 Clock To: **1**
 1st Value:
 2nd Value:
 Value Percent:
 Continuous Index:
 Within 8" of Joint: **YES**
 Remarks:

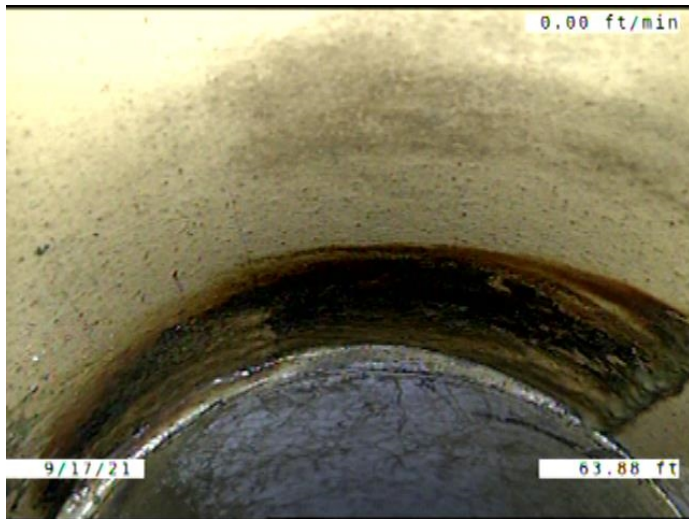
Code: **ISB**
Description: **Infiltration Stain Barrel**

Distance (ft): **63.9**
Structural Grade: **0**
O&M Grade: **1**
Clock Start/From: **8**
Clock To: **12**
1st Value:
2nd Value:
Value Percent:
Continuous Index:
Within 8" of Joint: **YES**
Remarks:

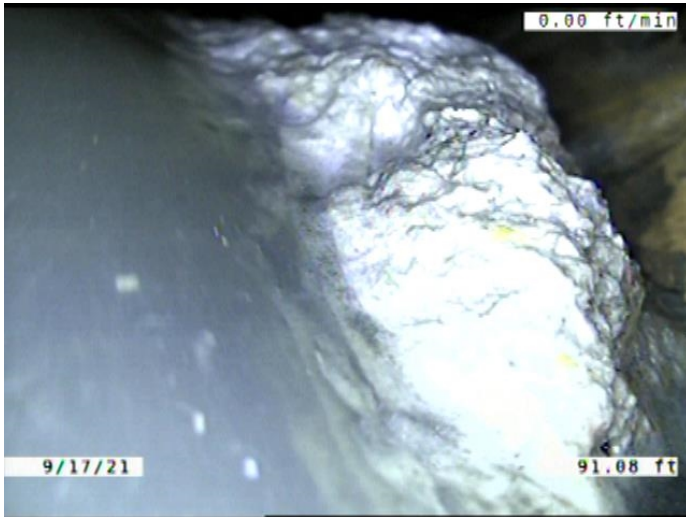
Code: **OBZ**
 Description: **Obstruction Other**

Distance (ft): **91.1**
 Structural Grade: **0**
 O&M Grade: **2**
 Clock Start/From: **5**
 Clock To:
 1st Value:
 2nd Value:
 Value Percent: **5.000**
 Continuous Index:
 Within 8" of Joint: **YES**
 Remarks: **TP AND RAGS**

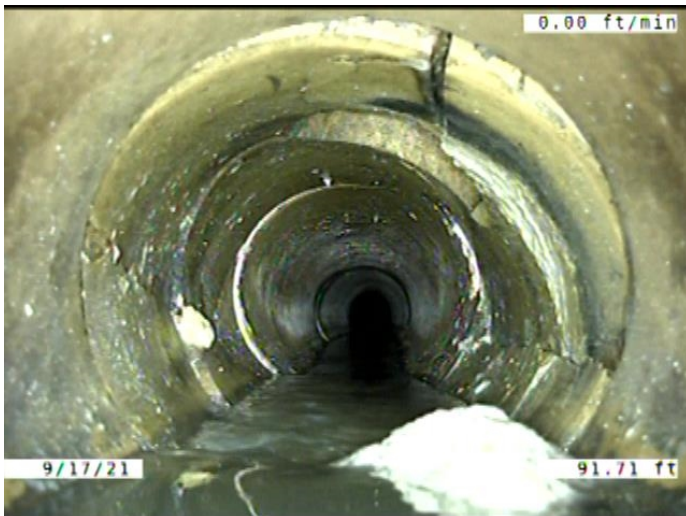
Code: **FM**
 Description: **Fracture Multiple**

Distance (ft): **91.7**
 Structural Grade: **4**
 O&M Grade: **0**
 Clock Start/From: **12**
 Clock To: **12**
 1st Value:
 2nd Value:
 Value Percent:
 Continuous Index:
 Within 8" of Joint: **YES**
 Remarks:

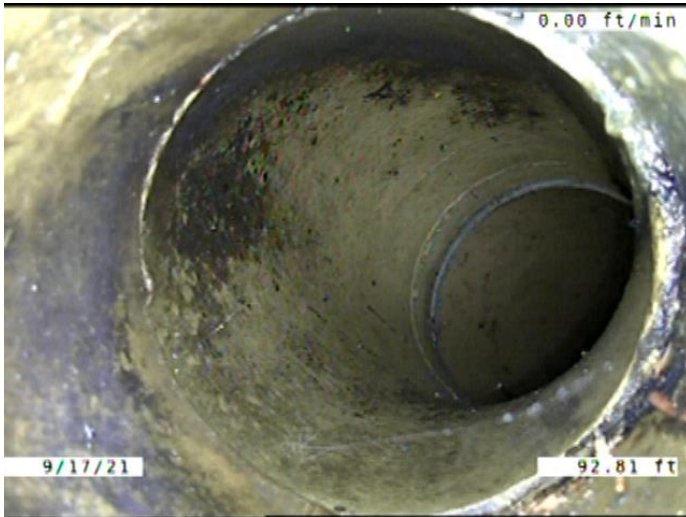
Code: **TFD**
Description: **Tap Factory Defective**

Distance (ft): **92.8**
Structural Grade: **0**
O&M Grade: **3**
Clock Start/From: **1**
Clock To:
1st Value: **4.000**
2nd Value:
Value Percent:
Continuous Index:
Within 8" of Joint: **YES**
Remarks: **Defective**

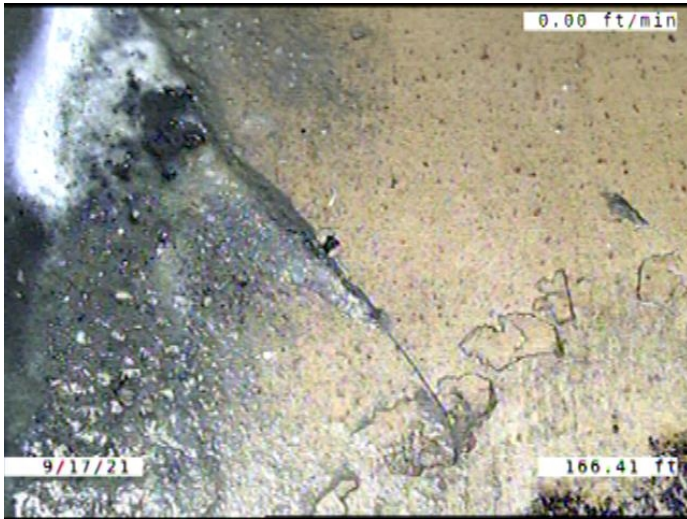
Code: **CS**
 Description: **Crack Spiral**

Distance (ft): **166.4**
 Structural Grade: **2**
 O&M Grade: **0**
 Clock Start/From: **3**
 Clock To: **5**
 1st Value:
 2nd Value:
 Value Percent:
 Continuous Index:
 Within 8" of Joint: **YES**
 Remarks:

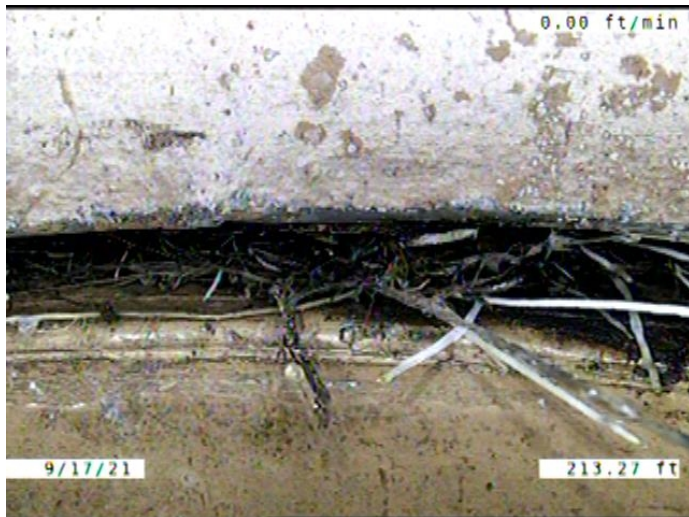
Code: **RFJ**
 Description: **Roots Fine Joint**

Distance (ft): **213.3**
 Structural Grade: **0**
 O&M Grade: **1**
 Clock Start/From: **11**
 Clock To: **2**
 1st Value:
 2nd Value:
 Value Percent:
 Continuous Index:
 Within 8" of Joint: **YES**
 Remarks:

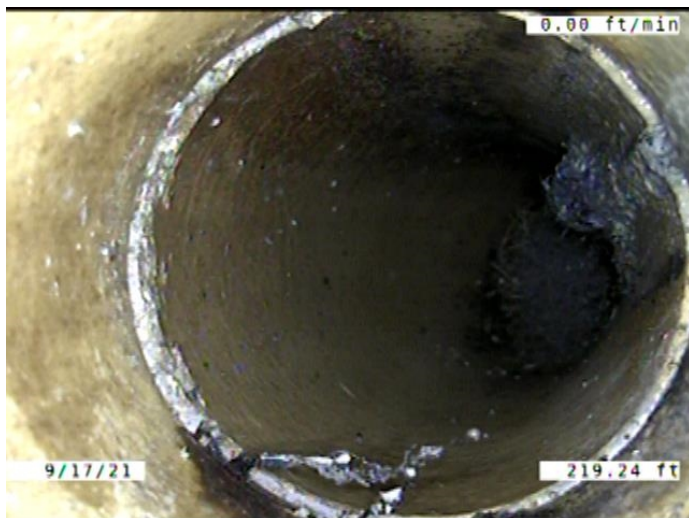
Code: **TF**
 Description: **Tap Factory**

Distance (ft): **219.2**
 Structural Grade: **0**
 O&M Grade: **0**
 Clock Start/From: **1**
 Clock To:
 1st Value: **4.000**
 2nd Value:
 Value Percent:
 Continuous Index:
 Within 8" of Joint: **YES**
 Remarks: **ROOTS GROWING IN THE TAP**

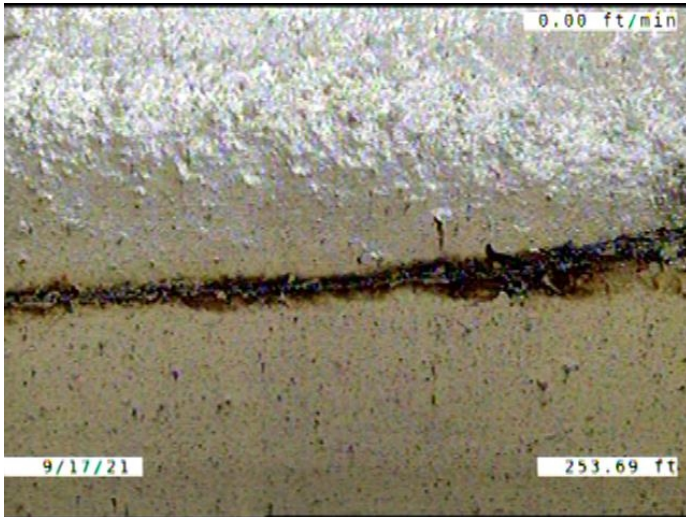
Code: **CS**
 Description: **Crack Spiral**

Distance (ft): **253.7**
 Structural Grade: **2**
 O&M Grade: **0**
 Clock Start/From: **10**
 Clock To: **3**
 1st Value:
 2nd Value:
 Value Percent:
 Continuous Index:
 Within 8" of Joint: **NO**
 Remarks:

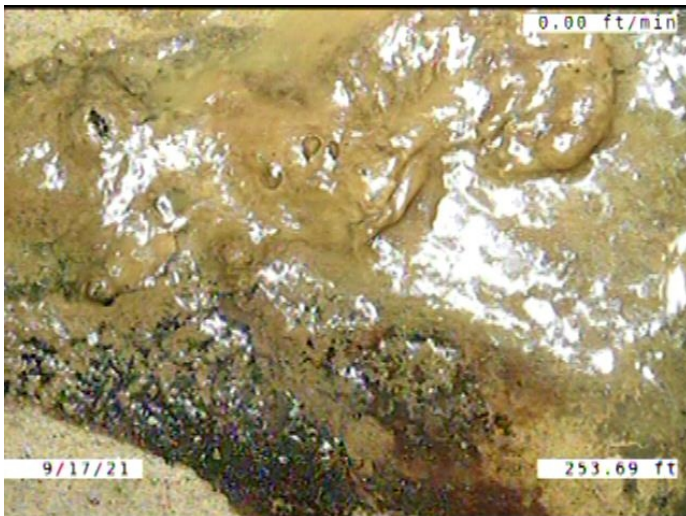
Code: **DAE**
 Description: **Deposits Attached Encrustation**

Distance (ft): **253.7**
 Structural Grade: **0**
 O&M Grade: **2**
 Clock Start/From: **7**
 Clock To: **5**
 1st Value:
 2nd Value:
 Value Percent: **5.000**
 Continuous Index:
 Within 8" of Joint: **NO**
 Remarks:

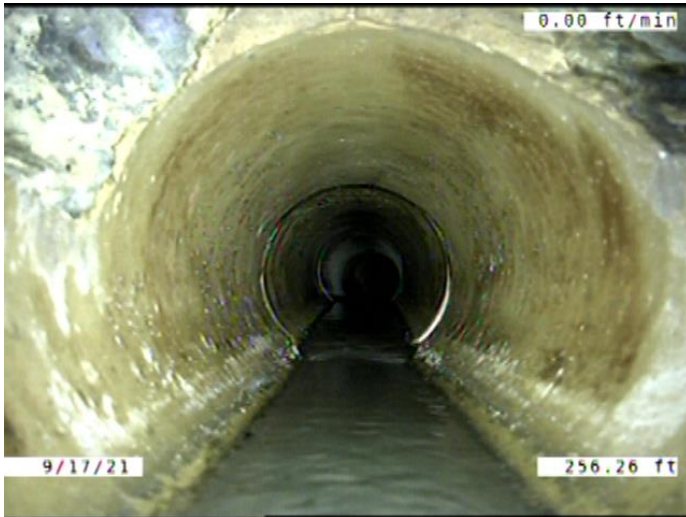
Code: **DAE**
 Description: **Deposits Attached Encrustation**

Distance (ft): **256.3**
 Structural Grade: **0**
 O&M Grade: **2**
 Clock Start/From: **8**
 Clock To: **4**
 1st Value:
 2nd Value:
 Value Percent: **5.000**
 Continuous Index: **F01**
 Within 8" of Joint: **YES**
 Remarks:
