Profile/Photo Observation Report

Date:	09/17/2021	Weather:		Coding:	PACP 7.0
Pipe Length (ft):	256.6	Owner:	City of Hobart	Pre Clean:	Heavy Cleaning
P.O.#:	YES502259	Surveyor:	S. Bucklin	PSR:	P-503-054-055
Customer:	City of Hobart	Clean Date:	08/24/2021	Shape:	C

Street:	North Guyer Street	Flow Control:	Not Controlled
City:	Hobart, IN	Year Renewed:	
Location:	Local rural streets with light traffic, t	Tape/Media #:	
Purpose:	Routine Assessment	Dia/Height:	10"
Use:	Sanitary Sewage Pipe	Material:	VCP
Drain Area:		Lining:	None
Category:	NA		
Comment:

Location Details:		Direction of Survey:	Downstream
US MH:	M-503-054	DS MH:	M-503-055
		Total Length Surveyed (ft):	256.6

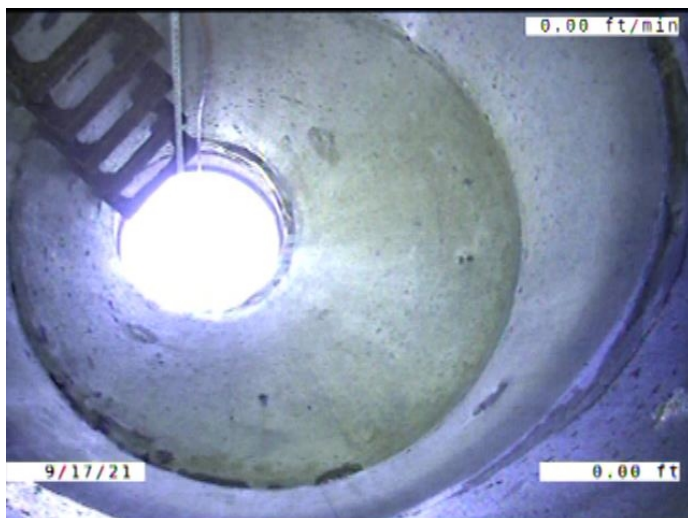
Code: **AMH**
 Description: **Manhole**

Distance (ft): **.0**
 Structural Grade: **0**
 O&M Grade: **0**
 Clock Start/From:
 Clock To:
 1st Value:
 2nd Value:
 Value Percent:
 Continuous Index:
 Within 8" of Joint: **NO**
 Remarks: **M-503-054**

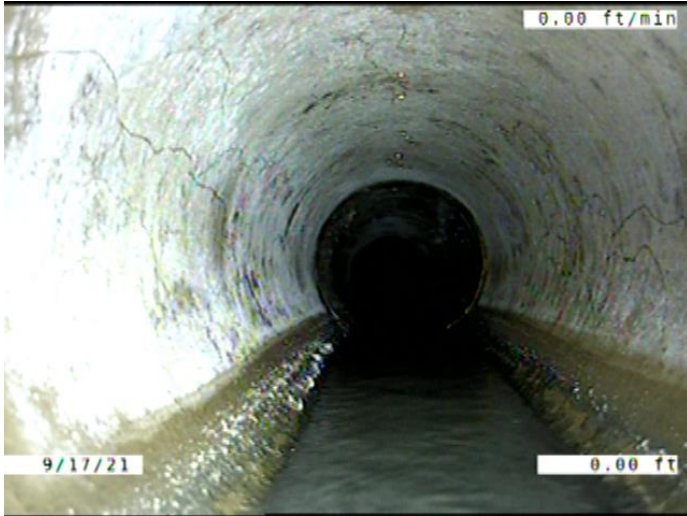
Code: **MWL**
Description: **Miscellaneous Water Level**

Distance (ft): **.0**
Structural Grade: **0**
O&M Grade: **0**
Clock Start/From:
Clock To:
1st Value:
2nd Value:
Value Percent: **5.000**
Continuous Index:
Within 8" of Joint: **NO**
Remarks:

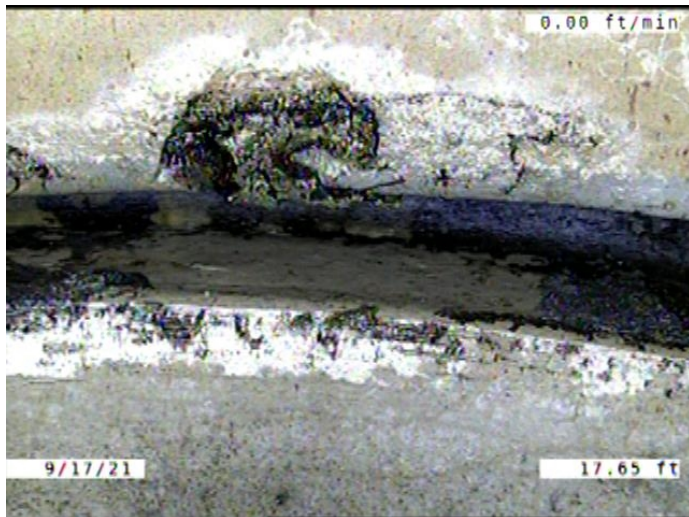
Code: **DAE**
 Description: **Deposits Attached Encrustation**

Distance (ft): **17.6**
 Structural Grade: **0**
 O&M Grade: **2**
 Clock Start/From: **8**
 Clock To: **4**
 1st Value:
 2nd Value:
 Value Percent: **5.000**
 Continuous Index:
 Within 8" of Joint: **YES**
 Remarks:

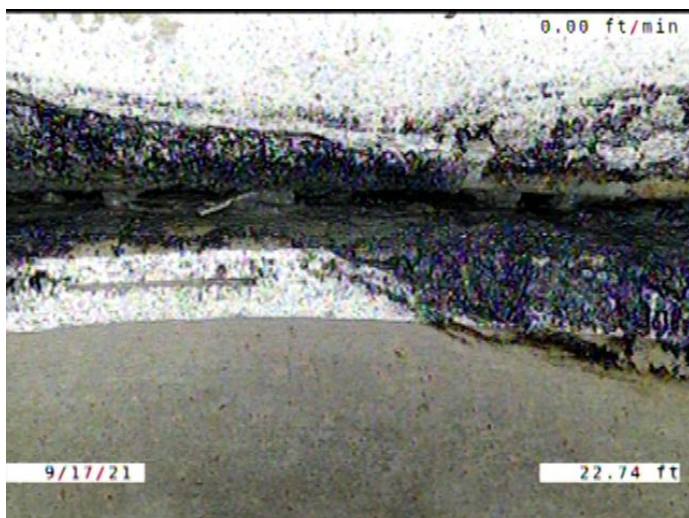
Code: **DAE**
 Description: **Deposits Attached Encrustation**

Distance (ft): **22.7**
 Structural Grade: **0**
 O&M Grade: **2**
 Clock Start/From: **8**
 Clock To: **4**
 1st Value:
 2nd Value:
 Value Percent: **5.000**
 Continuous Index: **S01**
 Within 8" of Joint: **YES**
 Remarks:

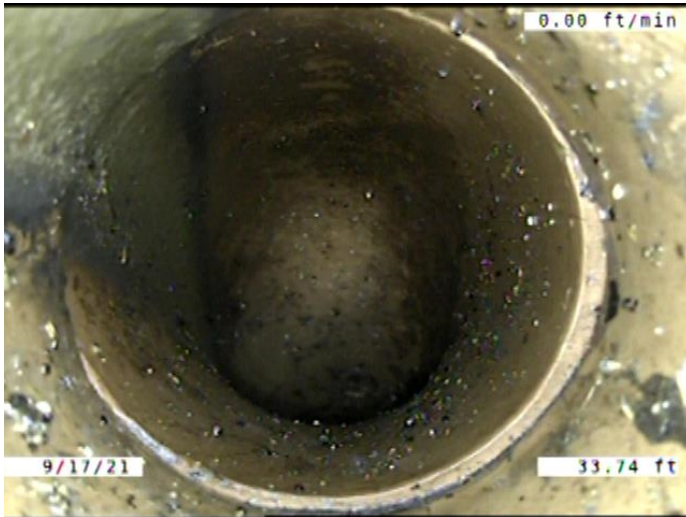
Code: **TF**
Description: **Tap Factory**

Distance (ft): **33.7**
Structural Grade: **0**
O&M Grade: **0**
Clock Start/From: **11**
Clock To:
1st Value: **4.000**
2nd Value:
Value Percent:
Continuous Index:
Within 8" of Joint: **YES**
Remarks:

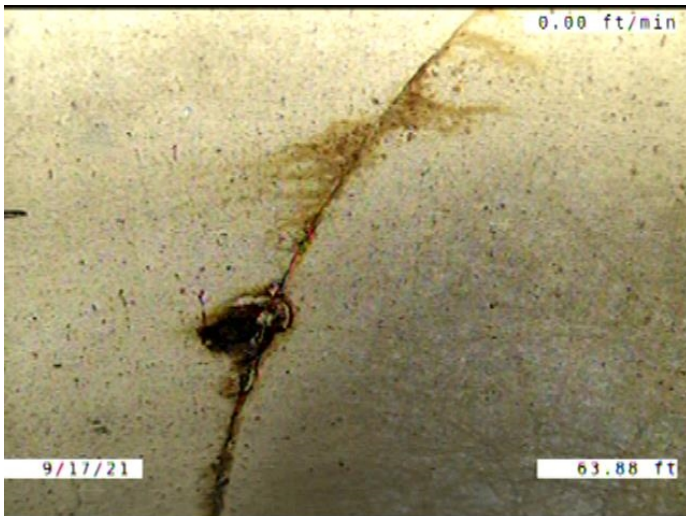
Code: **CS**
Description: **Crack Spiral**

Distance (ft): **63.9**
Structural Grade: **2**
O&M Grade: **0**
Clock Start/From: **11**
Clock To: **1**
1st Value:
2nd Value:
Value Percent:
Continuous Index:
Within 8" of Joint: **YES**
Remarks:

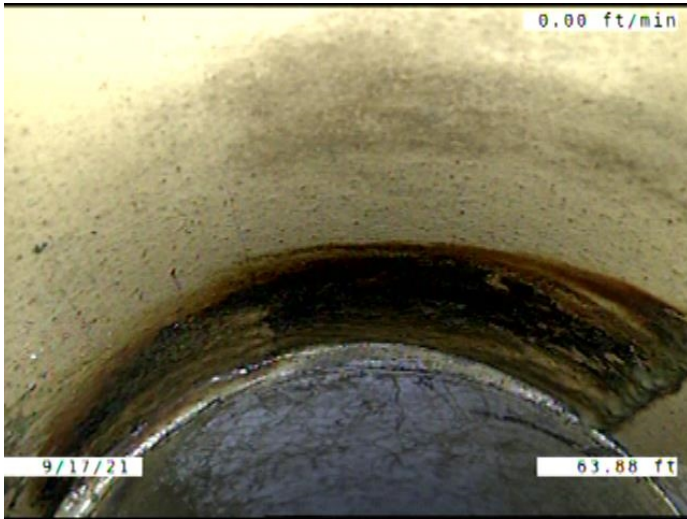
Code: **ISB**
Description: **Infiltration Stain Barrel**

Distance (ft): **63.9**
Structural Grade: **0**
O&M Grade: **1**
Clock Start/From: **8**
Clock To: **12**
1st Value:
2nd Value:
Value Percent:
Continuous Index:
Within 8" of Joint: **YES**
Remarks:

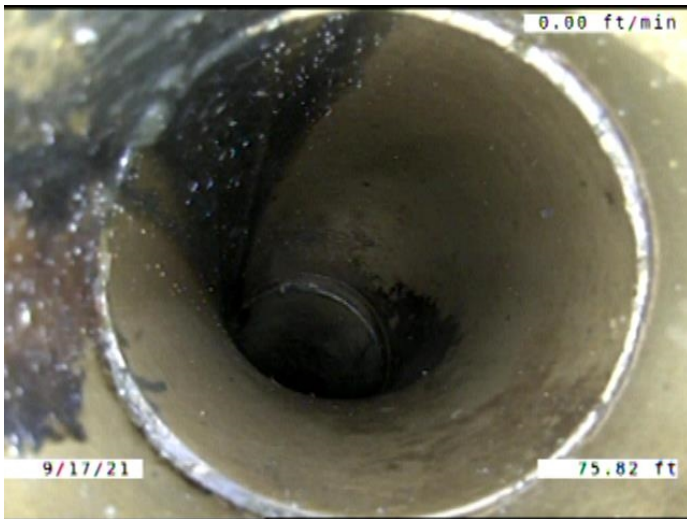
Code: **TF**
Description: **Tap Factory**

Distance (ft): **75.8**
Structural Grade: **0**
O&M Grade: **0**
Clock Start/From: **11**
Clock To:
1st Value: **4.000**
2nd Value:
Value Percent:
Continuous Index:
Within 8" of Joint: **YES**
Remarks:

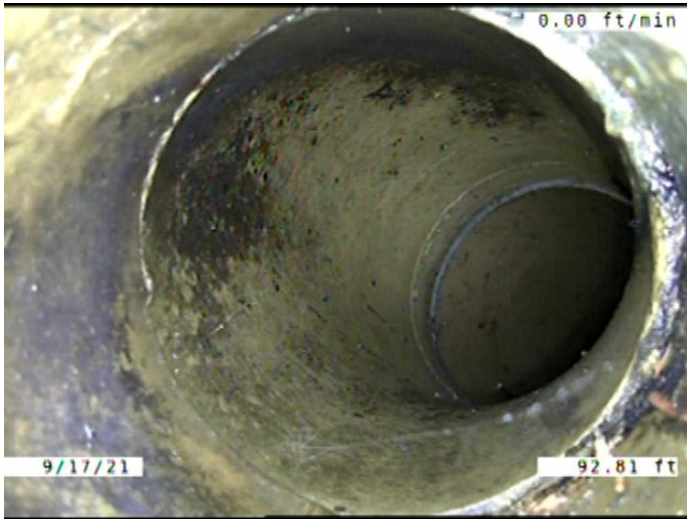
Code: **TFD**
Description: **Tap Factory Defective**

Distance (ft): **92.8**
Structural Grade: **0**
O&M Grade: **3**
Clock Start/From: **1**
Clock To:
1st Value: **4.000**
2nd Value:
Value Percent:
Continuous Index:
Within 8" of Joint: **YES**
Remarks: **Defective**

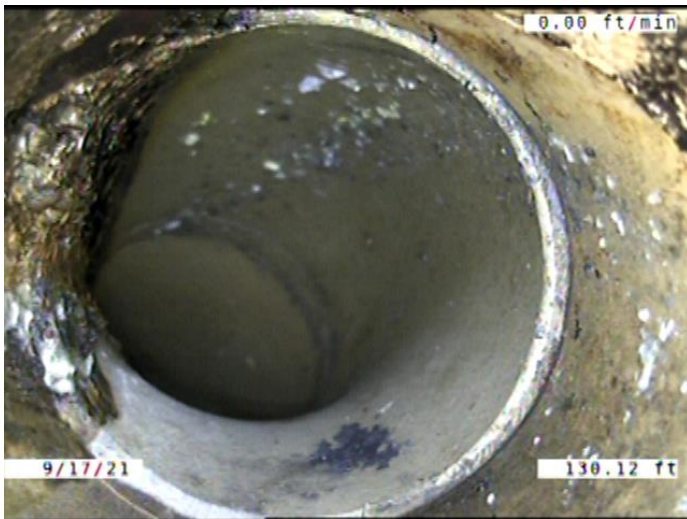
Code: **TF**
Description: **Tap Factory**

Distance (ft): **130.1**
Structural Grade: **0**
O&M Grade: **0**
Clock Start/From: **11**
Clock To:
1st Value: **4.000**
2nd Value:
Value Percent:
Continuous Index:
Within 8" of Joint: **YES**
Remarks:

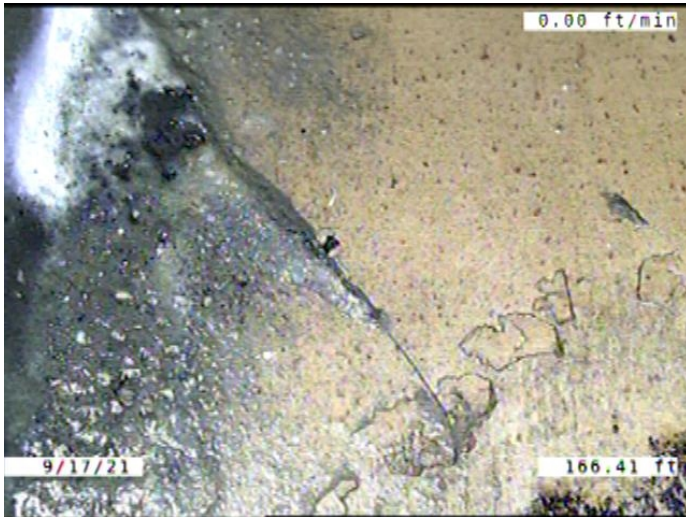
Code: **CS**
 Description: **Crack Spiral**

Distance (ft): **166.4**
 Structural Grade: **2**
 O&M Grade: **0**
 Clock Start/From: **3**
 Clock To: **5**
 1st Value:
 2nd Value:
 Value Percent:
 Continuous Index:
 Within 8" of Joint: **YES**
 Remarks:

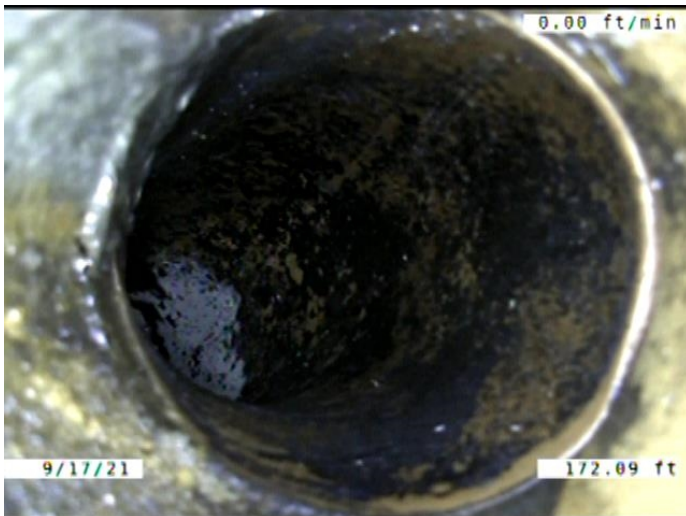
Code: **TFA**
 Description: **Tap Factory Activity**

Distance (ft): **172.1**
 Structural Grade: **0**
 O&M Grade: **0**
 Clock Start/From: **11**
 Clock To:
 1st Value: **4.000**
 2nd Value:
 Value Percent:
 Continuous Index:
 Within 8" of Joint: **YES**
 Remarks:

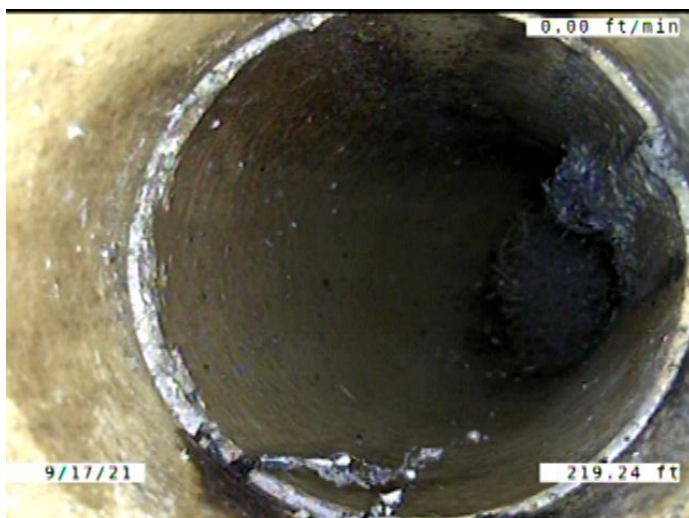
Code: **TF**
 Description: **Tap Factory**

Distance (ft): **219.2**
 Structural Grade: **0**
 O&M Grade: **0**
 Clock Start/From: **1**
 Clock To:
 1st Value: **4.000**
 2nd Value:
 Value Percent:
 Continuous Index:
 Within 8" of Joint: **YES**
 Remarks: **ROOTS GROWING IN THE TAP**

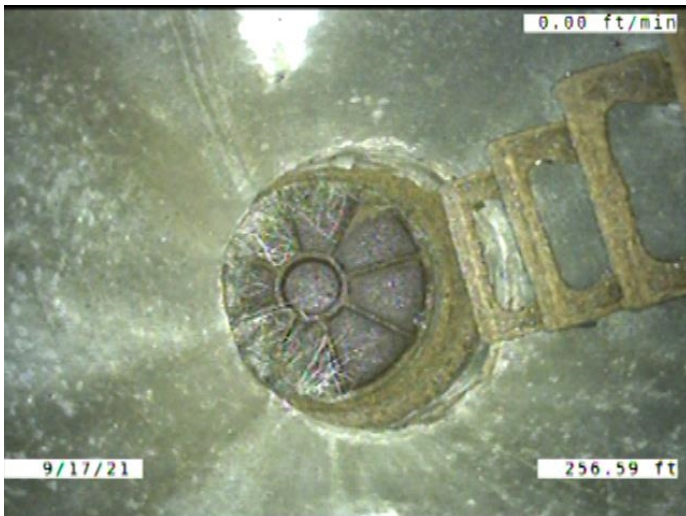
Code: **AMH**
 Description: **Manhole**

Distance (ft): **256.6**
 Structural Grade: **0**
 O&M Grade: **0**
 Clock Start/From:
 Clock To:
 1st Value:
 2nd Value:
 Value Percent:
 Continuous Index:
 Within 8" of Joint: **NO**
 Remarks: **M-503-055**
