Profile/Photo Observation Report

Street:	ALLEY BEWTWEEN W 38TH PL & W 3	Flow Control:	Not Controlled
City:	Hobart, IN	Year Renewed:	
Location:	Other	Tape/Media #:	
Purpose:	Not Known	Dia/Height:	10"
Use:	Sanitary	Material:	VCP
Drain Area:	NA	Lining:	
Category:	NA		
Comment:

Location Details:		Direction of Survey:	Downstream
US MH:	M-503-055	DS MH:	M-503-056
		Total Length Surveyed (ft):	83.0

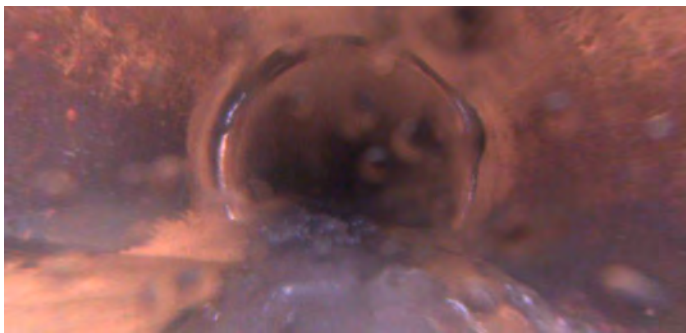
Code: **AMH**
Description: **Manhole**

Distance (ft): **.0**
Structural Grade: **0**
O&M Grade: **0**
Clock Start/From:
Clock To:
1st Value:
2nd Value:
Value Percent:
Continuous Index:
Within 8" of Joint: **NO**
Remarks: **M-503-055**

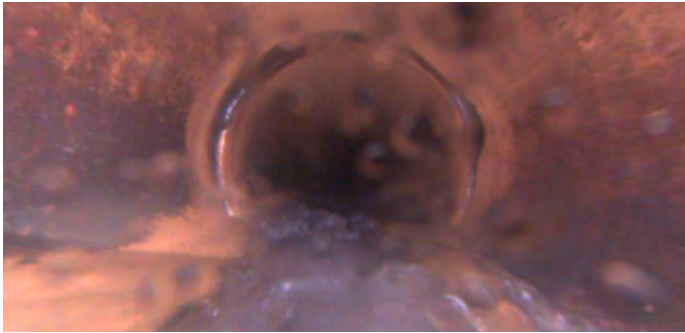
Code:	MWL
Description:	Water Level

Distance (ft):	.0
Structural Grade:	0
O&M Grade:	0
Clock Start/From:	
Clock To:	
1st Value:	
2nd Value:	
Value Percent:	10.000
Continuous Index:	
Within 8" of Joint:	NO
Remarks:

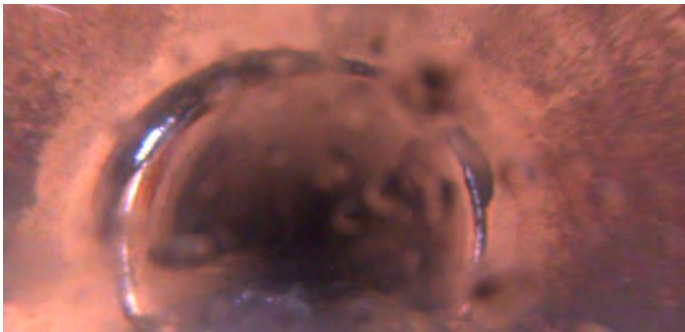
Code:	IW
Description:	Infil Weeper

Distance (ft):	.8
Structural Grade:	0
O&M Grade:	2
Clock Start/From:	8
Clock To:	4
1st Value:	
2nd Value:	
Value Percent:	
Continuous Index:	
Within 8" of Joint:	YES
Remarks:

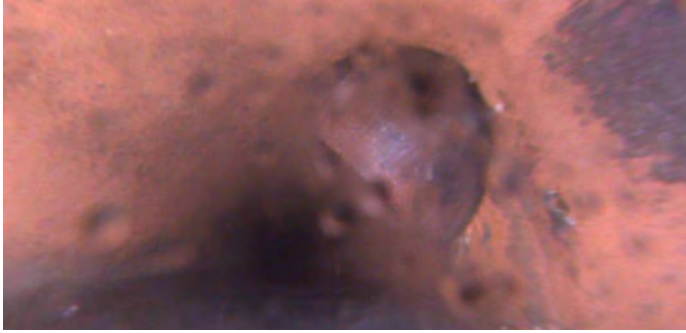
Code: **TF**
Description: **Tap Factory**

Distance (ft): **31.4**
Structural Grade: **0**
O&M Grade: **0**
Clock Start/From: **2**
Clock To:
1st Value: **4.000**
2nd Value:
Value Percent:
Continuous Index:
Within 8" of Joint:
Remarks:

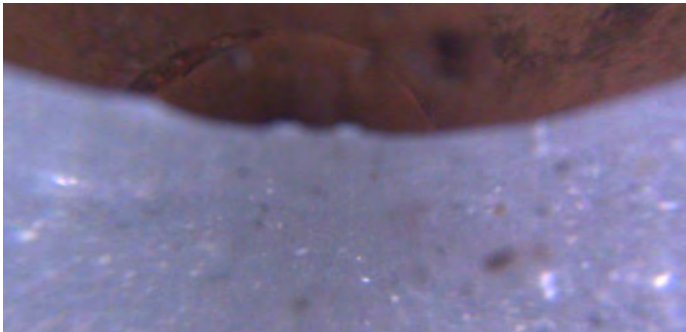
Code: **MWL**
Description: **Water Level**

Distance (ft): **32.7**
Structural Grade: **0**
O&M Grade: **0**
Clock Start/From:
Clock To:
1st Value:
2nd Value:
Value Percent: **60.000**
Continuous Index:
Within 8" of Joint: **NO**
Remarks:

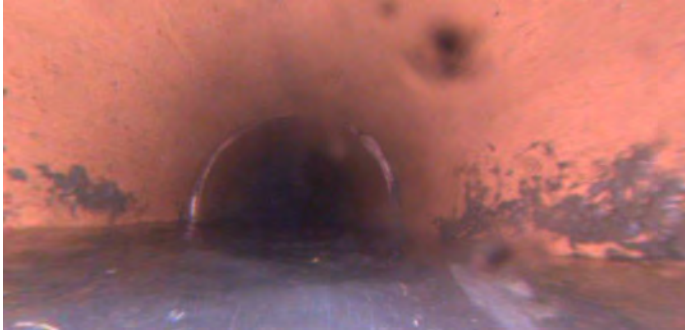
Code: **MWL**
Description: **Water Level**

Distance (ft): **37.0**
Structural Grade: **0**
O&M Grade: **0**
Clock Start/From:
Clock To:
1st Value:
2nd Value:
Value Percent: **40.000**
Continuous Index:
Within 8" of Joint: **NO**
Remarks:

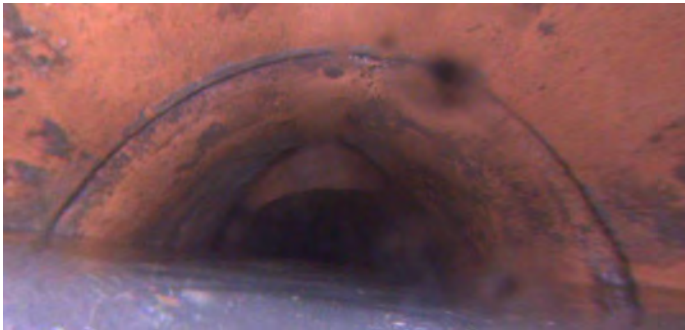
Code: **TF**
Description: **Tap Factory**

Distance (ft): **67.0**
Structural Grade: **0**
O&M Grade: **0**
Clock Start/From: **11**
Clock To:
1st Value: **4.000**
2nd Value:
Value Percent:
Continuous Index:
Within 8" of Joint:
Remarks:

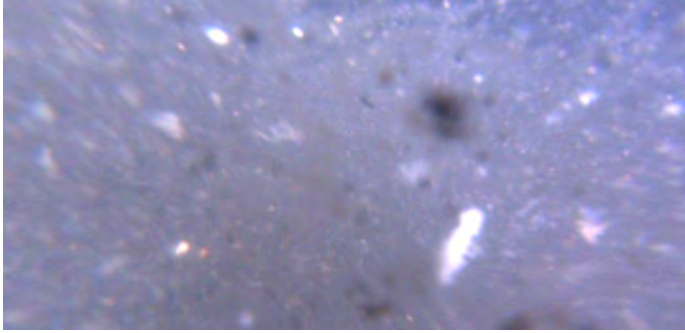
Code: **MWL**
Description: **Water Level**

Distance (ft): **67.3**
Structural Grade: **0**
O&M Grade: **0**
Clock Start/From:
Clock To:
1st Value:
2nd Value:
Value Percent: **70.000**
Continuous Index:
Within 8" of Joint: **NO**
Remarks:

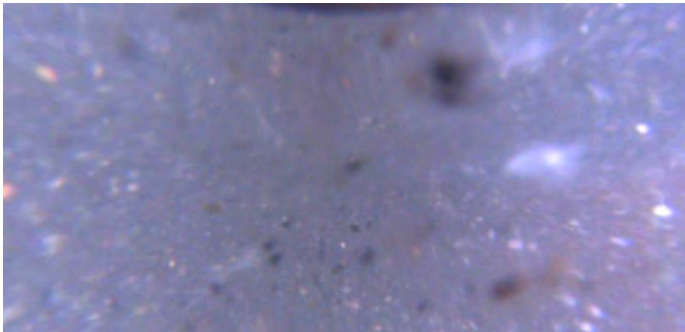
Code: **MCU**
Description: **Camera Underwater**

Distance (ft): **68.4**
Structural Grade: **0**
O&M Grade: **4**
Clock Start/From:
Clock To:
1st Value:
2nd Value:
Value Percent:
Continuous Index: **S01**
Within 8" of Joint: **NO**
Remarks:

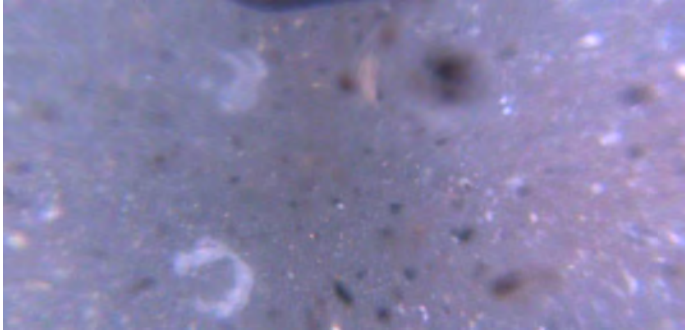
Code: **MCU**
Description: **Camera Underwater**

Distance (ft): **83.0**
Structural Grade: **0**
O&M Grade: **4**
Clock Start/From:
Clock To:
1st Value:
2nd Value:
Value Percent:
Continuous Index: **F01**
Within 8" of Joint: **NO**
Remarks:

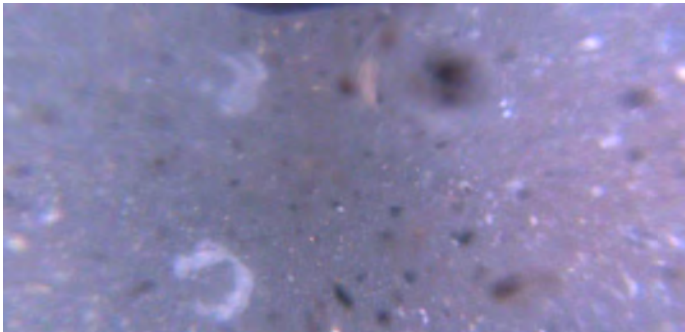
Code: **MCU**
Description: **Camera Underwater**

Distance (ft): **83.0**
Structural Grade: **0**
O&M Grade: **4**
Clock Start/From:
Clock To:
1st Value:
2nd Value:
Value Percent:
Continuous Index:
Within 8" of Joint: **NO**
Remarks:

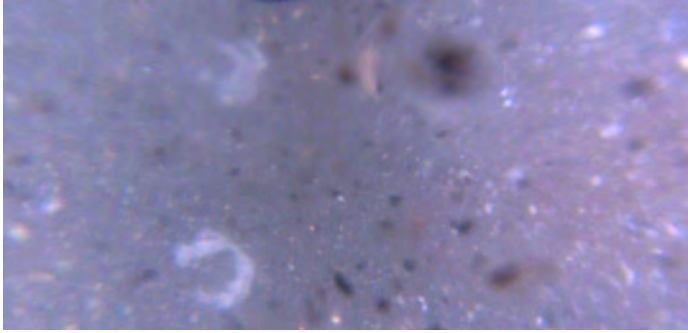
Code:	MSA
Description:	Abandoned Survey
Distance (ft):	83.0
Structural Grade:	0
O&M Grade:	0
Clock Start/From:	
Clock To:	
1st Value:	
2nd Value:	
Value Percent:	
Continuous Index:	
Within 8" of Joint:	NO
Remarks:	UNDER WATER
