Profile/Photo Observation Report

Street:	ALLEY BEWTWEEN W 38TH PL & W 3	Flow Control:	Not Controlled
City:	Hobart, IN	Year Renewed:	
Location:	Other	Tape/Media #:	
Purpose:	Not Known	Dia/Height:	10"
Use:	Sanitary	Material:	VCP
Drain Area:	NA	Lining:	
Category:	NA		
Comment:

Location Details:		Direction of Survey:	Upstream
US MH:	M-503-055	DS MH:	M-503-056
		Total Length Surveyed (ft):	118.3

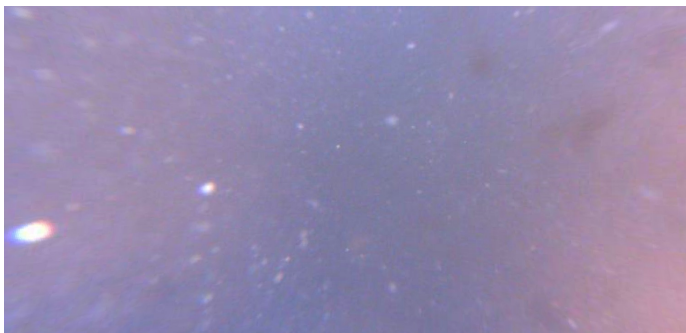
Code: **AMH**
Description: **Manhole**

Distance (ft): **.0**
Structural Grade: **0**
O&M Grade: **0**
Clock Start/From:
Clock To:
1st Value:
2nd Value:
Value Percent:
Continuous Index:
Within 8" of Joint: **NO**
Remarks: **M-503-055**

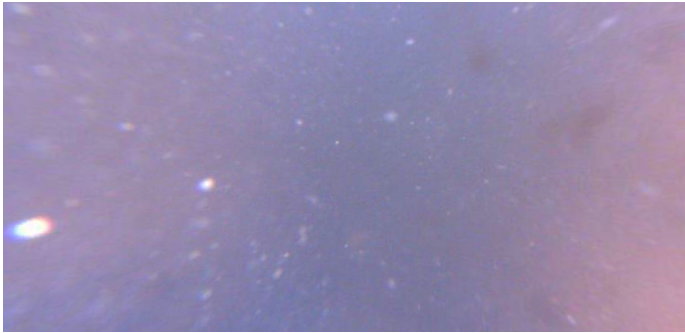
Code:	MWL
Description:	Water Level

Distance (ft):	.0
Structural Grade:	0
O&M Grade:	0
Clock Start/From:	
Clock To:	
1st Value:	
2nd Value:	
Value Percent:	100.000
Continuous Index:	
Within 8" of Joint:	NO
Remarks:

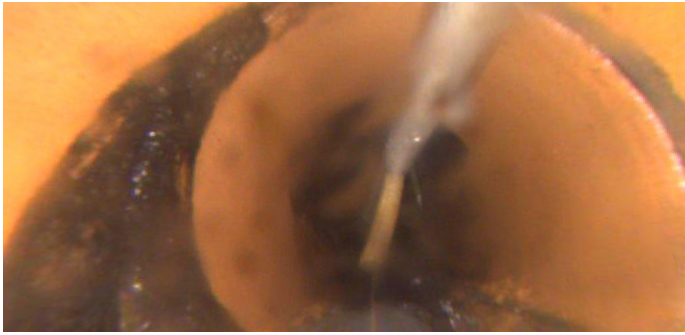
Code: **IW**
Description: **Infil Weeper**

Distance (ft): **.8**
Structural Grade: **0**
O&M Grade: **2**
Clock Start/From: **1**
Clock To: **4**
1st Value:
2nd Value:
Value Percent:
Continuous Index:
Within 8" of Joint: **YES**
Remarks:

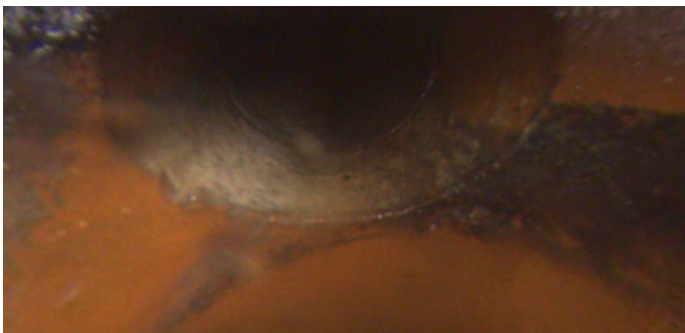
Code: **TF**
Description: **Tap Factory**

Distance (ft): **11.5**
Structural Grade: **0**
O&M Grade: **0**
Clock Start/From: **12**
Clock To:
1st Value: **4.000**
2nd Value:
Value Percent:
Continuous Index:
Within 8" of Joint:
Remarks:

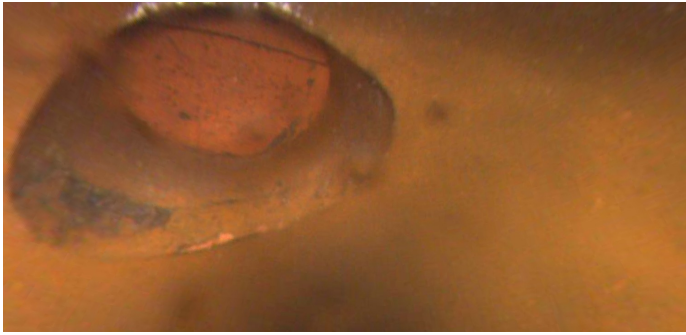
Code: **TFC**
Description: **Tap Factory Capped**

Distance (ft): **37.9**
Structural Grade: **0**
O&M Grade: **0**
Clock Start/From: **1**
Clock To:
1st Value: **4.000**
2nd Value:
Value Percent:
Continuous Index:
Within 8" of Joint:
Remarks:

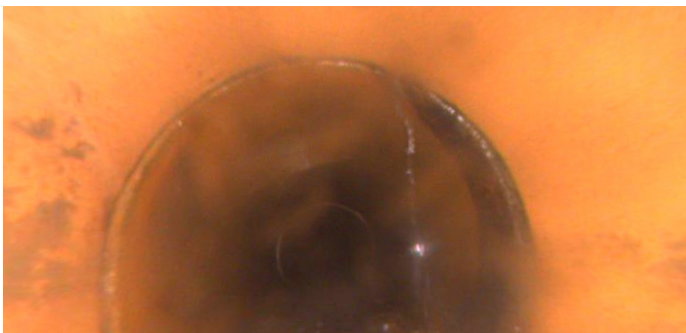
Code: **IR**
Description: **Infil Runner**

Distance (ft): **38.8**
Structural Grade: **0**
O&M Grade: **4**
Clock Start/From: **11**
Clock To:
1st Value:
2nd Value:
Value Percent:
Continuous Index:
Within 8" of Joint: **YES**
Remarks:

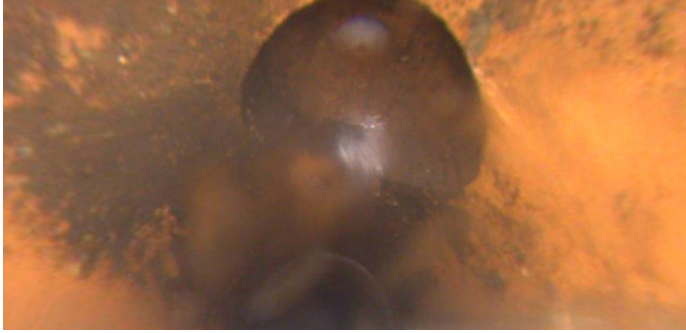
Code: **TF**
Description: **Tap Factory**

Distance (ft): **64.3**
Structural Grade: **0**
O&M Grade: **0**
Clock Start/From: **12**
Clock To:
1st Value: **4.000**
2nd Value:
Value Percent:
Continuous Index:
Within 8" of Joint:
Remarks:

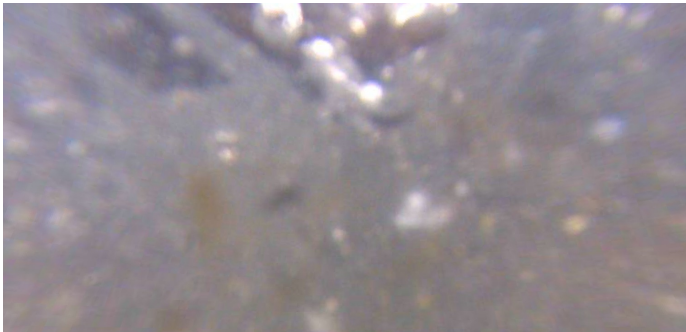
Code: **MCU**
Description: **Camera Underwater**

Distance (ft): **80.7**
Structural Grade: **0**
O&M Grade: **4**
Clock Start/From:
Clock To:
1st Value:
2nd Value:
Value Percent:
Continuous Index: **S01**
Within 8" of Joint: **NO**
Remarks:

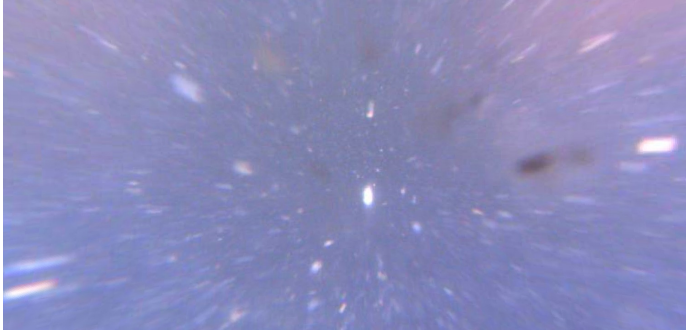
Code: **MCU**
Description: **Camera Underwater**

Distance (ft): **118.3**
Structural Grade: **0**
O&M Grade: **4**
Clock Start/From:
Clock To:
1st Value:
2nd Value:
Value Percent:
Continuous Index: **F01**
Within 8" of Joint: **NO**
Remarks:

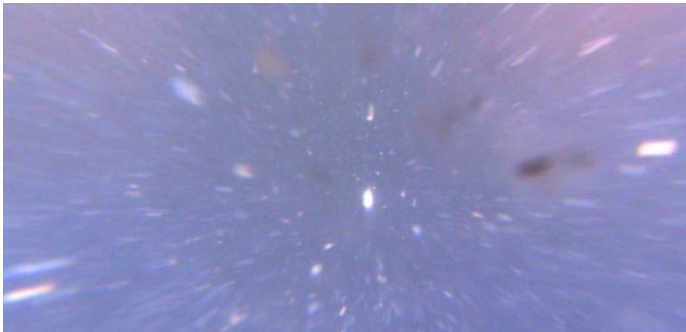
Code: **MSA**
Description: **Abandoned Survey**

Distance (ft): **118.3**
Structural Grade: **0**
O&M Grade: **0**
Clock Start/From:
Clock To:
1st Value:
2nd Value:
Value Percent:
Continuous Index:
Within 8" of Joint: **NO**
Remarks: **under water**
