Profile/Photo Observation Report

Date:	04/14/2018	Weather:		Coding:	PACP 6.0
Pipe Length (ft):	234.5	Owner:	NA	Pre Clean:	Not Known
P.O.#:		Surveyor:	Jen Costello	PSR:	P-503-055-056
Customer:		Clean Date:	01/01/1900	Shape:	C

Street:	W 40th ave	Flow Control:	Not Controlled
City:	Hobart, IN	Year Renewed:	
Location:	Other	Tape/Media #:	
Purpose:	Not Known	Dia/Height:	10"
Use:	Sanitary	Material:	VCP
Drain Area:	NA	Lining:	
Category:	NA		
Comment:

Location Details:		Direction of Survey:	Upstream
US MH:	M-503-055	DS MH:	M-503-056
		Total Length Surveyed (ft):	118.3

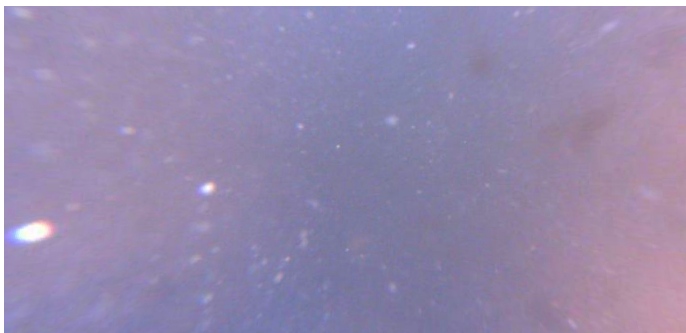
Code: **AMH**
Description: **Manhole**

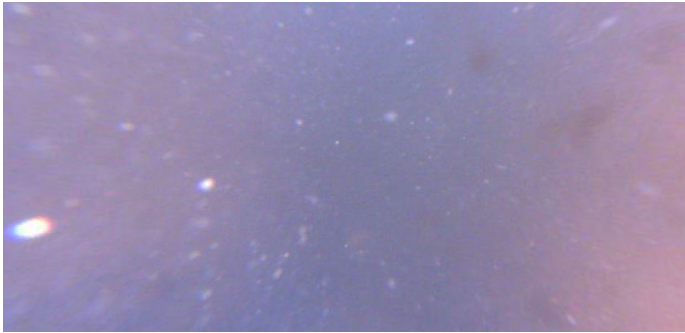
Code:	MWL
Description:	Water Level

Distance (ft):	.0
Structural Grade:	0
O&M Grade:	0
Clock Start/From:	
Clock To:	
1st Value:	
2nd Value:	
Value Percent:	100.000
Continuous Index:	
Within 8" of Joint:	NO
Remarks:

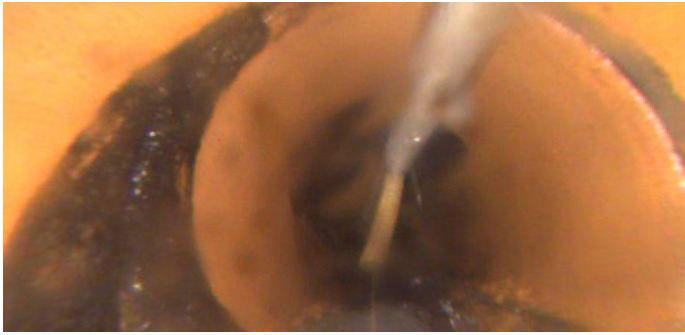
Code: **IW**
Description: **Infil Weeper**

Distance (ft): **.8**
Structural Grade: **0**
O&M Grade: **2**
Clock Start/From: **1**
Clock To: **4**
1st Value:
2nd Value:
Value Percent:
Continuous Index:
Within 8" of Joint: **YES**
Remarks:

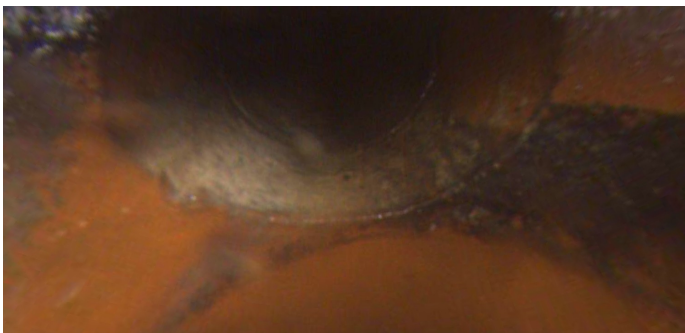
Code: **TF**
Description: **Tap Factory**

Distance (ft): **11.5**
Structural Grade: **0**
O&M Grade: **0**
Clock Start/From: **12**
Clock To:
1st Value: **4.000**
2nd Value:
Value Percent:
Continuous Index:
Within 8" of Joint:
Remarks:

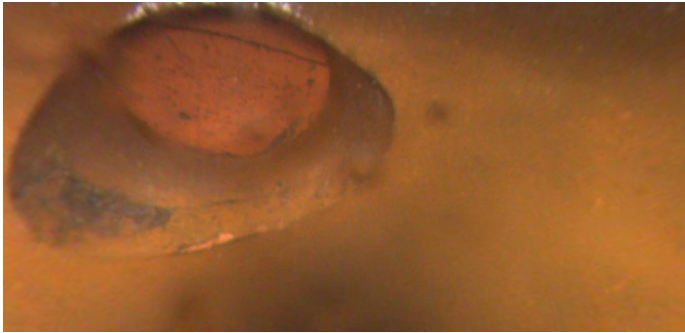
Code: **TFC**
Description: **Tap Factory Capped**

Distance (ft): **37.9**
Structural Grade: **0**
O&M Grade: **0**
Clock Start/From: **1**
Clock To:
1st Value: **4.000**
2nd Value:
Value Percent:
Continuous Index:
Within 8" of Joint:
Remarks:

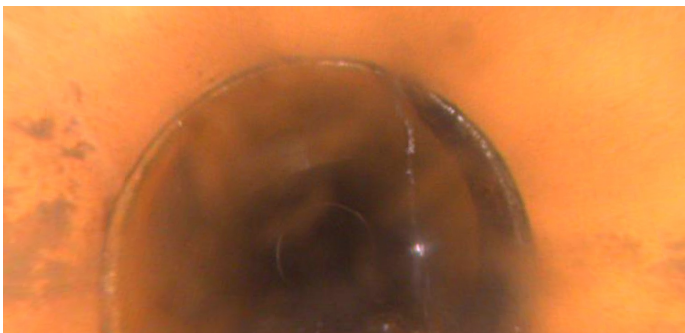
Code: **IR**
Description: **Infil Runner**

Distance (ft): **38.8**
Structural Grade: **0**
O&M Grade: **4**
Clock Start/From: **11**
Clock To:
1st Value:
2nd Value:
Value Percent:
Continuous Index:
Within 8" of Joint: **YES**
Remarks:

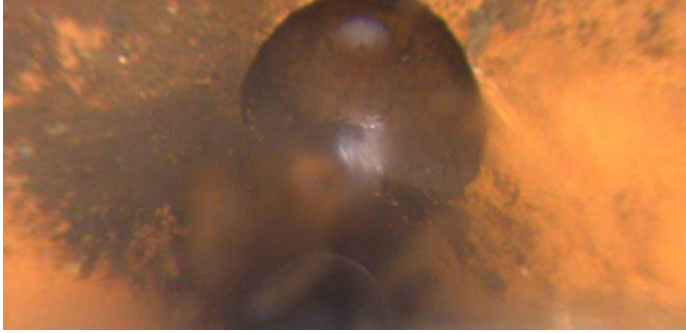
Code: **TF**
Description: **Tap Factory**

Distance (ft): **64.3**
Structural Grade: **0**
O&M Grade: **0**
Clock Start/From: **12**
Clock To:
1st Value: **4.000**
2nd Value:
Value Percent:
Continuous Index:
Within 8" of Joint:
Remarks:

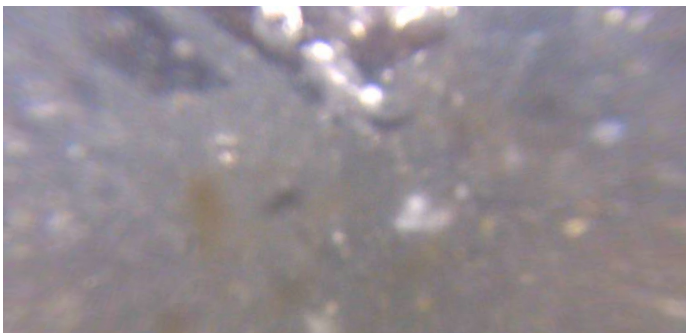
Code: **MCU**
Description: **Camera Underwater**

Distance (ft): **80.7**
Structural Grade: **0**
O&M Grade: **4**
Clock Start/From:
Clock To:
1st Value:
2nd Value:
Value Percent:
Continuous Index: **S01**
Within 8" of Joint: **NO**
Remarks:

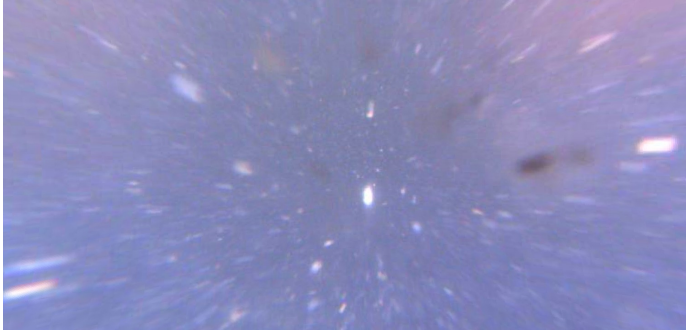
Code: **MCU**
Description: **Camera Underwater**

Distance (ft): **118.3**
Structural Grade: **0**
O&M Grade: **4**
Clock Start/From:
Clock To:
1st Value:
2nd Value:
Value Percent:
Continuous Index: **F01**
Within 8" of Joint: **NO**
Remarks:

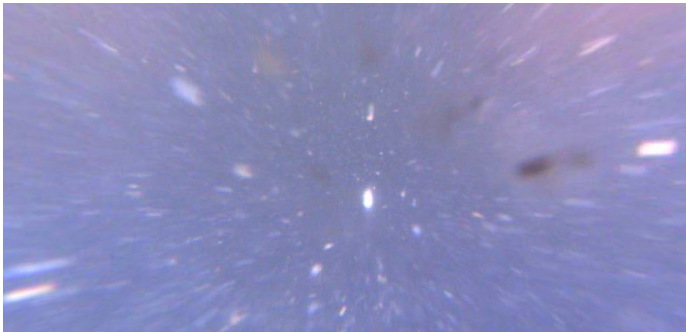
Code: **MSA**
Description: **Abandoned Survey**

Distance (ft): **118.3**
Structural Grade: **0**
O&M Grade: **0**
Clock Start/From:
Clock To:
1st Value:
2nd Value:
Value Percent:
Continuous Index:
Within 8" of Joint: **NO**
Remarks: **under water**
