## Profile/Photo Observation Report

Date:	<b>09/17/2021</b>	Weather:		Coding:	<b>PACP 7.0</b>
Pipe Length (ft):	<b>251.1</b>	Owner:	<b>City of Hobart</b>	Pre Clean:	<b>Heavy Cleaning</b>
P.O.#:	<b>YES502259</b>	Surveyor:	<b>S. Bucklin</b>	PSR:	<b>P-503-055-056</b>
Customer:	<b>City of Hobart</b>	Clean Date:	<b>08/24/2021</b>	Shape:	<b>C</b>

Street:	<b>North Guyer Street</b>	Flow Control:	<b>Not Controlled</b>
City:	<b>Hobart, IN</b>	Year Renewed:	
Location:	<b>Alley</b>	Tape/Media #:	
Purpose:	<b>Routine Assessment</b>	Dia/Height:	<b>10"</b>
Use:	<b>Sanitary Sewage Pipe</b>	Material:	<b>VCP</b>
Drain Area:		Lining:	<b>None</b>
Category:	<b>NA</b>		
Comment:

Location Details:		Direction of Survey:	<b>Downstream</b>
US MH:	<b>M-503-055</b>	DS MH:	<b>M-503-056</b>
		Total Length Surveyed (ft):	<b>251.1</b>

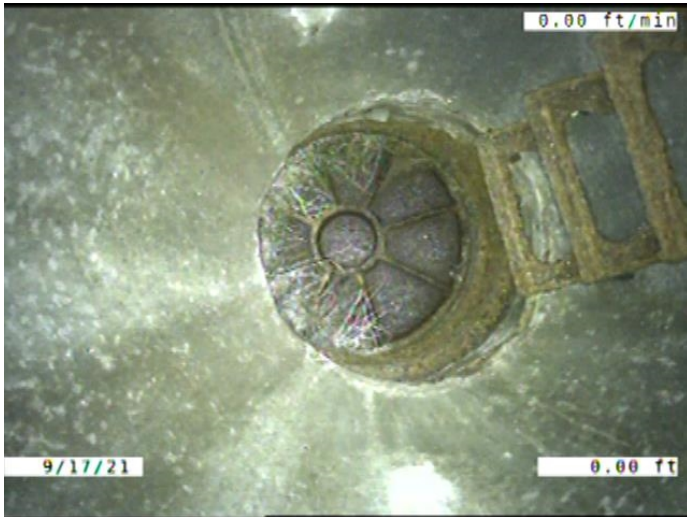
Code: **AMH**  
 Description: **Manhole**

Distance (ft): **.0**  
 Structural Grade: **0**  
 O&M Grade: **0**  
 Clock Start/From:  
 Clock To:  
 1st Value:  
 2nd Value:  
 Value Percent:  
 Continuous Index:  
 Within 8" of Joint: **NO**  
 Remarks: **M-503-055**

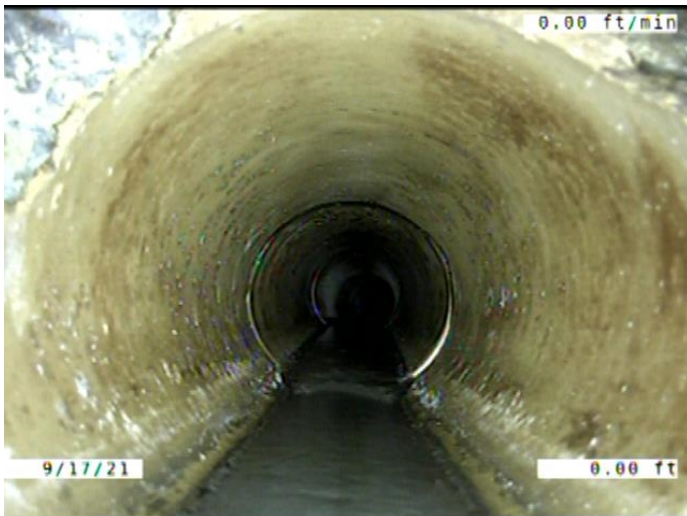
Code: **MWL**  
 Description: **Miscellaneous Water Level**

Distance (ft): **.0**  
 Structural Grade: **0**  
 O&M Grade: **0**  
 Clock Start/From:  
 Clock To:  
 1st Value:  
 2nd Value:  
 Value Percent: **5.000**  
 Continuous Index:  
 Within 8" of Joint: **NO**  
 Remarks:

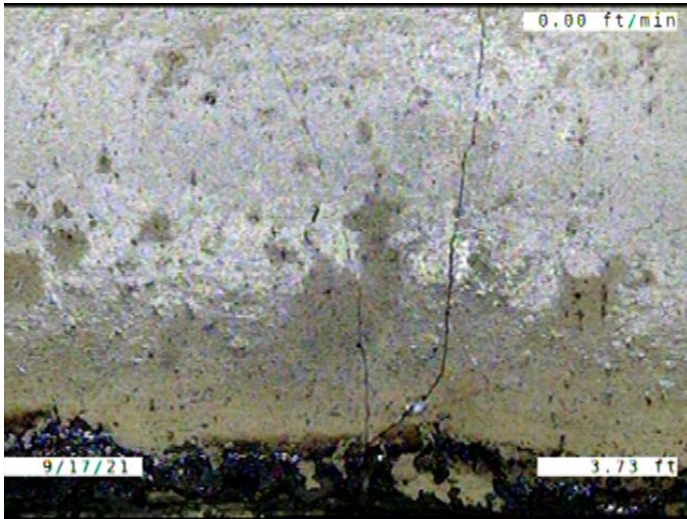
Code: **CM**  
 Description: **Crack Multiple**

Distance (ft): **3.7**  
 Structural Grade: **3**  
 O&M Grade: **0**  
 Clock Start/From: **12**  
 Clock To: **1**  
 1st Value:  
 2nd Value:  
 Value Percent:  
 Continuous Index:  
 Within 8" of Joint: **YES**  
 Remarks:

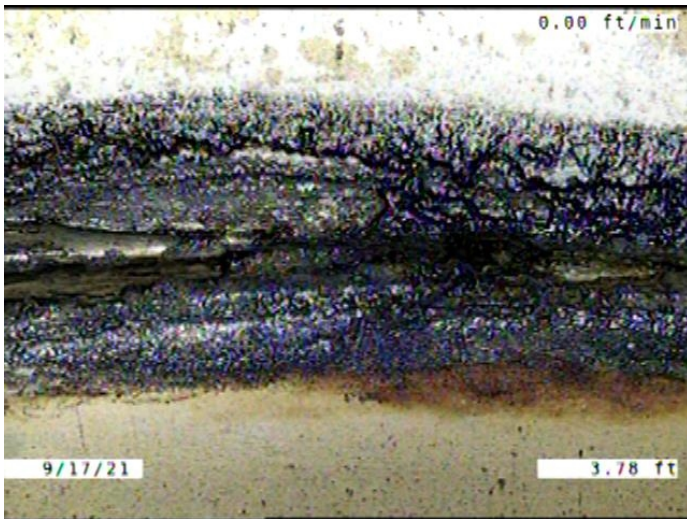
Code: **DAE**  
 Description: **Deposits Attached Encrustation**

Distance (ft): **3.8**  
 Structural Grade: **0**  
 O&M Grade: **2**  
 Clock Start/From: **8**  
 Clock To: **4**  
 1st Value:  
 2nd Value:  
 Value Percent: **5.000**  
 Continuous Index: **S01**  
 Within 8" of Joint: **YES**  
 Remarks:

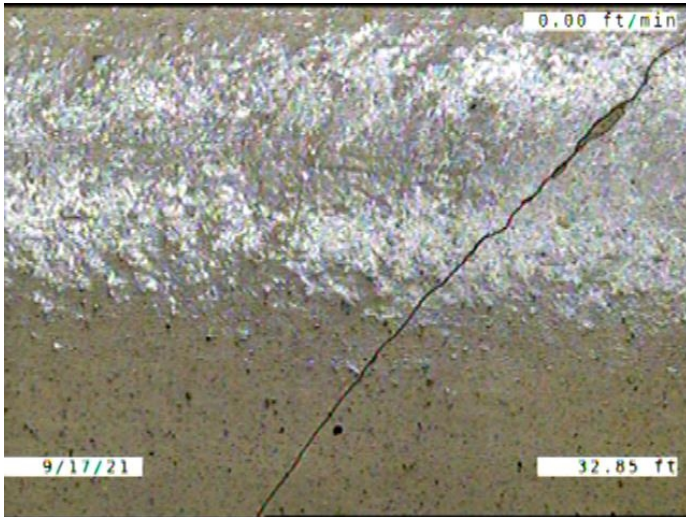
Code: **CM**  
 Description: **Crack Multiple**

Distance (ft): **32.8**  
 Structural Grade: **3**  
 O&M Grade: **0**  
 Clock Start/From: **12**  
 Clock To: **2**  
 1st Value:  
 2nd Value:  
 Value Percent:  
 Continuous Index:  
 Within 8" of Joint: **YES**  
 Remarks:

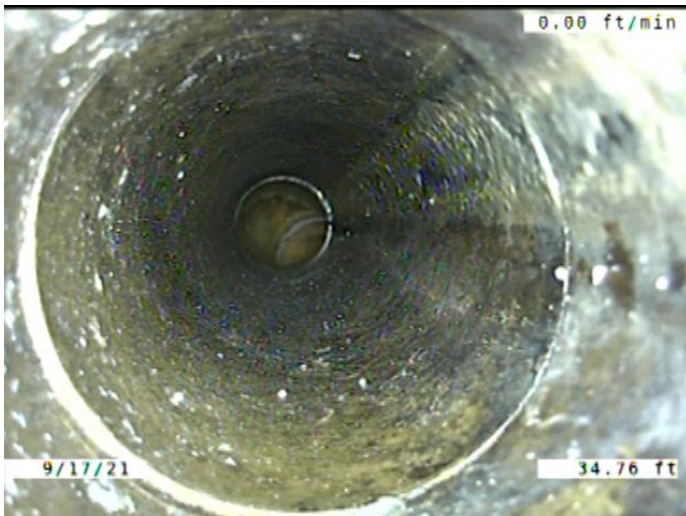
Code: **TF**  
 Description: **Tap Factory**

Distance (ft): **34.8**  
 Structural Grade: **0**  
 O&M Grade: **0**  
 Clock Start/From: **1**  
 Clock To:  
 1st Value: **4.000**  
 2nd Value:  
 Value Percent:  
 Continuous Index:  
 Within 8" of Joint: **YES**  
 Remarks:

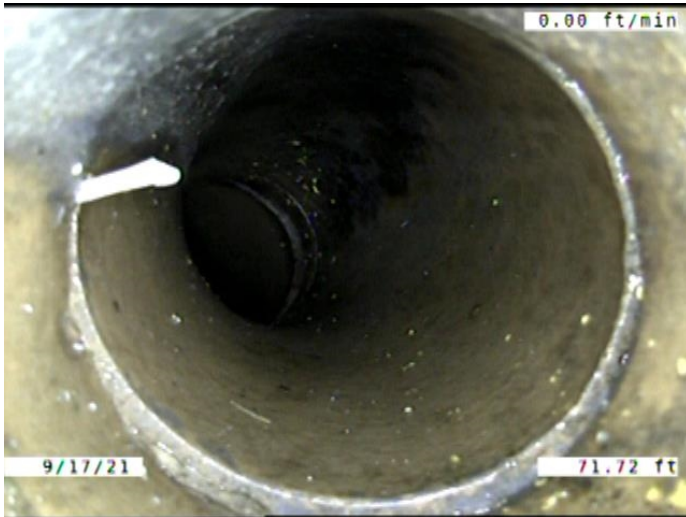
Code: **TF**  
Description: **Tap Factory**

Distance (ft): **71.7**  
Structural Grade: **0**  
O&M Grade: **0**  
Clock Start/From: **11**  
Clock To:  
1st Value: **4.000**  
2nd Value:  
Value Percent:  
Continuous Index:  
Within 8" of Joint: **YES**  
Remarks:

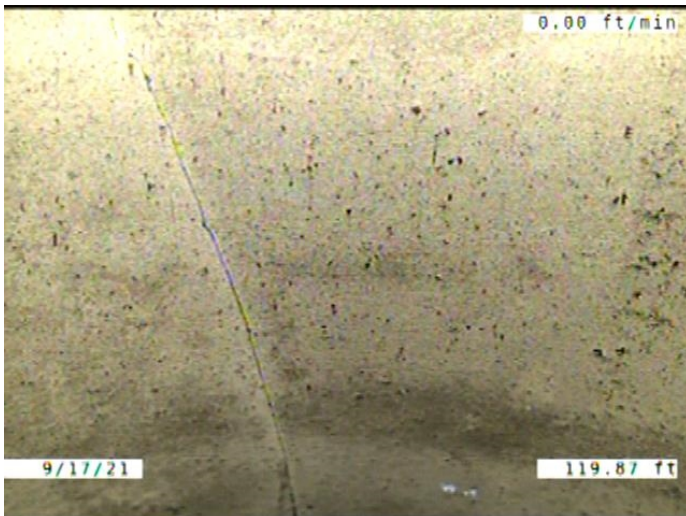
Code: **FM**  
Description: **Fracture Multiple**

Distance (ft): **119.9**  
Structural Grade: **4**  
O&M Grade: **0**  
Clock Start/From: **8**  
Clock To: **1**  
1st Value:  
2nd Value:  
Value Percent:  
Continuous Index:  
Within 8" of Joint: **NO**  
Remarks:

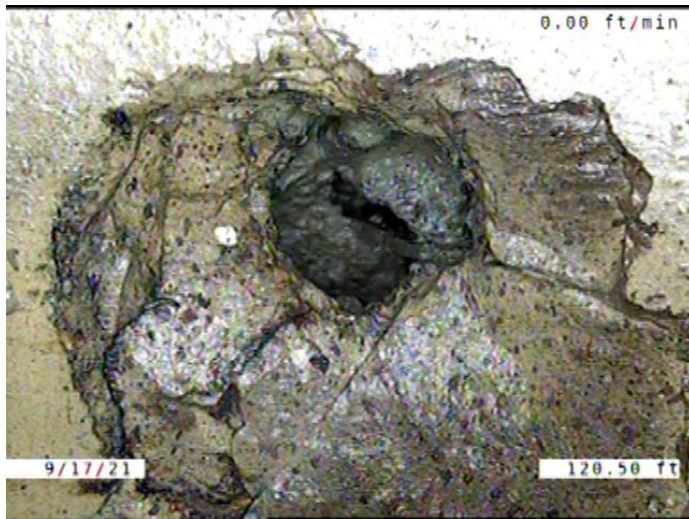
Code: **HSV**  
Description: **Hole Soil Visible**

Distance (ft): **120.5**  
Structural Grade: **5**  
O&M Grade: **0**  
Clock Start/From: **11**  
Clock To: **12**  
1st Value:  
2nd Value:  
Value Percent:  
Continuous Index:  
Within 8" of Joint: **NO**  
Remarks:

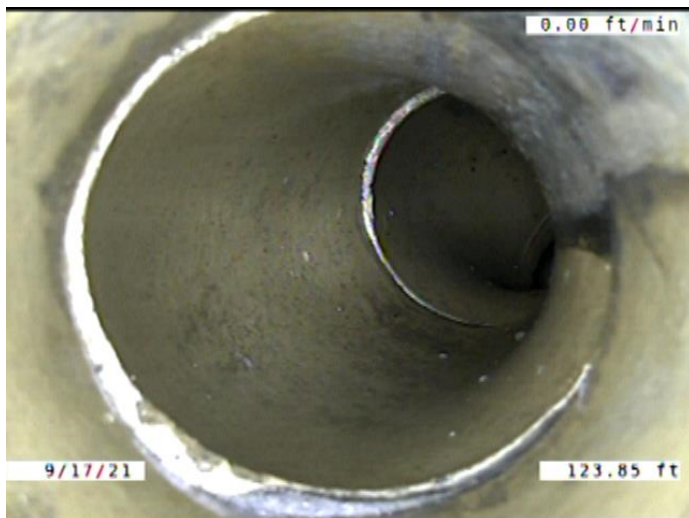
Code: **TF**  
Description: **Tap Factory**

Distance (ft): **123.9**  
Structural Grade: **0**  
O&M Grade: **0**  
Clock Start/From: **1**  
Clock To:  
1st Value: **4.000**  
2nd Value:  
Value Percent:  
Continuous Index:  
Within 8" of Joint: **YES**  
Remarks:

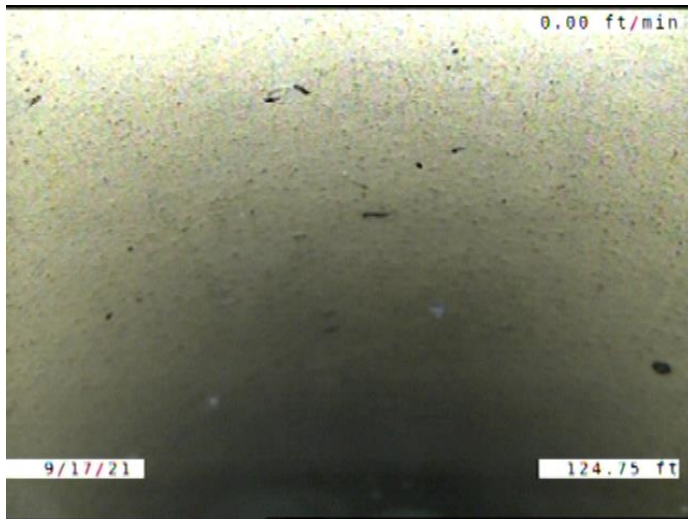
Code: **MWL**  
Description: **Miscellaneous Water Level**

Distance (ft): **124.7**  
Structural Grade: **0**  
O&M Grade: **0**  
Clock Start/From:  
Clock To:  
1st Value:  
2nd Value:  
Value Percent: **15.000**  
Continuous Index:  
Within 8" of Joint: **NO**  
Remarks:

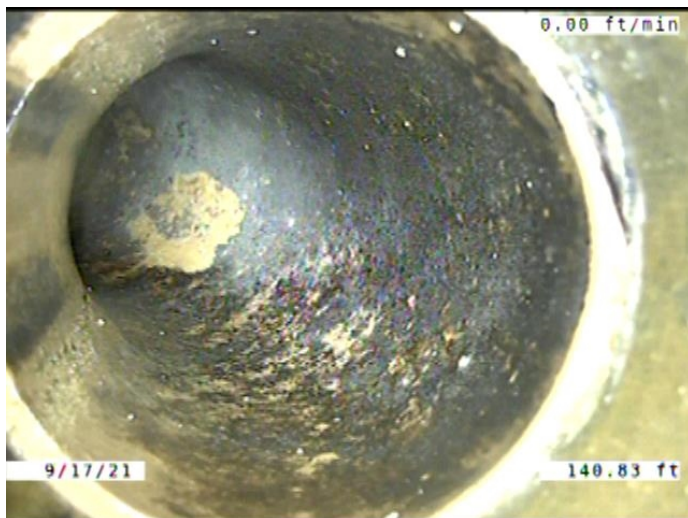
Code: **TF**  
Description: **Tap Factory**

Distance (ft): **140.8**  
Structural Grade: **0**  
O&M Grade: **0**  
Clock Start/From: **11**  
Clock To:  
1st Value: **4.000**  
2nd Value:  
Value Percent:  
Continuous Index:  
Within 8" of Joint: **YES**  
Remarks:

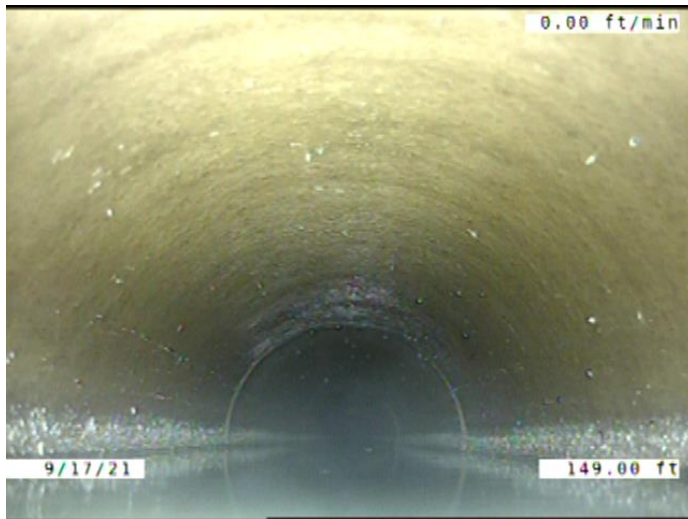
Code: **DSF**  
 Description: **Deposits Settled Fine**

Distance (ft): **149.0**  
 Structural Grade: **0**  
 O&M Grade: **2**  
 Clock Start/From: **5**  
 Clock To: **7**  
 1st Value:  
 2nd Value:  
 Value Percent: **5.000**  
 Continuous Index: **S02**  
 Within 8" of Joint: **YES**  
 Remarks:

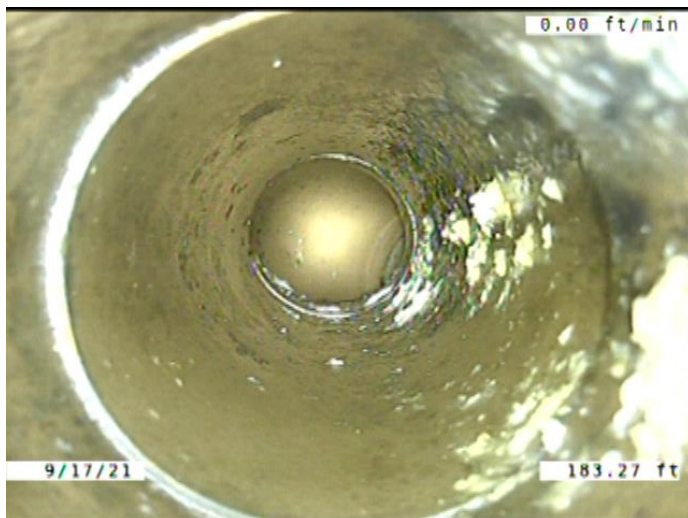
Code: **TF**  
 Description: **Tap Factory**

Distance (ft): **183.3**  
 Structural Grade: **0**  
 O&M Grade: **0**  
 Clock Start/From: **1**  
 Clock To:  
 1st Value: **4.000**  
 2nd Value:  
 Value Percent:  
 Continuous Index:  
 Within 8" of Joint: **YES**  
 Remarks:

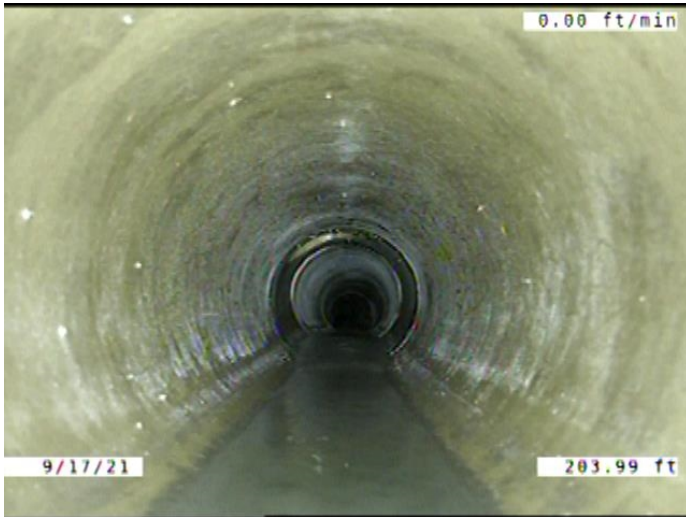
Code: **MWL**  
 Description: **Miscellaneous Water Level**

Distance (ft): **204.0**  
 Structural Grade: **0**  
 O&M Grade: **0**  
 Clock Start/From:  
 Clock To:  
 1st Value:  
 2nd Value:  
 Value Percent: **5.000**  
 Continuous Index:  
 Within 8" of Joint: **NO**  
 Remarks:

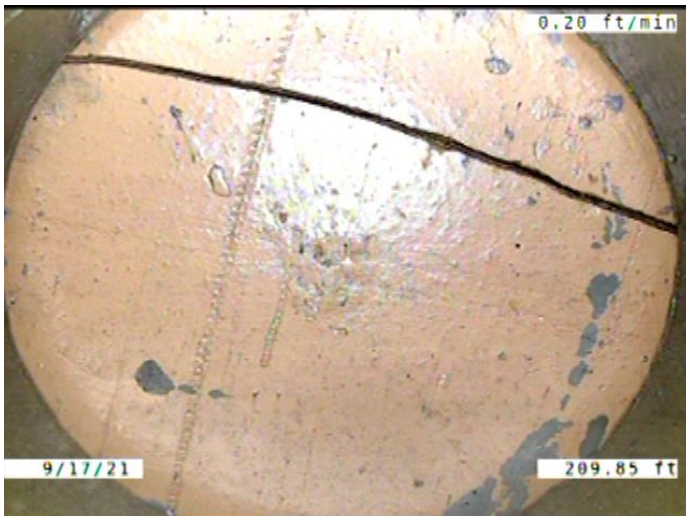
Code: **TFC**  
 Description: **Tap Factory Capped**

Distance (ft): **209.8**  
 Structural Grade: **0**  
 O&M Grade: **0**  
 Clock Start/From: **11**  
 Clock To:  
 1st Value: **4.000**  
 2nd Value:  
 Value Percent:  
 Continuous Index:  
 Within 8" of Joint: **YES**  
 Remarks: **CAP IS BROKEN**

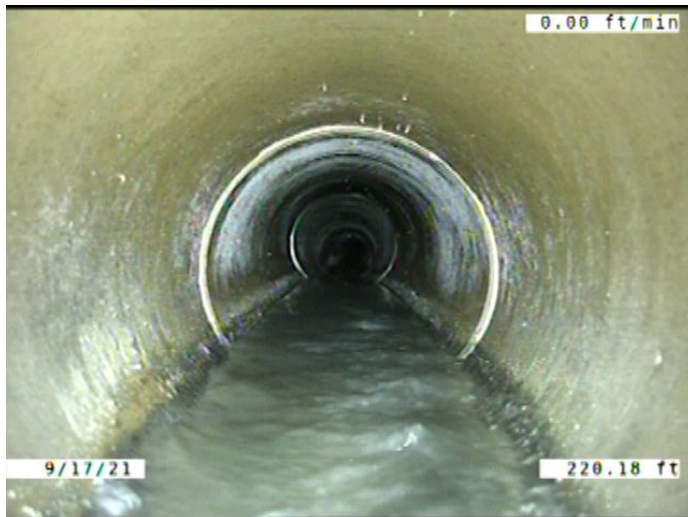
Code: **MWLS**  
Description: **Miscellaneous Water Level Sag**

Distance (ft): **220.2**  
Structural Grade: **2**  
O&M Grade: **0**  
Clock Start/From:  
Clock To:  
1st Value:  
2nd Value:  
Value Percent: **10.000**  
Continuous Index: **S03**  
Within 8" of Joint: **NO**  
Remarks:

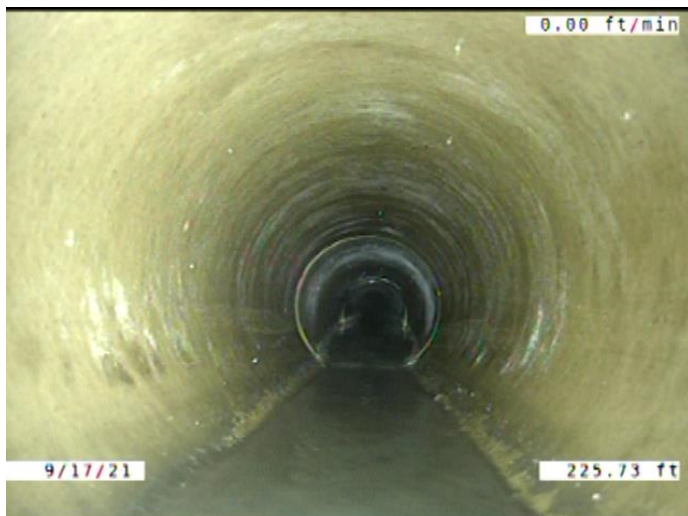
Code: **MWLS**  
Description: **Miscellaneous Water Level Sag**

Distance (ft): **225.7**  
Structural Grade: **2**  
O&M Grade: **0**  
Clock Start/From:  
Clock To:  
1st Value:  
2nd Value:  
Value Percent: **10.000**  
Continuous Index: **F03**  
Within 8" of Joint: **NO**  
Remarks:

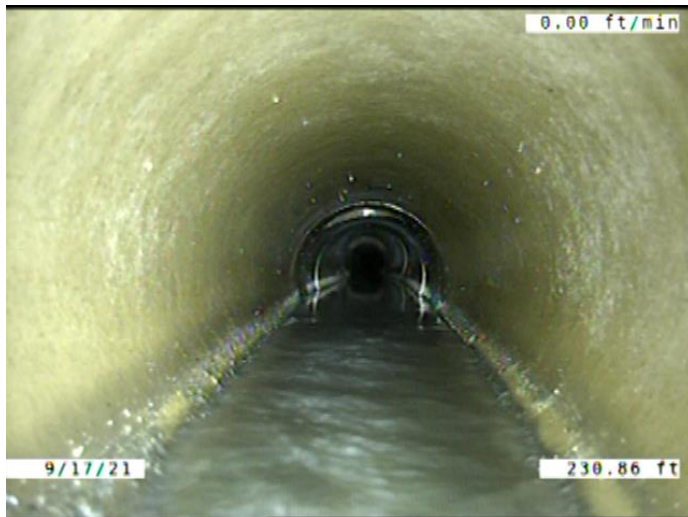
Code: **MWLS**  
 Description: **Miscellaneous Water Level Sag**

Distance (ft): **230.9**  
 Structural Grade: **2**  
 O&M Grade: **0**  
 Clock Start/From:  
 Clock To:  
 1st Value:  
 2nd Value:  
 Value Percent: **10.000**  
 Continuous Index: **S04**  
 Within 8" of Joint: **NO**  
 Remarks:

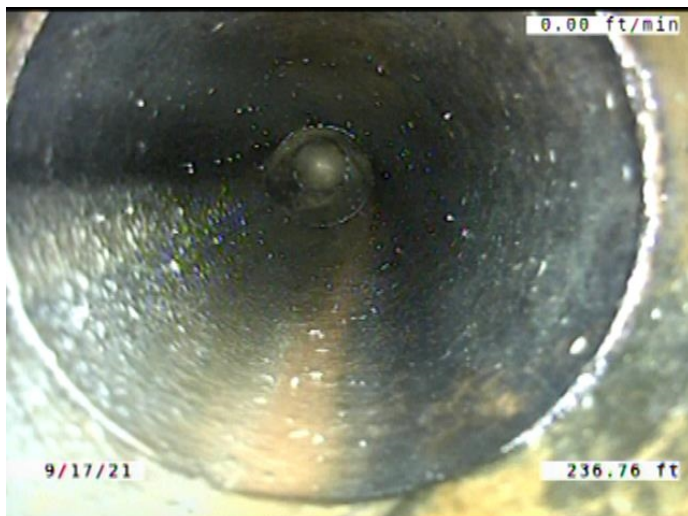
Code: **TF**  
 Description: **Tap Factory**

Distance (ft): **236.8**  
 Structural Grade: **0**  
 O&M Grade: **0**  
 Clock Start/From: **12**  
 Clock To:  
 1st Value: **4.000**  
 2nd Value:  
 Value Percent:  
 Continuous Index:  
 Within 8" of Joint: **YES**  
 Remarks:

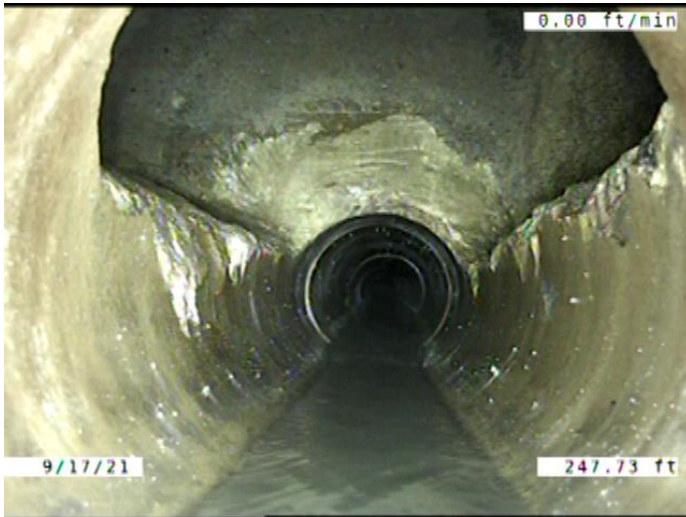
Code: **MWLS**  
 Description: **Miscellaneous Water Level Sag**

Distance (ft): **247.7**  
 Structural Grade: **2**  
 O&M Grade: **0**  
 Clock Start/From:  
 Clock To:  
 1st Value:  
 2nd Value:  
 Value Percent: **10.000**  
 Continuous Index: **F04**  
 Within 8" of Joint: **NO**  
 Remarks:

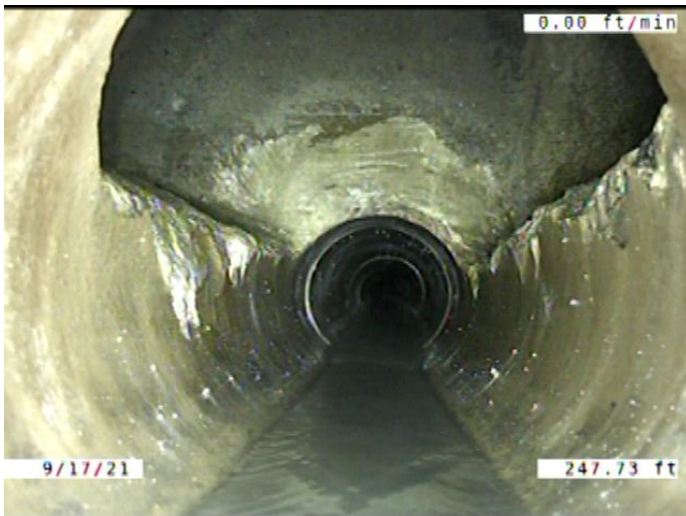
Code: **DAE**  
 Description: **Deposits Attached Encrustation**

Distance (ft): **247.7**  
 Structural Grade: **0**  
 O&M Grade: **2**  
 Clock Start/From: **8**  
 Clock To: **4**  
 1st Value:  
 2nd Value:  
 Value Percent: **5.000**  
 Continuous Index: **F01**  
 Within 8" of Joint: **YES**  
 Remarks:

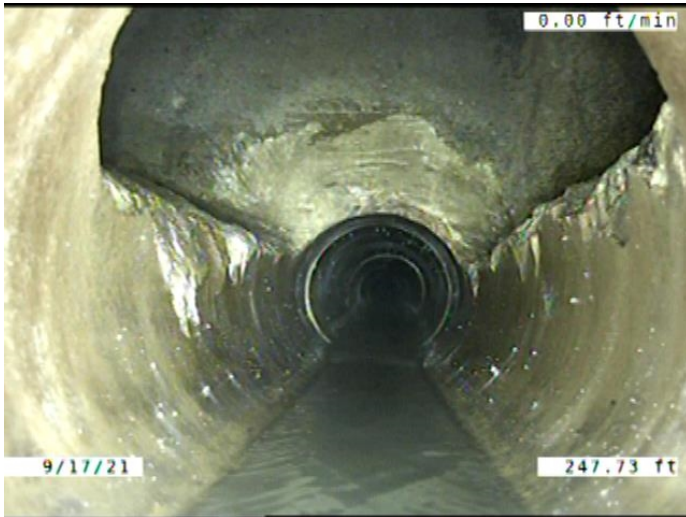
Code: **DSF**  
 Description: **Deposits Settled Fine**

Distance (ft): **247.7**  
 Structural Grade: **0**  
 O&M Grade: **2**  
 Clock Start/From: **5**  
 Clock To: **7**  
 1st Value:  
 2nd Value:  
 Value Percent: **5.000**  
 Continuous Index: **F02**  
 Within 8" of Joint: **YES**  
 Remarks:

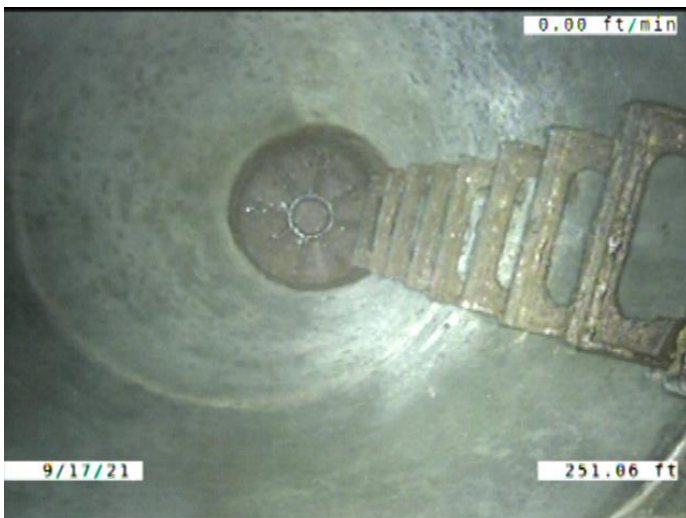
Code: **AMH**  
 Description: **Manhole**

Distance (ft): **251.1**  
 Structural Grade: **0**  
 O&M Grade: **0**  
 Clock Start/From:  
 Clock To:  
 1st Value:  
 2nd Value:  
 Value Percent:  
 Continuous Index:  
 Within 8" of Joint: **NO**  
 Remarks: **M-503-056**
