Profile/Photo Observation Report

Date:	09/17/2021	Weather:		Coding:	PACP 7.0
Pipe Length (ft):	238.1	Owner:	City of Hobart	Pre Clean:	Heavy Cleaning
P.O.#:	YES502259	Surveyor:	S. Bucklin	PSR:	P-503-056-057
Customer:	City of Hobart	Clean Date:	08/24/2021	Shape:	C

Street:	North Colorado Street	Flow Control:	Not Controlled
City:	Hobart, IN	Year Renewed:	
Location:	Alley	Tape/Media #:	
Purpose:	Routine Assessment	Dia/Height:	10"
Use:	Sanitary Sewage Pipe	Material:	VCP
Drain Area:		Lining:	None
Category:	NA		
Comment:			
Location Details:		Direction of Survey:	Downstream
US MH:	M-503-056	DS MH:	M-503-057
		Total Length Surveyed (ft):	238.1

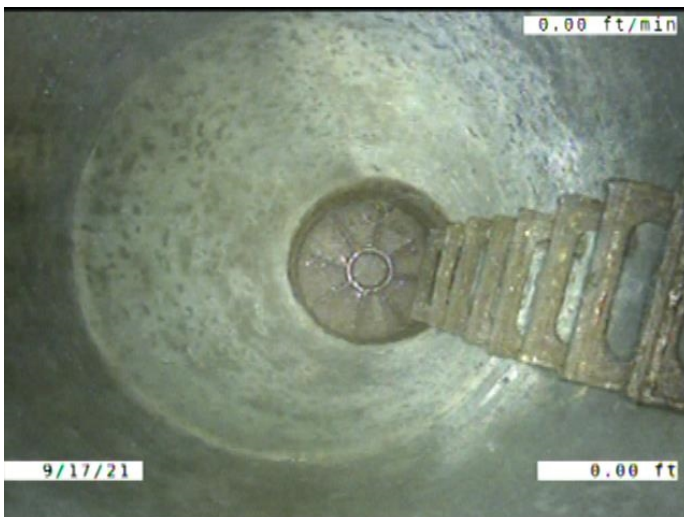
Code: **AMH**
Description: **Manhole**

Distance (ft): **.0**
Structural Grade: **0**
O&M Grade: **0**
Clock Start/From:
Clock To:
1st Value:
2nd Value:
Value Percent:
Continuous Index:
Within 8" of Joint: **NO**
Remarks: **M-503-056**

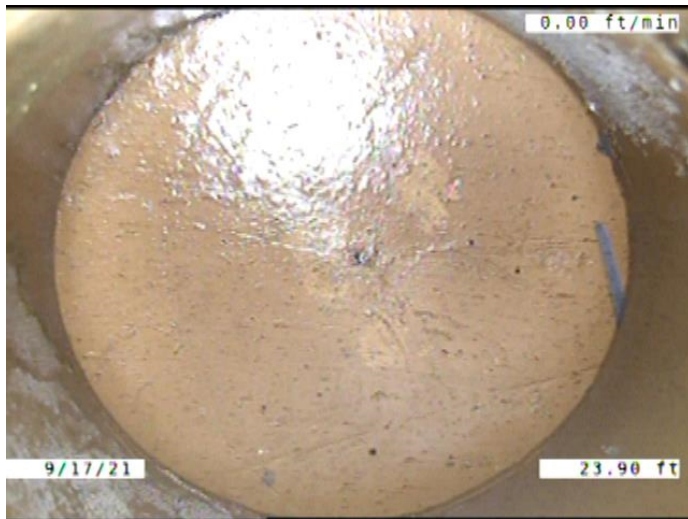
Code: **TFC**
 Description: **Tap Factory Capped**

Distance (ft): **23.9**
 Structural Grade: **0**
 O&M Grade: **0**
 Clock Start/From: **11**
 Clock To:
 1st Value: **4.000**
 2nd Value:
 Value Percent:
 Continuous Index:
 Within 8" of Joint: **YES**
 Remarks:

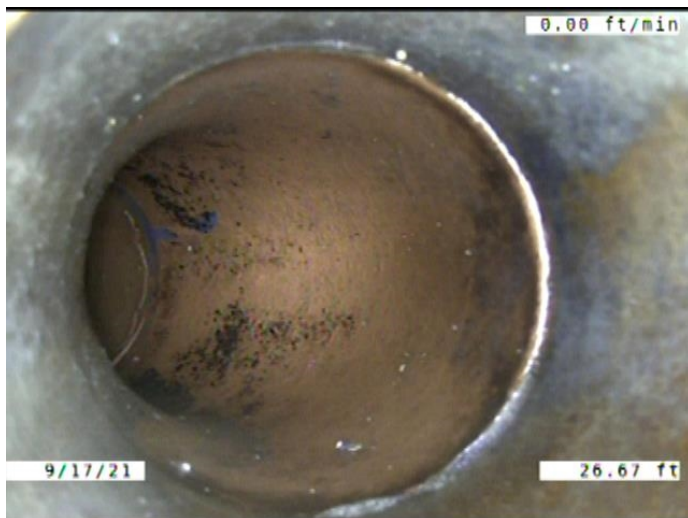
Code: **TBI**
 Description: **Tap Break-in Intruding**

Distance (ft): **26.7**
 Structural Grade: **0**
 O&M Grade: **2**
 Clock Start/From: **11**
 Clock To:
 1st Value: **4.000**
 2nd Value: **1.000**
 Value Percent:
 Continuous Index:
 Within 8" of Joint: **NO**
 Remarks:

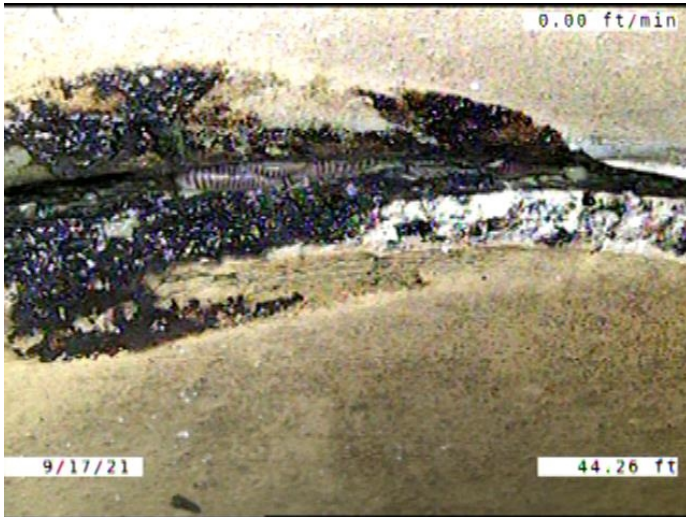
Code: **DAE**
 Description: **Deposits Attached Encrustation**

Distance (ft): **44.3**
 Structural Grade: **0**
 O&M Grade: **2**
 Clock Start/From: **9**
 Clock To: **11**
 1st Value:
 2nd Value:
 Value Percent: **5.000**
 Continuous Index:
 Within 8" of Joint: **YES**
 Remarks:

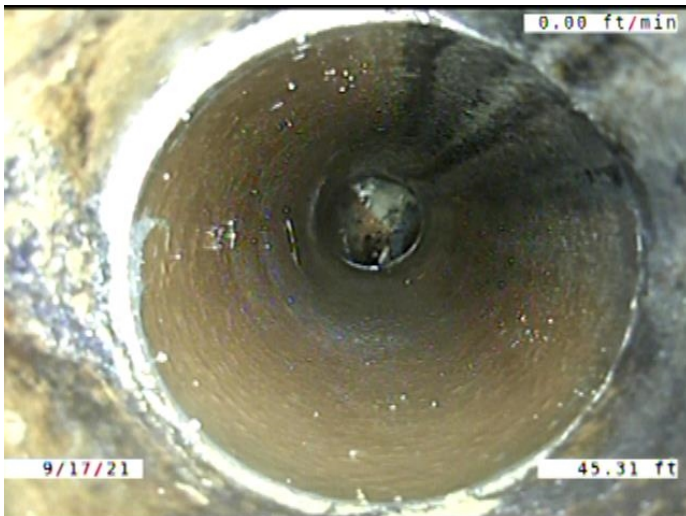
Code: **TF**
 Description: **Tap Factory**

Distance (ft): **45.3**
 Structural Grade: **0**
 O&M Grade: **0**
 Clock Start/From: **1**
 Clock To:
 1st Value: **4.000**
 2nd Value:
 Value Percent:
 Continuous Index:
 Within 8" of Joint: **YES**
 Remarks: **CONSTANTLY RUNNING WATER**

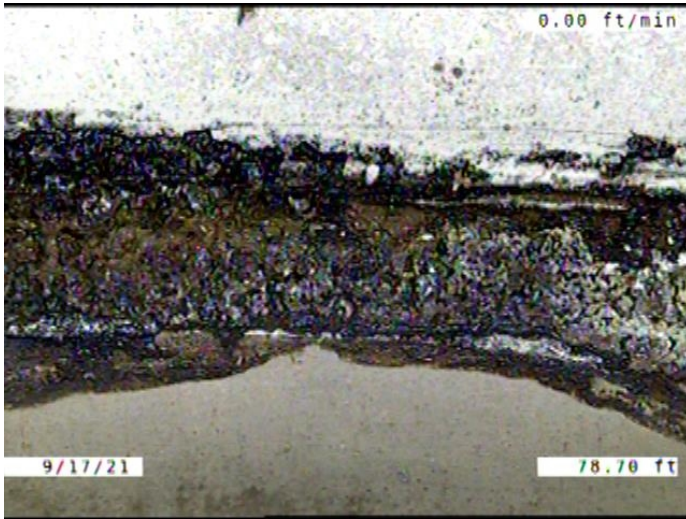
Code: **DAE**
Description: **Deposits Attached Encrustation**

Distance (ft): **78.7**
Structural Grade: **0**
O&M Grade: **2**
Clock Start/From: **8**
Clock To: **4**
1st Value:
2nd Value:
Value Percent: **5.000**
Continuous Index:
Within 8" of Joint: **YES**
Remarks:

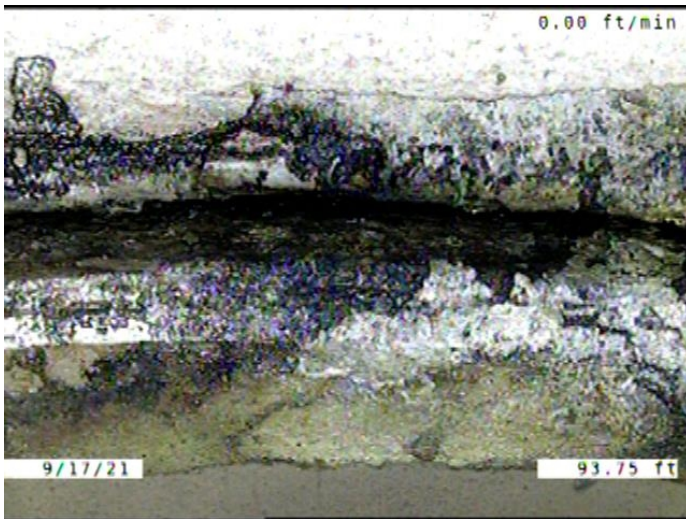
Code: **DAE**
Description: **Deposits Attached Encrustation**

Distance (ft): **93.7**
Structural Grade: **0**
O&M Grade: **2**
Clock Start/From: **7**
Clock To: **5**
1st Value:
2nd Value:
Value Percent: **5.000**
Continuous Index:
Within 8" of Joint: **YES**
Remarks:

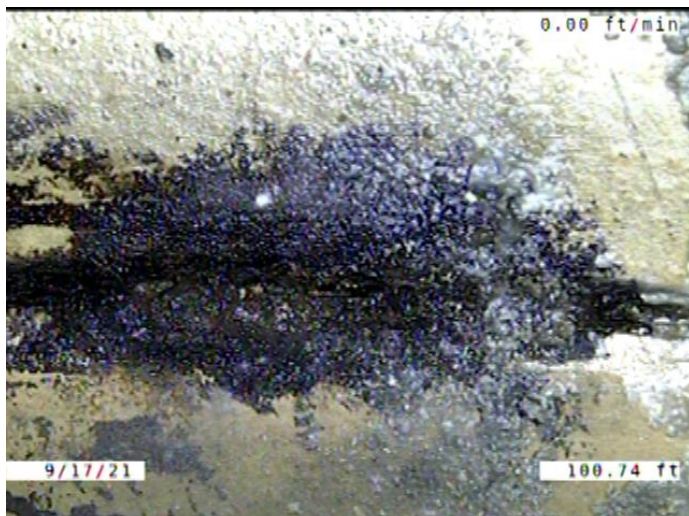
Code: **DAE**
 Description: **Deposits Attached Encrustation**

Distance (ft): **100.7**
 Structural Grade: **0**
 O&M Grade: **2**
 Clock Start/From: **8**
 Clock To: **4**
 1st Value:
 2nd Value:
 Value Percent: **5.000**
 Continuous Index:
 Within 8" of Joint: **YES**
 Remarks:

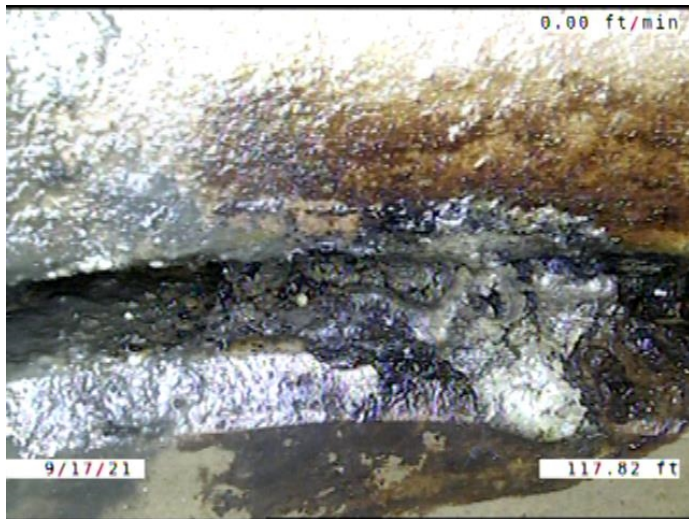
Code: **DAE**
 Description: **Deposits Attached Encrustation**

Distance (ft): **117.8**
 Structural Grade: **0**
 O&M Grade: **2**
 Clock Start/From: **8**
 Clock To: **4**
 1st Value:
 2nd Value:
 Value Percent: **5.000**
 Continuous Index:
 Within 8" of Joint: **YES**
 Remarks:

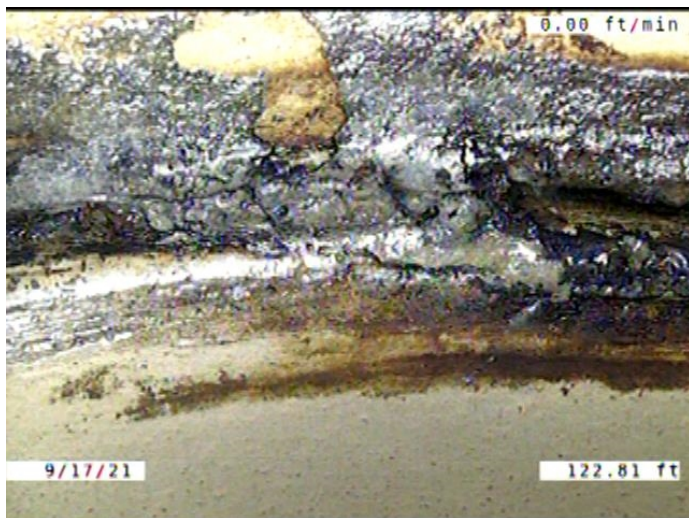
Code: **DAE**
 Description: **Deposits Attached Encrustation**

Distance (ft): **122.8**
 Structural Grade: **0**
 O&M Grade: **2**
 Clock Start/From: **9**
 Clock To: **1**
 1st Value:
 2nd Value:
 Value Percent: **5.000**
 Continuous Index:
 Within 8" of Joint: **YES**
 Remarks:

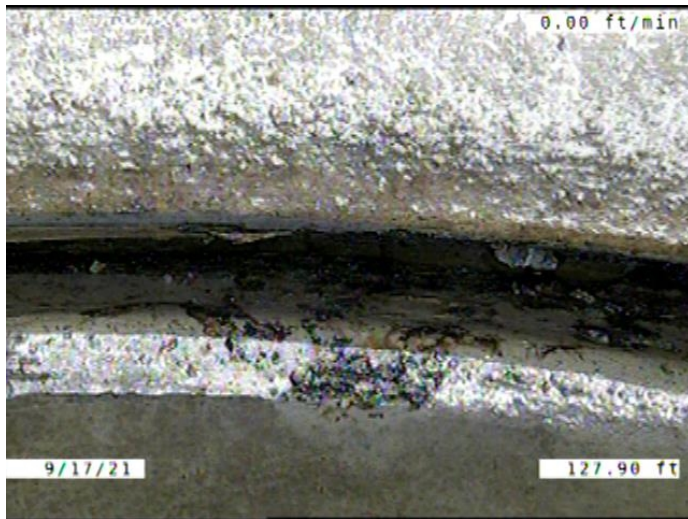
Code: **DAE**
 Description: **Deposits Attached Encrustation**

Distance (ft): **127.9**
 Structural Grade: **0**
 O&M Grade: **2**
 Clock Start/From: **8**
 Clock To: **4**
 1st Value:
 2nd Value:
 Value Percent: **5.000**
 Continuous Index:
 Within 8" of Joint: **YES**
 Remarks:

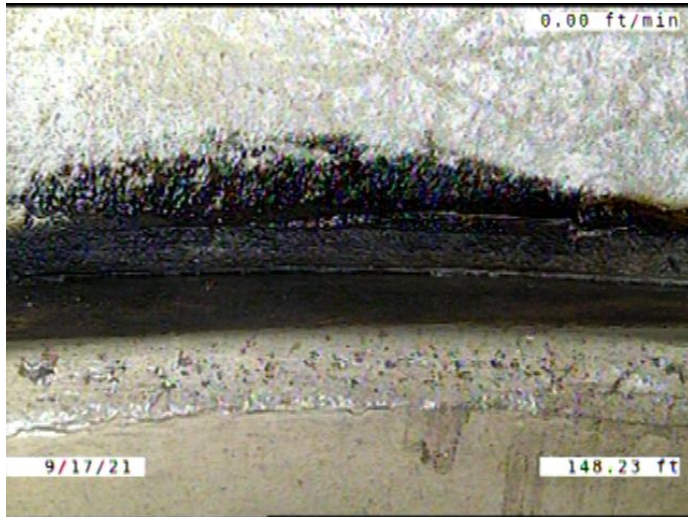
Code: **ISJ**
 Description: **Infiltration Stain Joint**

Distance (ft): **148.2**
 Structural Grade: **0**
 O&M Grade: **1**
 Clock Start/From: **9**
 Clock To: **10**
 1st Value:
 2nd Value:
 Value Percent:
 Continuous Index:
 Within 8" of Joint: **YES**
 Remarks:

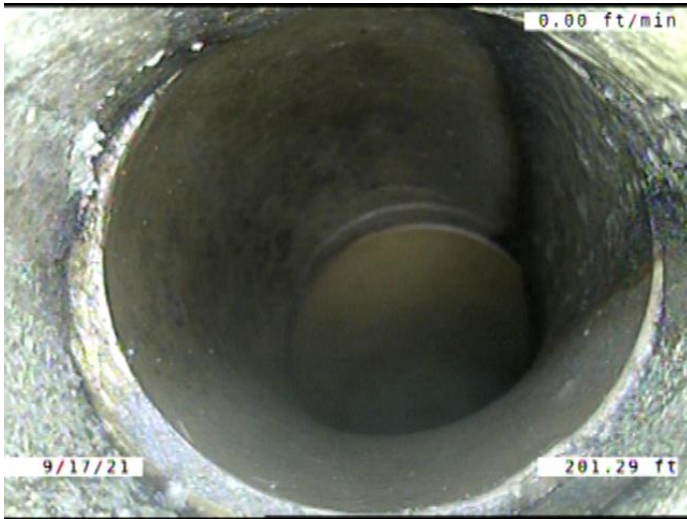
Code: **TF**
Description: **Tap Factory**

Distance (ft): **201.3**
Structural Grade: **0**
O&M Grade: **0**
Clock Start/From: **1**
Clock To:
1st Value: **5.000**
2nd Value:
Value Percent:
Continuous Index:
Within 8" of Joint: **YES**
Remarks:

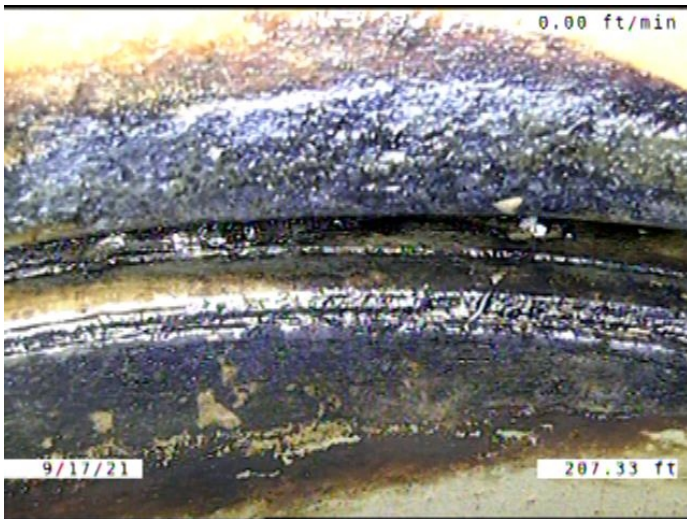
Code: **ISJ**
Description: **Infiltration Stain Joint**

Distance (ft): **207.3**
Structural Grade: **0**
O&M Grade: **1**
Clock Start/From: **8**
Clock To: **4**
1st Value:
2nd Value:
Value Percent:
Continuous Index:
Within 8" of Joint: **YES**
Remarks:
