Profile/Photo Observation Report

Date:	09/17/2021	Weather:		Coding:	PACP 7.0
Pipe Length (ft):	238.1	Owner:	City of Hobart	Pre Clean:	Heavy Cleaning
P.O.#:	YES502259	Surveyor:	S. Bucklin	PSR:	P-503-056-057
Customer:	City of Hobart	Clean Date:	08/24/2021	Shape:	C

Street:	North Colorado Street	Flow Control:	Not Controlled
City:	Hobart, IN	Year Renewed:	
Location:	Alley	Tape/Media #:	
Purpose:	Routine Assessment	Dia/Height:	10"
Use:	Sanitary Sewage Pipe	Material:	VCP
Drain Area:		Lining:	None
Category:	NA		
Comment:			
Location Details:		Direction of Survey:	Downstream
US MH:	M-503-056	DS MH:	M-503-057
		Total Length Surveyed (ft):	238.1

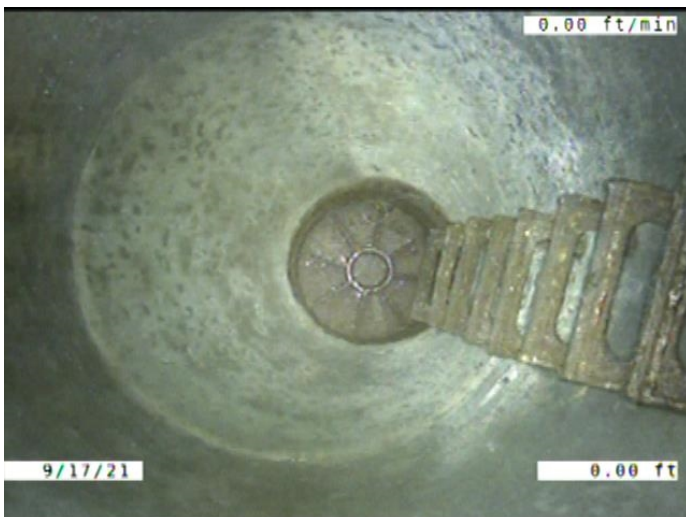
Code: **AMH**
Description: **Manhole**

Distance (ft): **.0**
Structural Grade: **0**
O&M Grade: **0**
Clock Start/From:
Clock To:
1st Value:
2nd Value:
Value Percent:
Continuous Index:
Within 8" of Joint: **NO**
Remarks: **M-503-056**

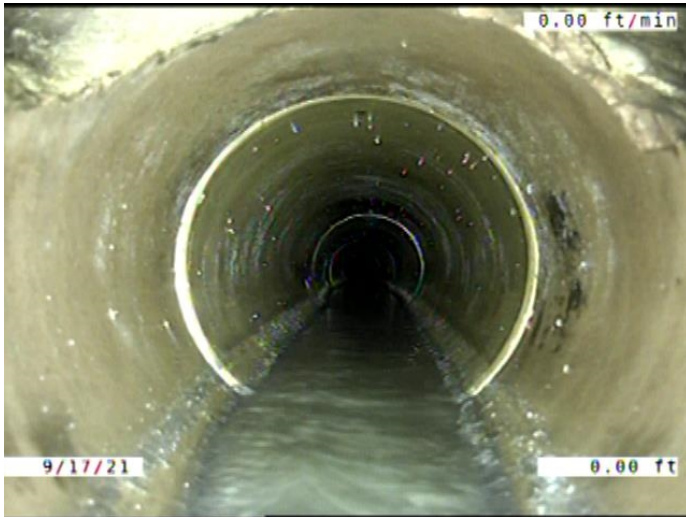
Code: **MWL**
 Description: **Miscellaneous Water Level**

Distance (ft): **.0**
 Structural Grade: **0**
 O&M Grade: **0**
 Clock Start/From:
 Clock To:
 1st Value:
 2nd Value:
 Value Percent: **5.000**
 Continuous Index:
 Within 8" of Joint: **NO**
 Remarks:

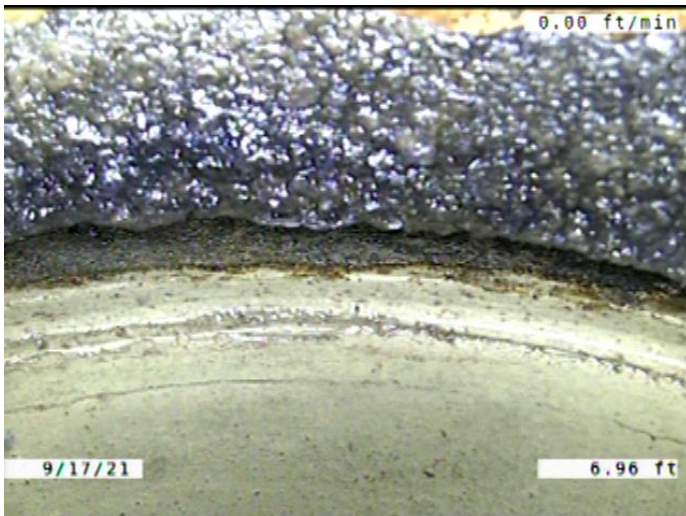
Code: **DAE**
 Description: **Deposits Attached Encrustation**

Distance (ft): **7.0**
 Structural Grade: **0**
 O&M Grade: **2**
 Clock Start/From: **11**
 Clock To: **3**
 1st Value:
 2nd Value:
 Value Percent: **5.000**
 Continuous Index:
 Within 8" of Joint: **YES**
 Remarks:

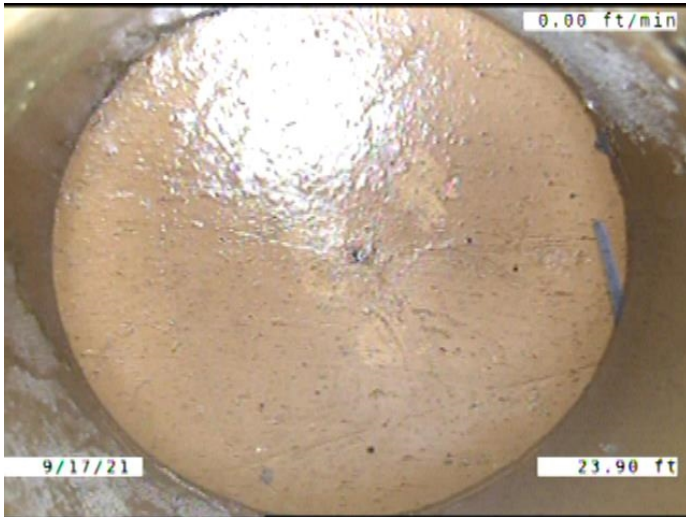
Code: **TFC**
Description: **Tap Factory Capped**

Distance (ft): **23.9**
Structural Grade: **0**
O&M Grade: **0**
Clock Start/From: **11**
Clock To:
1st Value: **4.000**
2nd Value:
Value Percent:
Continuous Index:
Within 8" of Joint: **YES**
Remarks:

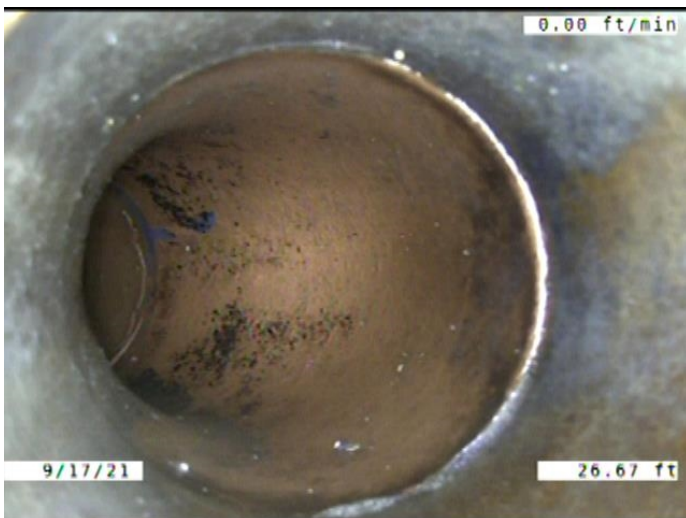
Code: **TBI**
Description: **Tap Break-in Intruding**

Distance (ft): **26.7**
Structural Grade: **0**
O&M Grade: **2**
Clock Start/From: **11**
Clock To:
1st Value: **4.000**
2nd Value: **1.000**
Value Percent:
Continuous Index:
Within 8" of Joint: **NO**
Remarks:

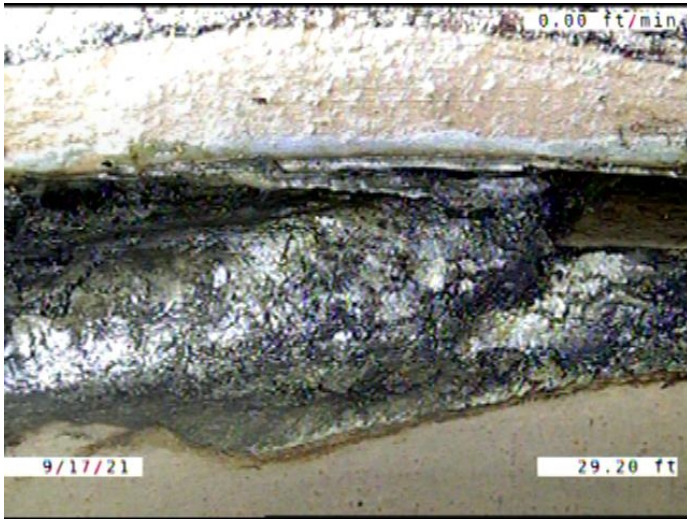
Code: **DAE**
 Description: **Deposits Attached Encrustation**

Distance (ft): **29.2**
 Structural Grade: **0**
 O&M Grade: **2**
 Clock Start/From: **9**
 Clock To: **12**
 1st Value:
 2nd Value:
 Value Percent: **5.000**
 Continuous Index:
 Within 8" of Joint: **YES**
 Remarks:

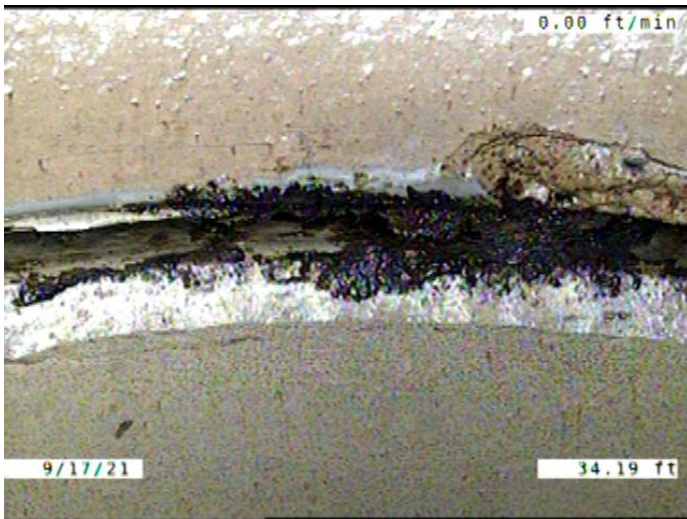
Code: **DAE**
 Description: **Deposits Attached Encrustation**

Distance (ft): **34.2**
 Structural Grade: **0**
 O&M Grade: **2**
 Clock Start/From: **8**
 Clock To: **4**
 1st Value:
 2nd Value:
 Value Percent: **5.000**
 Continuous Index:
 Within 8" of Joint: **YES**
 Remarks:

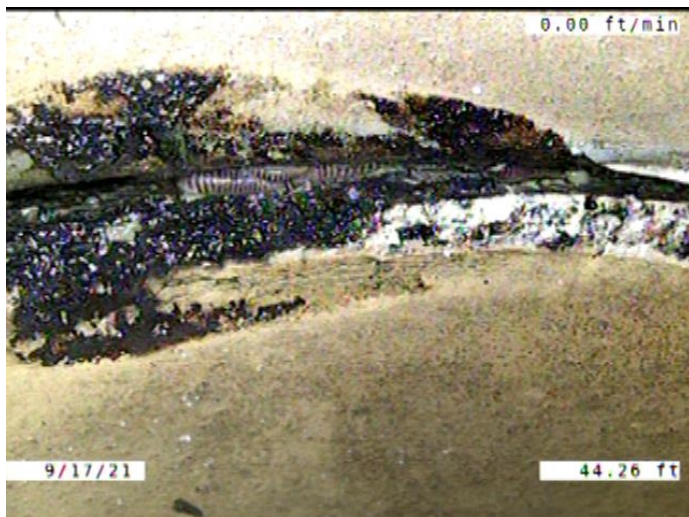
Code: **DAE**
 Description: **Deposits Attached Encrustation**

Distance (ft): **44.3**
 Structural Grade: **0**
 O&M Grade: **2**
 Clock Start/From: **9**
 Clock To: **11**
 1st Value:
 2nd Value:
 Value Percent: **5.000**
 Continuous Index:
 Within 8" of Joint: **YES**
 Remarks:

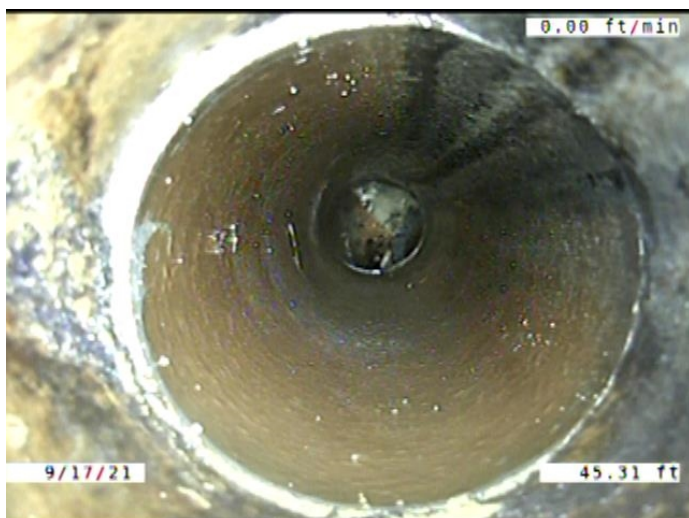
Code: **TF**
 Description: **Tap Factory**

Distance (ft): **45.3**
 Structural Grade: **0**
 O&M Grade: **0**
 Clock Start/From: **1**
 Clock To:
 1st Value: **4.000**
 2nd Value:
 Value Percent:
 Continuous Index:
 Within 8" of Joint: **YES**
 Remarks: **CONSTANTLY RUNNING WATER**

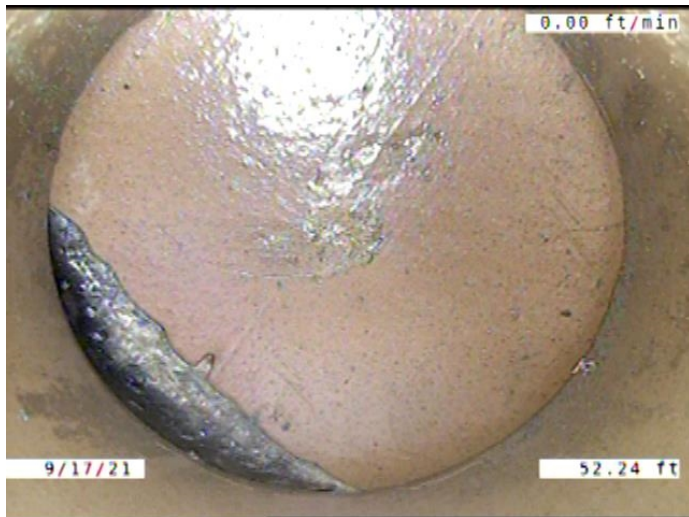
Code: **TFC**
 Description: **Tap Factory Capped**

Distance (ft): **52.2**
 Structural Grade: **0**
 O&M Grade: **0**
 Clock Start/From: **12**
 Clock To:
 1st Value: **4.000**
 2nd Value:
 Value Percent:
 Continuous Index:
 Within 8" of Joint: **YES**
 Remarks:

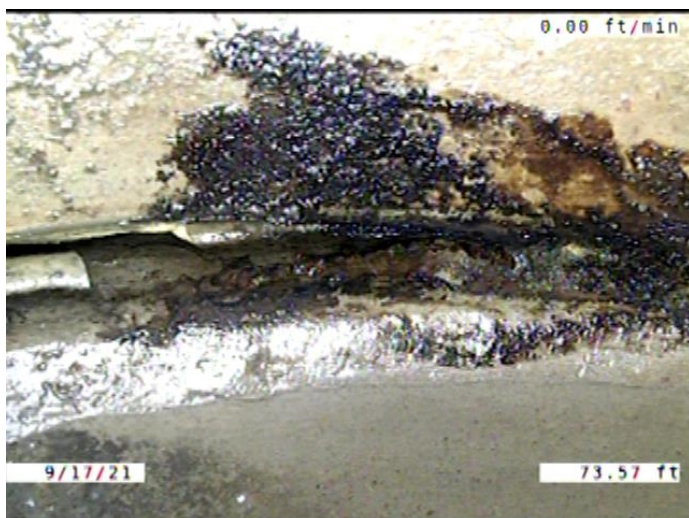
Code: **DAE**
 Description: **Deposits Attached Encrustation**

Distance (ft): **73.6**
 Structural Grade: **0**
 O&M Grade: **2**
 Clock Start/From: **8**
 Clock To: **4**
 1st Value:
 2nd Value:
 Value Percent: **5.000**
 Continuous Index:
 Within 8" of Joint: **YES**
 Remarks:

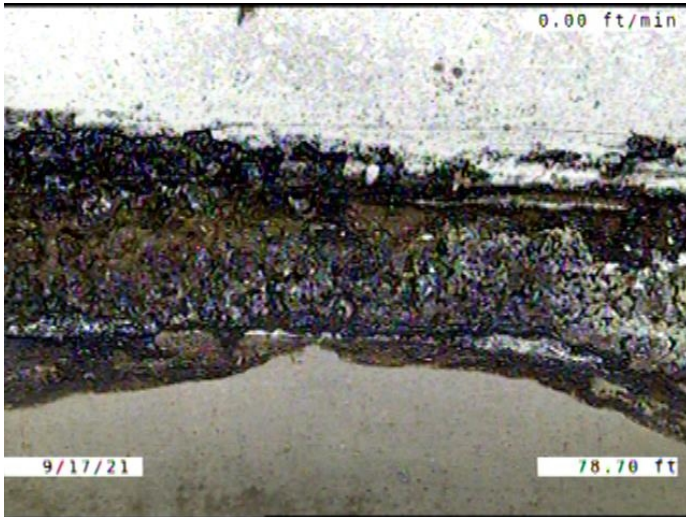
Code: **DAE**
 Description: **Deposits Attached Encrustation**

Distance (ft): **78.7**
 Structural Grade: **0**
 O&M Grade: **2**
 Clock Start/From: **8**
 Clock To: **4**
 1st Value:
 2nd Value:
 Value Percent: **5.000**
 Continuous Index:
 Within 8" of Joint: **YES**
 Remarks:

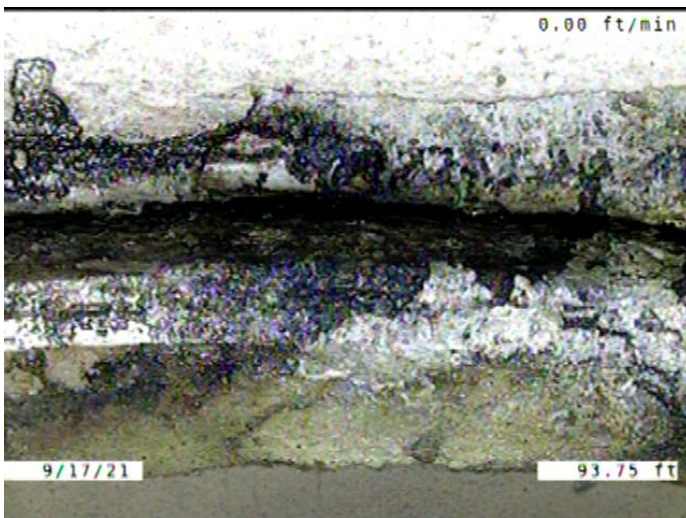
Code: **DAE**
 Description: **Deposits Attached Encrustation**

Distance (ft): **93.7**
 Structural Grade: **0**
 O&M Grade: **2**
 Clock Start/From: **7**
 Clock To: **5**
 1st Value:
 2nd Value:
 Value Percent: **5.000**
 Continuous Index:
 Within 8" of Joint: **YES**
 Remarks:

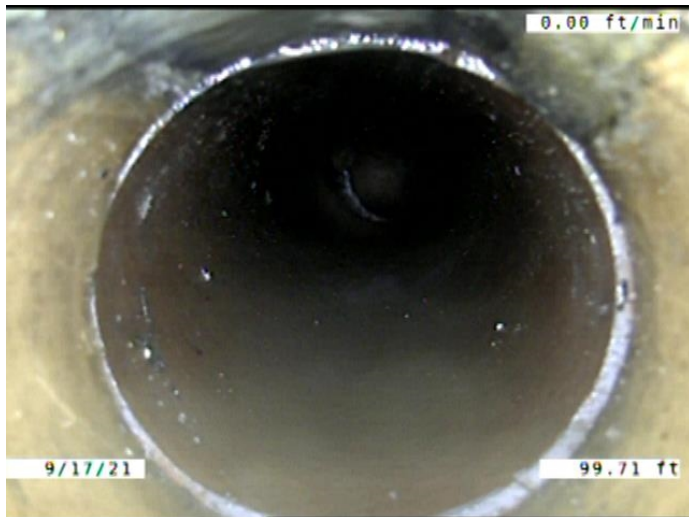
Code: **TF**
 Description: **Tap Factory**

Distance (ft): **99.7**
 Structural Grade: **0**
 O&M Grade: **0**
 Clock Start/From: **12**
 Clock To:
 1st Value: **4.000**
 2nd Value:
 Value Percent:
 Continuous Index:
 Within 8" of Joint: **YES**
 Remarks:

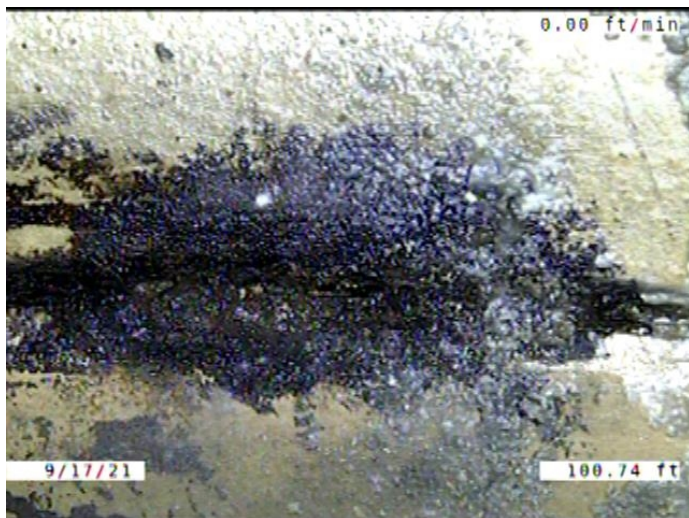
Code: **DAE**
 Description: **Deposits Attached Encrustation**

Distance (ft): **100.7**
 Structural Grade: **0**
 O&M Grade: **2**
 Clock Start/From: **8**
 Clock To: **4**
 1st Value:
 2nd Value:
 Value Percent: **5.000**
 Continuous Index:
 Within 8" of Joint: **YES**
 Remarks:

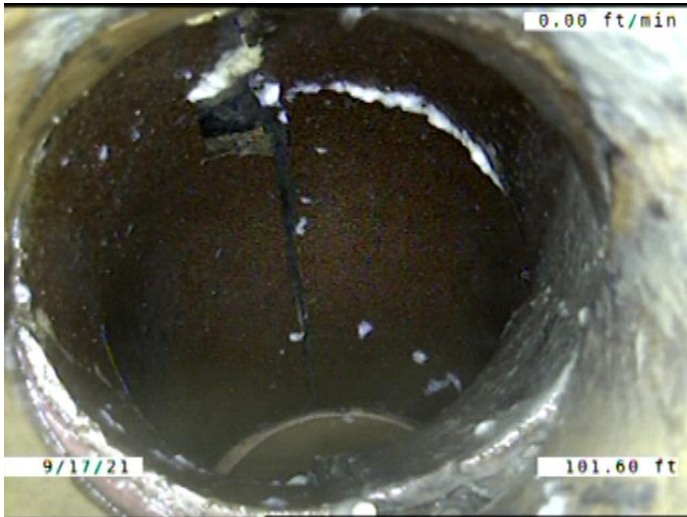
Code: **TFD**
 Description: **Tap Factory Defective**

Distance (ft): **101.6**
 Structural Grade: **0**
 O&M Grade: **3**
 Clock Start/From: **1**
 Clock To:
 1st Value: **4.000**
 2nd Value:
 Value Percent:
 Continuous Index:
 Within 8" of Joint: **YES**
 Remarks: **Defective**

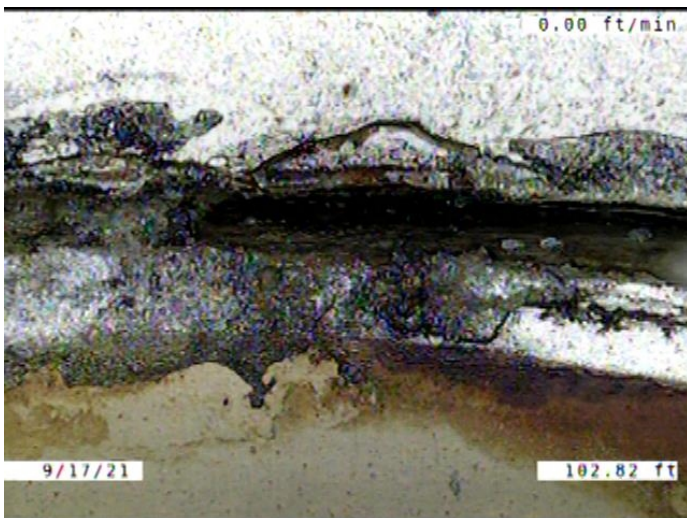
Code: **DAE**
 Description: **Deposits Attached Encrustation**

Distance (ft): **102.8**
 Structural Grade: **0**
 O&M Grade: **2**
 Clock Start/From: **8**
 Clock To: **4**
 1st Value:
 2nd Value:
 Value Percent: **5.000**
 Continuous Index:
 Within 8" of Joint: **YES**
 Remarks:

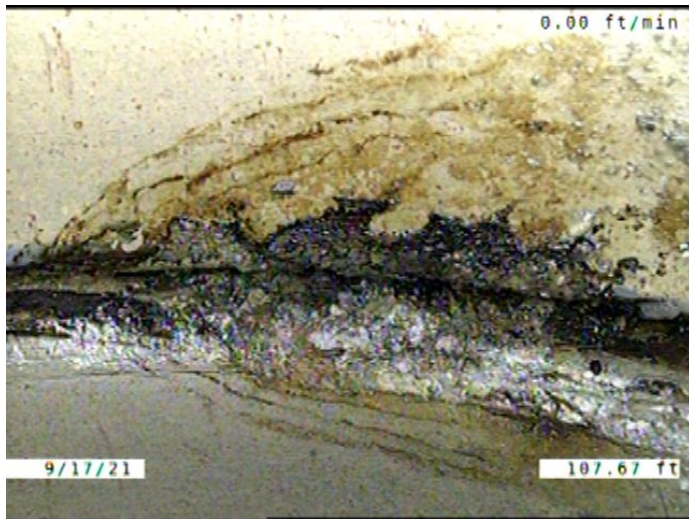
Code: **DAE**
 Description: **Deposits Attached Encrustation**

Distance (ft): **107.7**
 Structural Grade: **0**
 O&M Grade: **2**
 Clock Start/From: **2**
 Clock To: **4**
 1st Value:
 2nd Value:
 Value Percent: **5.000**
 Continuous Index:
 Within 8" of Joint: **YES**
 Remarks:

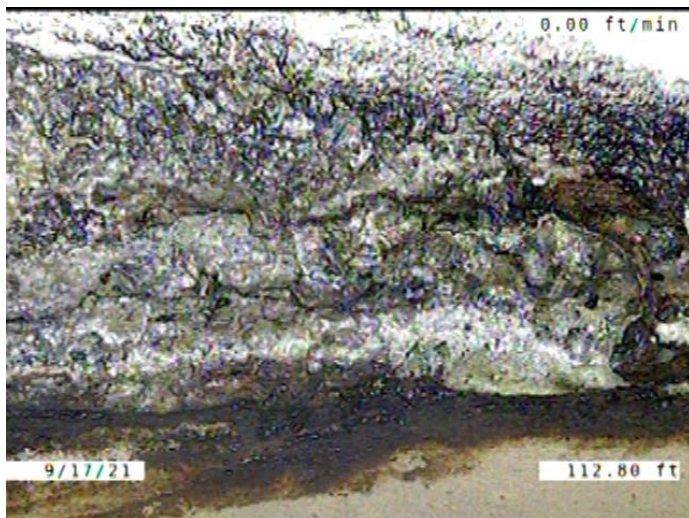
Code: **DAE**
 Description: **Deposits Attached Encrustation**

Distance (ft): **112.8**
 Structural Grade: **0**
 O&M Grade: **2**
 Clock Start/From: **8**
 Clock To: **4**
 1st Value:
 2nd Value:
 Value Percent: **5.000**
 Continuous Index:
 Within 8" of Joint: **YES**
 Remarks:

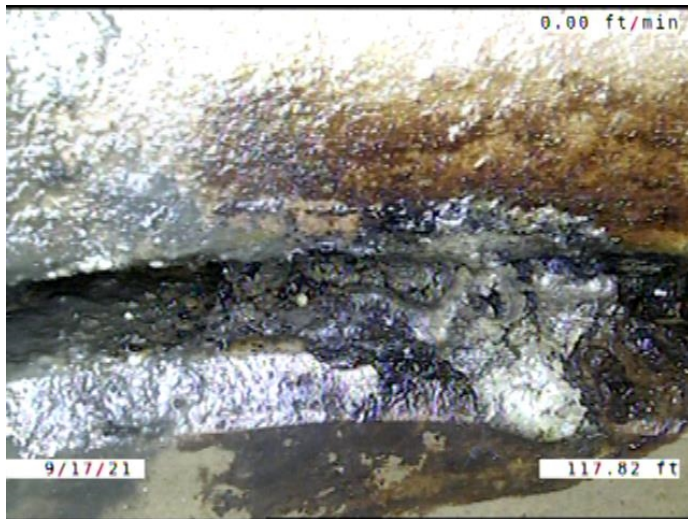
Code: **DAE**
 Description: **Deposits Attached Encrustation**

Distance (ft): **117.8**
 Structural Grade: **0**
 O&M Grade: **2**
 Clock Start/From: **8**
 Clock To: **4**
 1st Value:
 2nd Value:
 Value Percent: **5.000**
 Continuous Index:
 Within 8" of Joint: **YES**
 Remarks:

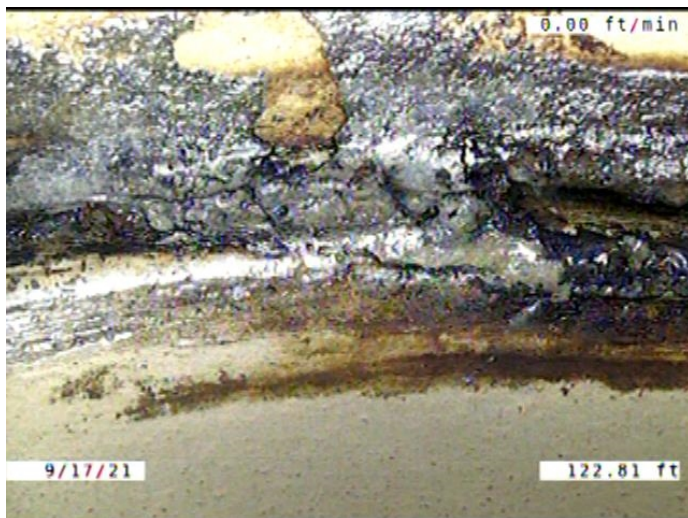
Code: **DAE**
 Description: **Deposits Attached Encrustation**

Distance (ft): **122.8**
 Structural Grade: **0**
 O&M Grade: **2**
 Clock Start/From: **9**
 Clock To: **1**
 1st Value:
 2nd Value:
 Value Percent: **5.000**
 Continuous Index:
 Within 8" of Joint: **YES**
 Remarks:

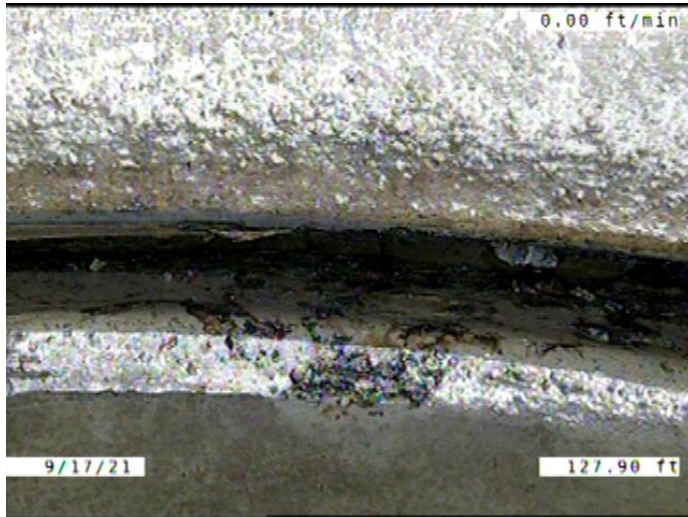
Code: **DAE**
 Description: **Deposits Attached Encrustation**

Distance (ft): **127.9**
 Structural Grade: **0**
 O&M Grade: **2**
 Clock Start/From: **8**
 Clock To: **4**
 1st Value:
 2nd Value:
 Value Percent: **5.000**
 Continuous Index:
 Within 8" of Joint: **YES**
 Remarks:

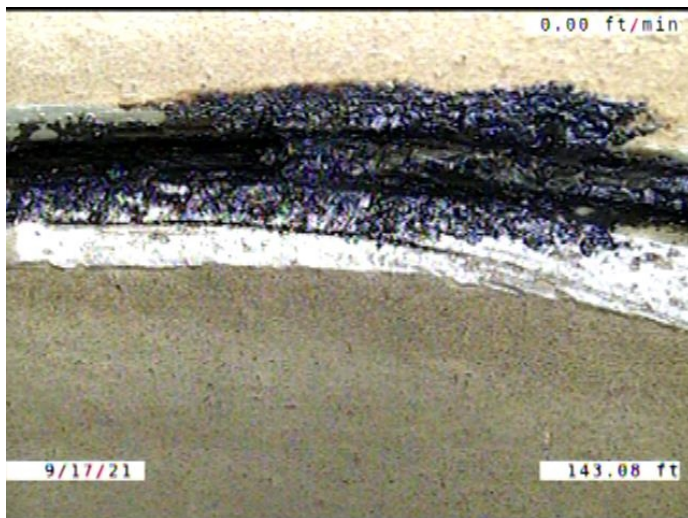
Code: **DAE**
 Description: **Deposits Attached Encrustation**

Distance (ft): **143.1**
 Structural Grade: **0**
 O&M Grade: **2**
 Clock Start/From: **12**
 Clock To: **3**
 1st Value:
 2nd Value:
 Value Percent: **5.000**
 Continuous Index:
 Within 8" of Joint: **YES**
 Remarks:

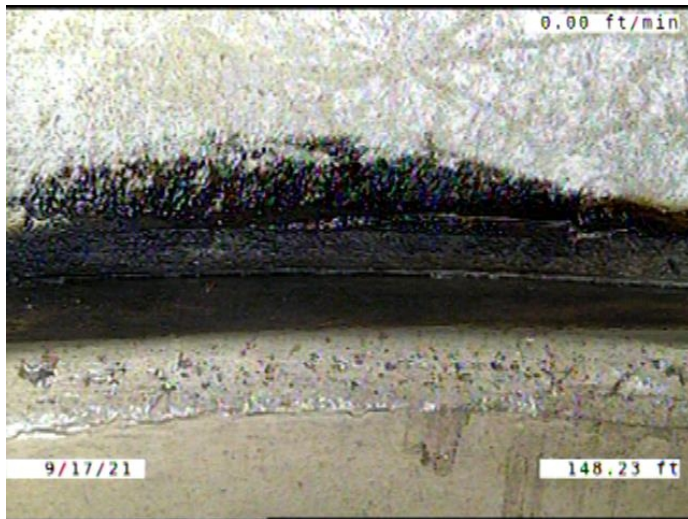
Code: **ISJ**
 Description: **Infiltration Stain Joint**

Distance (ft): **148.2**
 Structural Grade: **0**
 O&M Grade: **1**
 Clock Start/From: **9**
 Clock To: **10**
 1st Value:
 2nd Value:
 Value Percent:
 Continuous Index:
 Within 8" of Joint: **YES**
 Remarks:

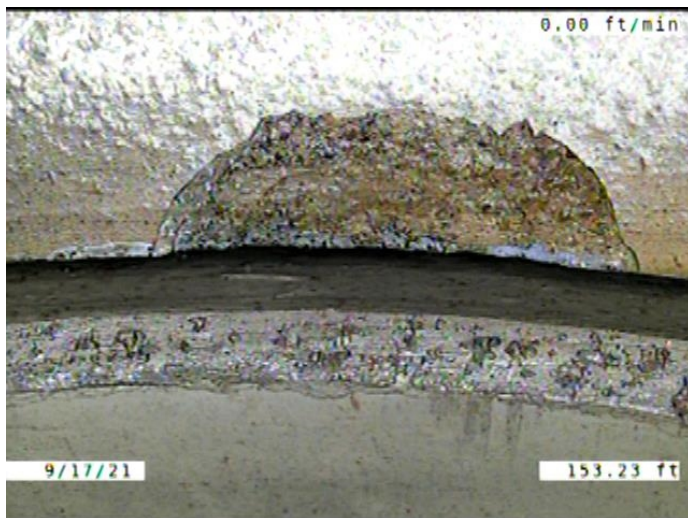
Code: **SZ**
 Description: **Surface Damage Other**

Distance (ft): **153.2**
 Structural Grade: **0**
 O&M Grade: **0**
 Clock Start/From: **1**
 Clock To:
 1st Value:
 2nd Value:
 Value Percent:
 Continuous Index:
 Within 8" of Joint: **YES**
 Remarks: **A PIECE CHIPPED AWAY FROM THE JOINT**

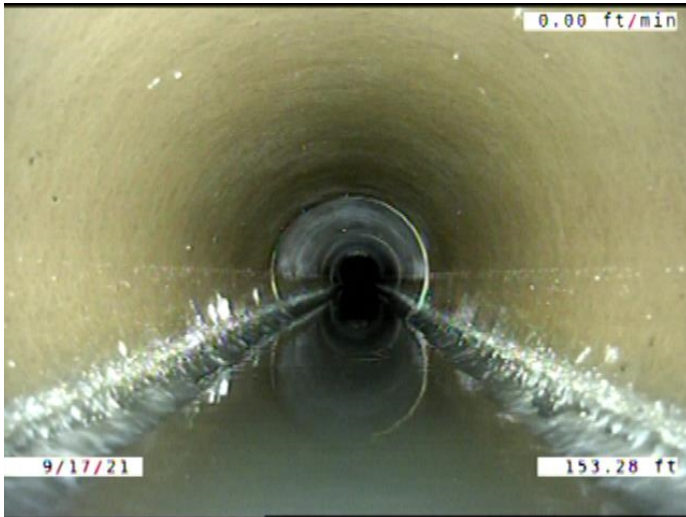
Code: **DSF**
 Description: **Deposits Settled Fine**

Distance (ft): **153.3**
 Structural Grade: **0**
 O&M Grade: **2**
 Clock Start/From: **4**
 Clock To: **8**
 1st Value:
 2nd Value:
 Value Percent: **5.000**
 Continuous Index: **S01**
 Within 8" of Joint: **YES**
 Remarks:

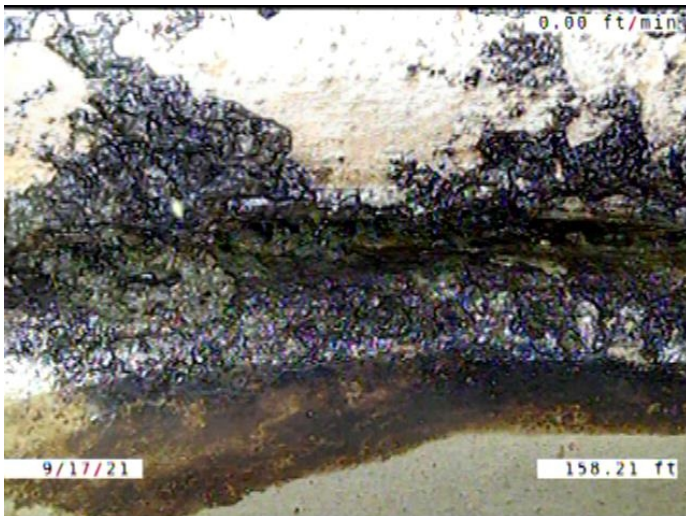
Code: **DAE**
 Description: **Deposits Attached Encrustation**

Distance (ft): **158.2**
 Structural Grade: **0**
 O&M Grade: **2**
 Clock Start/From: **9**
 Clock To: **12**
 1st Value:
 2nd Value:
 Value Percent: **5.000**
 Continuous Index:
 Within 8" of Joint: **YES**
 Remarks:

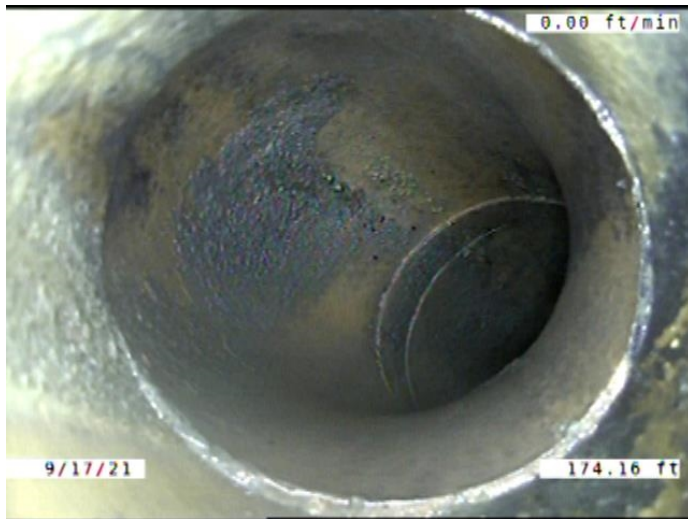
Code: **TF**
 Description: **Tap Factory**

Distance (ft): **174.2**
 Structural Grade: **0**
 O&M Grade: **0**
 Clock Start/From: **11**
 Clock To:
 1st Value: **4.000**
 2nd Value:
 Value Percent:
 Continuous Index:
 Within 8" of Joint: **YES**
 Remarks:

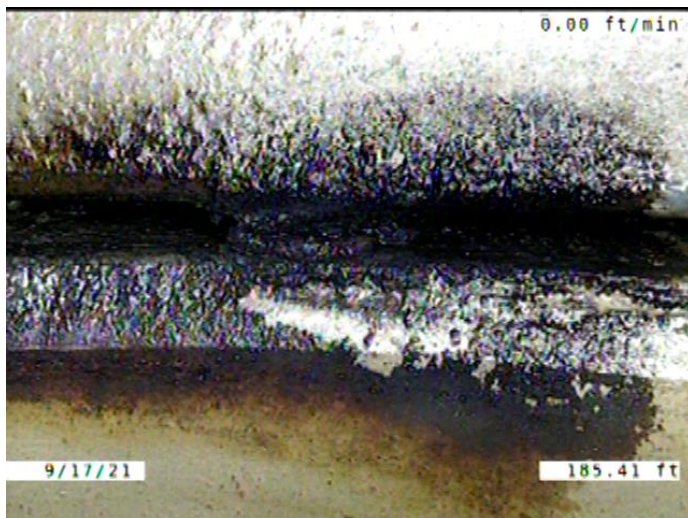
Code: **ISJ**
 Description: **Infiltration Stain Joint**

Distance (ft): **185.4**
 Structural Grade: **0**
 O&M Grade: **1**
 Clock Start/From: **12**
 Clock To: **4**
 1st Value:
 2nd Value:
 Value Percent:
 Continuous Index:
 Within 8" of Joint: **YES**
 Remarks:

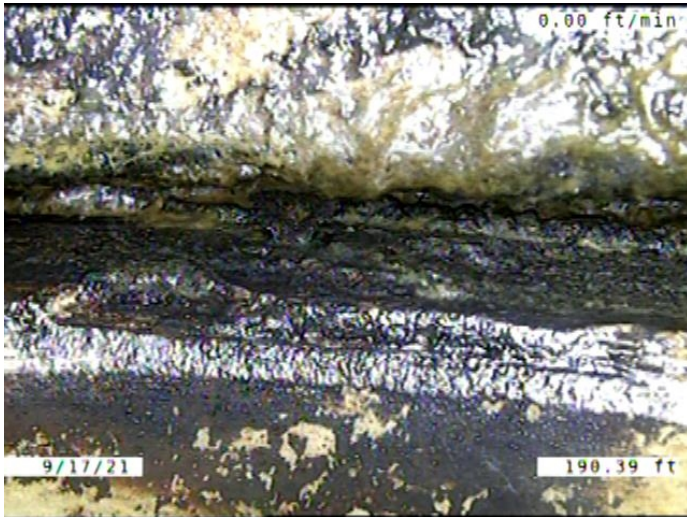
Code: **DAE**
 Description: **Deposits Attached Encrustation**

Distance (ft): **190.4**
 Structural Grade: **0**
 O&M Grade: **2**
 Clock Start/From: **12**
 Clock To: **4**
 1st Value:
 2nd Value:
 Value Percent: **5.000**
 Continuous Index:
 Within 8" of Joint: **YES**
 Remarks:

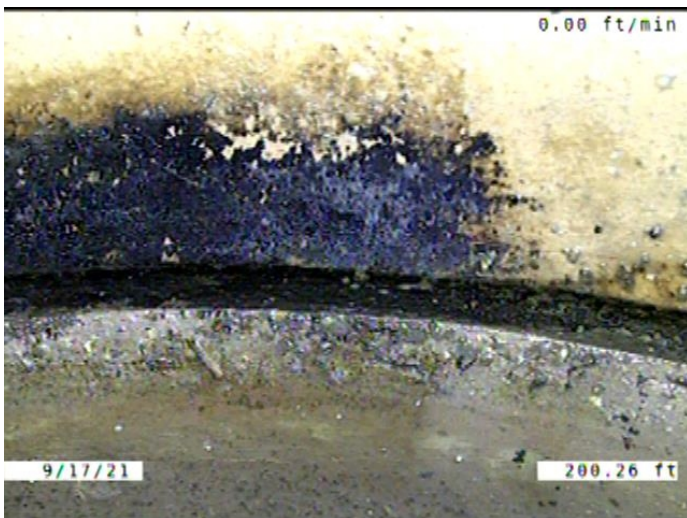
Code: **ISJ**
 Description: **Infiltration Stain Joint**

Distance (ft): **200.3**
 Structural Grade: **0**
 O&M Grade: **1**
 Clock Start/From: **9**
 Clock To: **3**
 1st Value:
 2nd Value:
 Value Percent:
 Continuous Index:
 Within 8" of Joint: **YES**
 Remarks:

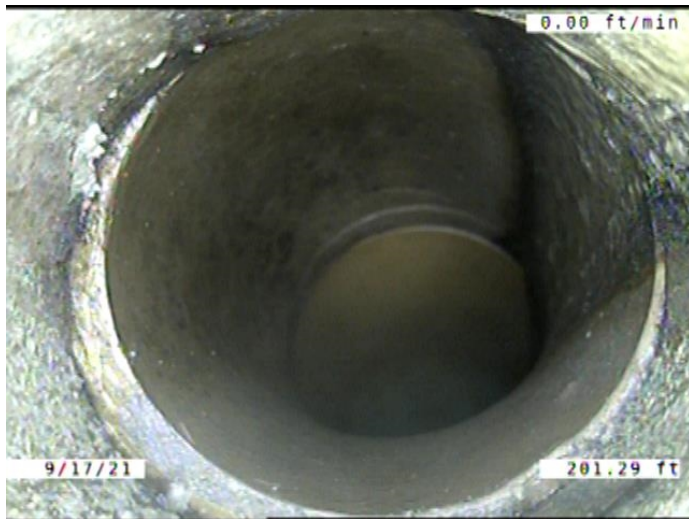
Code: **TF**
 Description: **Tap Factory**

Distance (ft): **201.3**
 Structural Grade: **0**
 O&M Grade: **0**
 Clock Start/From: **1**
 Clock To:
 1st Value: **5.000**
 2nd Value:
 Value Percent:
 Continuous Index:
 Within 8" of Joint: **YES**
 Remarks:

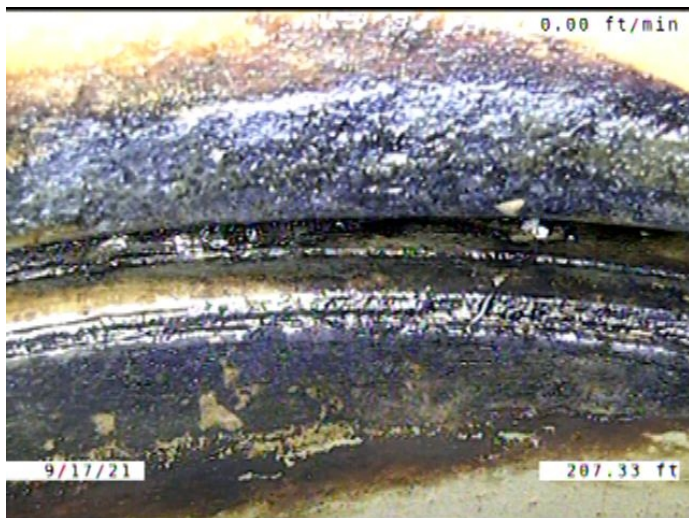
Code: **ISJ**
 Description: **Infiltration Stain Joint**

Distance (ft): **207.3**
 Structural Grade: **0**
 O&M Grade: **1**
 Clock Start/From: **8**
 Clock To: **4**
 1st Value:
 2nd Value:
 Value Percent:
 Continuous Index:
 Within 8" of Joint: **YES**
 Remarks:

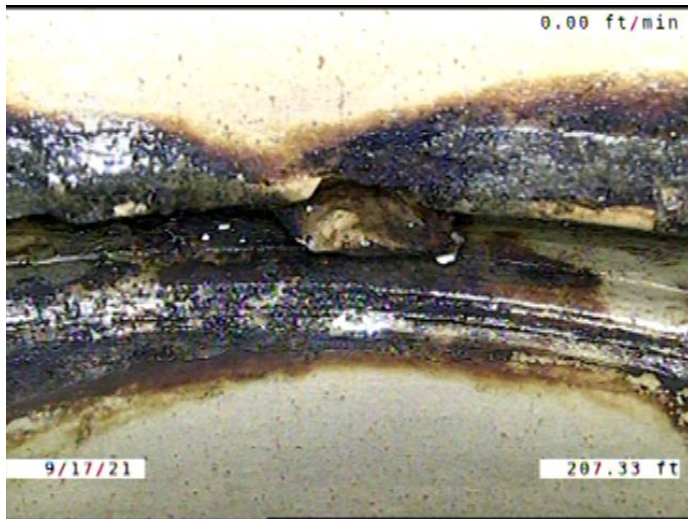
Code: **OBJ**
 Description: **Obstruction Wedged In The Joint**

Distance (ft): **207.3**
 Structural Grade: **0**
 O&M Grade: **2**
 Clock Start/From: **12**
 Clock To:
 1st Value:
 2nd Value:
 Value Percent: **5.000**
 Continuous Index:
 Within 8" of Joint: **YES**
 Remarks:

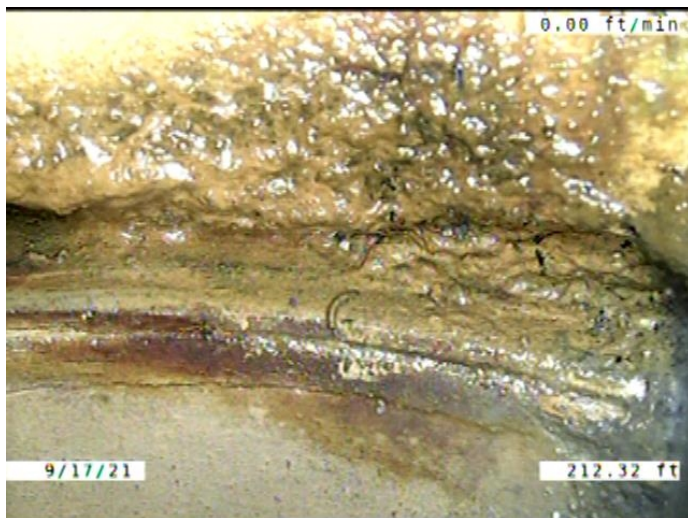
Code: **DAE**
 Description: **Deposits Attached Encrustation**

Distance (ft): **212.3**
 Structural Grade: **0**
 O&M Grade: **2**
 Clock Start/From: **2**
 Clock To: **4**
 1st Value:
 2nd Value:
 Value Percent: **5.000**
 Continuous Index:
 Within 8" of Joint: **YES**
 Remarks:

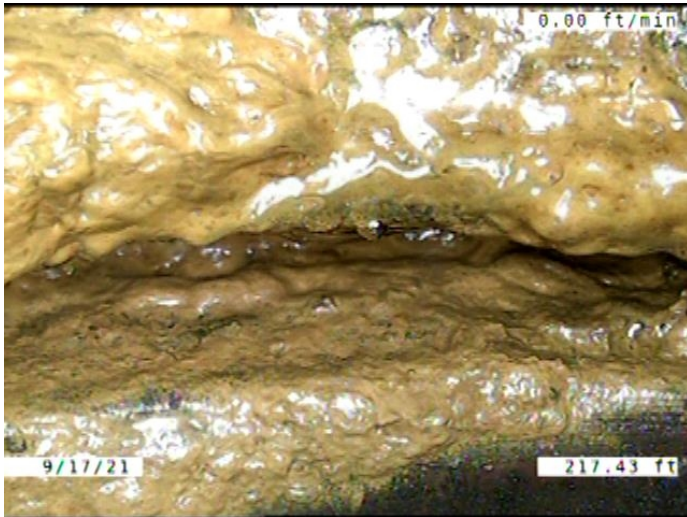
Code: **DAE**
 Description: **Deposits Attached Encrustation**

Distance (ft): **217.4**
 Structural Grade: **0**
 O&M Grade: **2**
 Clock Start/From: **8**
 Clock To: **4**
 1st Value:
 2nd Value:
 Value Percent: **5.000**
 Continuous Index:
 Within 8" of Joint: **YES**
 Remarks:

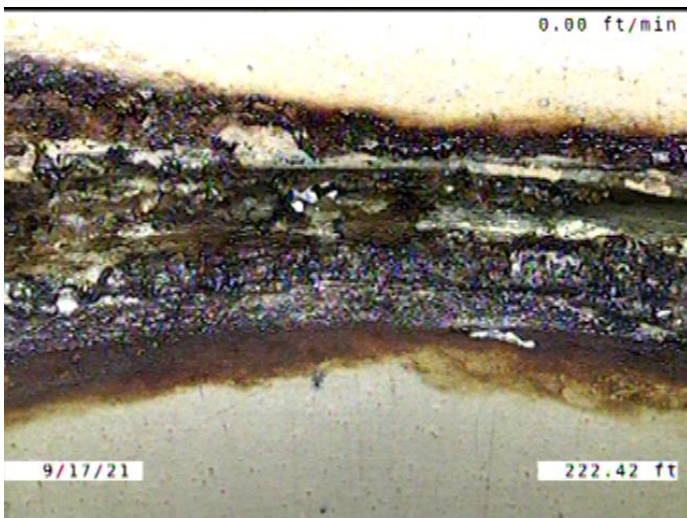
Code: **DAE**
 Description: **Deposits Attached Encrustation**

Distance (ft): **222.4**
 Structural Grade: **0**
 O&M Grade: **2**
 Clock Start/From: **8**
 Clock To: **4**
 1st Value:
 2nd Value:
 Value Percent: **5.000**
 Continuous Index:
 Within 8" of Joint: **YES**
 Remarks:

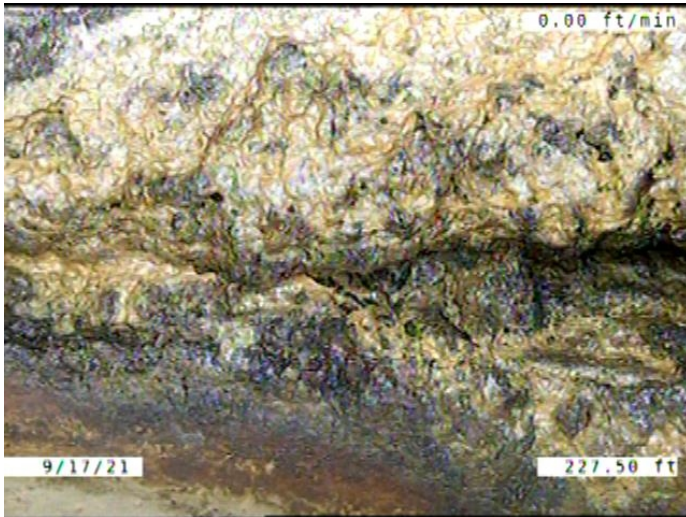
Code: **DAE**
Description: **Deposits Attached Encrustation**

Distance (ft): **227.5**
Structural Grade: **0**
O&M Grade: **2**
Clock Start/From: **8**
Clock To: **4**
1st Value:
2nd Value:
Value Percent: **5.000**
Continuous Index:
Within 8" of Joint: **YES**
Remarks:

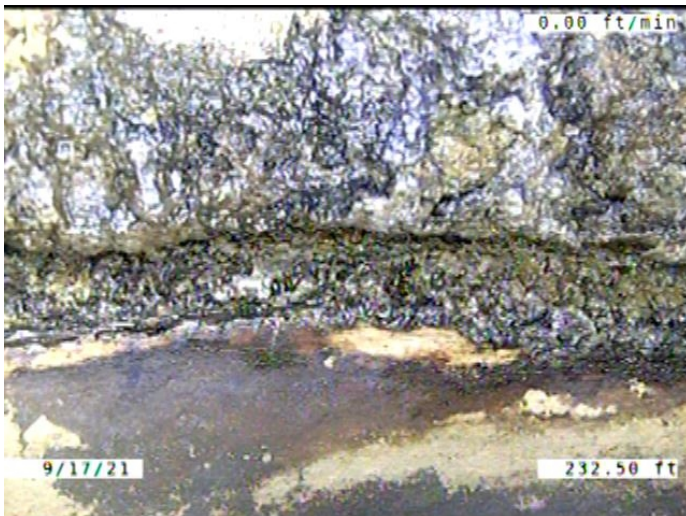
Code: **DAE**
Description: **Deposits Attached Encrustation**

Distance (ft): **232.5**
Structural Grade: **0**
O&M Grade: **2**
Clock Start/From: **8**
Clock To: **4**
1st Value:
2nd Value:
Value Percent: **5.000**
Continuous Index:
Within 8" of Joint: **YES**
Remarks:

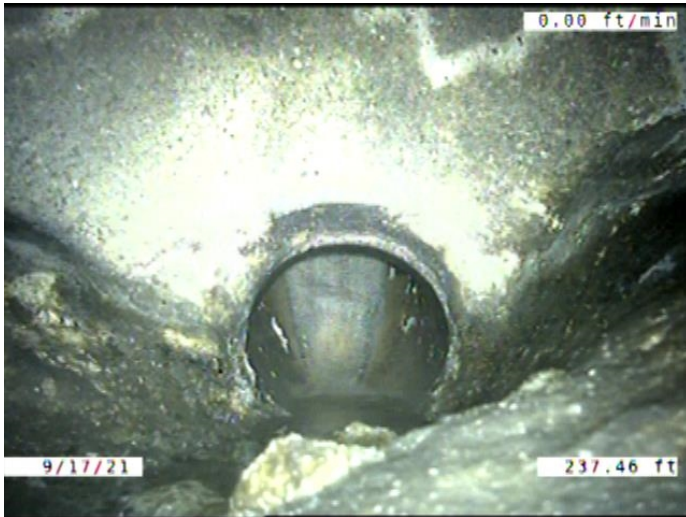
Code: **DSF**
 Description: **Deposits Settled Fine**

Distance (ft): **237.5**
 Structural Grade: **0**
 O&M Grade: **2**
 Clock Start/From: **4**
 Clock To: **8**
 1st Value:
 2nd Value:
 Value Percent: **5.000**
 Continuous Index: **F01**
 Within 8" of Joint: **YES**
 Remarks:

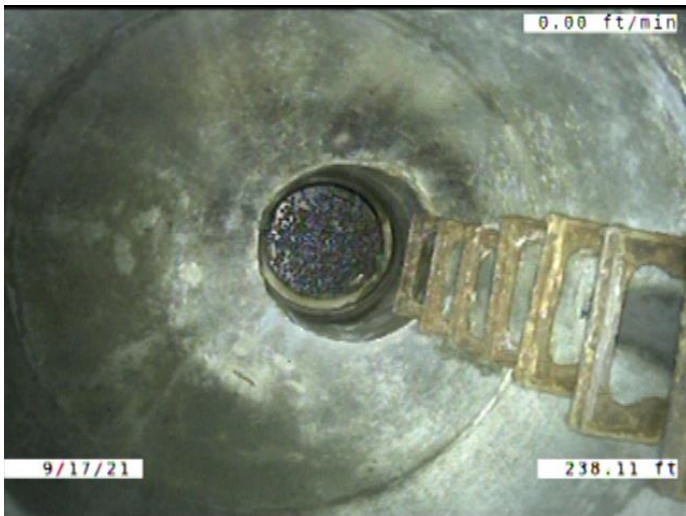
Code: **AMH**
 Description: **Manhole**

Distance (ft): **238.1**
 Structural Grade: **0**
 O&M Grade: **0**
 Clock Start/From:
 Clock To:
 1st Value:
 2nd Value:
 Value Percent:
 Continuous Index:
 Within 8" of Joint: **NO**
 Remarks: **M-503-057**
