Profile/Photo Observation Report

Street:	N COLORADO ST	Flow Control:	Not Controlled
City:	Hobart, IN	Year Renewed:	
Location:	Other	Tape/Media #:	
Purpose:	Not Known	Dia/Height:	10"
Use:	Sanitary	Material:	VCP
Drain Area:	NA	Lining:	
Category:	NA		
Comment:

Location Details:		Direction of Survey:	Downstream
US MH:	M-503-057	DS MH:	M-503-058
		Total Length Surveyed (ft):	4.0

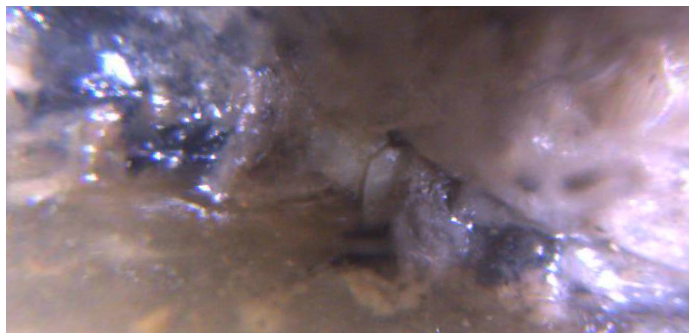
Code: **AMH**
Description: **Manhole**

Distance (ft): **.0**
Structural Grade: **0**
O&M Grade: **0**
Clock Start/From:
Clock To:
1st Value:
2nd Value:
Value Percent:
Continuous Index:
Within 8" of Joint: **NO**
Remarks: **M-503-057**

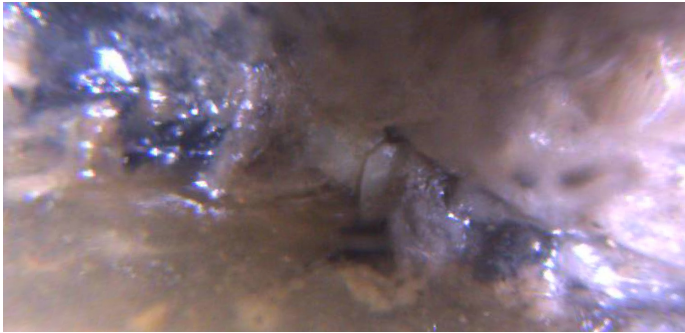
Code:	MWL
Description:	Water Level

Distance (ft):	.0
Structural Grade:	0
O&M Grade:	0
Clock Start/From:	
Clock To:	
1st Value:	
2nd Value:	
Value Percent:	40.000
Continuous Index:	
Within 8" of Joint:	NO
Remarks:
