Profile/Photo Observation Report

Date:	04/13/2018	Weather:		Coding:	PACP 6.0
Pipe Length (ft):	292.2	Owner:	NA	Pre Clean:	Not Known
P.O.#:		Surveyor:	Jen Costello	PSR:	P-503-058-057
Customer:		Clean Date:	01/01/1900	Shape:	C

Street:	W 40th ave	Flow Control:	Not Controlled
City:	Hobart, IN	Year Renewed:	
Location:	Other	Tape/Media #:	
Purpose:	Not Known	Dia/Height:	10"
Use:	Sanitary	Material:	VCP
Drain Area:	NA	Lining:	
Category:	NA		
Comment:

Location Details:		Direction of Survey:	Downstream
US MH:	M-503-057	DS MH:	M-503-058
		Total Length Surveyed (ft):	4.0

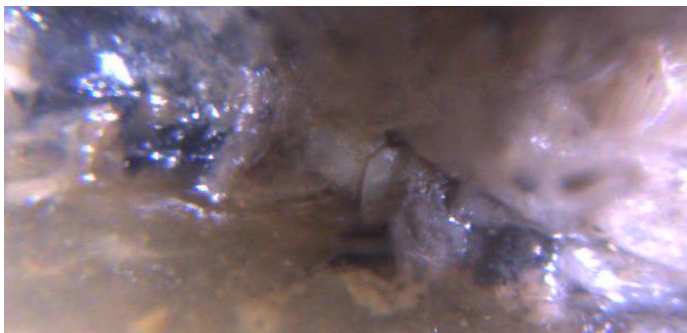
Code: **AMH**
Description: **Manhole**

Distance (ft): **.0**
Structural Grade: **0**
O&M Grade: **0**
Clock Start/From:
Clock To:
1st Value:
2nd Value:
Value Percent:
Continuous Index:
Within 8" of Joint: **NO**
Remarks: **M-503-057**

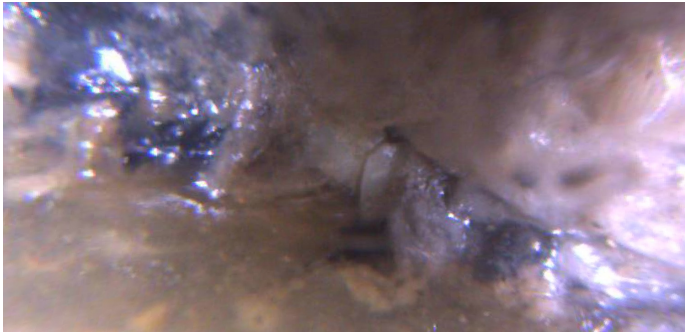
Code:	MWL
Description:	Water Level

Distance (ft):	.0
Structural Grade:	0
O&M Grade:	0
Clock Start/From:	
Clock To:	
1st Value:	
2nd Value:	
Value Percent:	40.000
Continuous Index:	
Within 8" of Joint:	NO
Remarks:
