Profile/Photo Observation Report

Street:	North Colorado Street	Flow Control:	Not Controlled
City:	Hobart, IN	Year Renewed:	
Location:	Alley	Tape/Media #:	
Purpose:	Routine Assessment	Dia/Height:	10"
Use:	Sanitary Sewage Pipe	Material:	VCP
Drain Area:		Lining:	None
Category:	NA		
Comment:

Location Details:		Direction of Survey:	Downstream
US MH:	M-503-057	DS MH:	M-503-058
		Total Length Surveyed (ft):	289.7

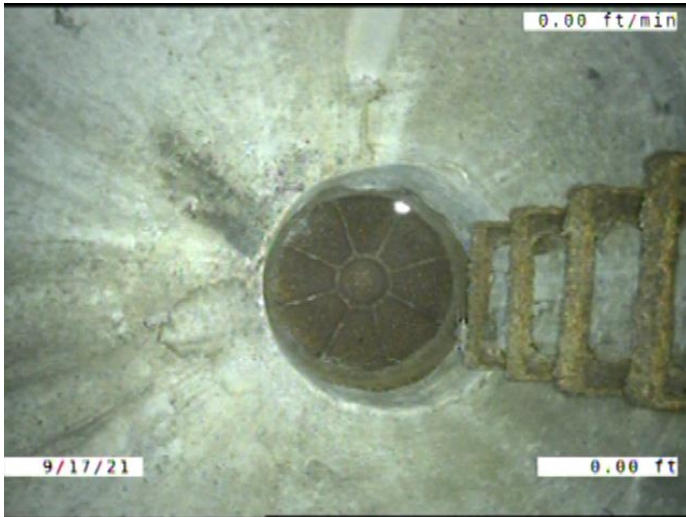
Code: **AMH**
 Description: **Manhole**

Distance (ft): **.0**
 Structural Grade: **0**
 O&M Grade: **0**
 Clock Start/From:
 Clock To:
 1st Value:
 2nd Value:
 Value Percent:
 Continuous Index:
 Within 8" of Joint: **NO**
 Remarks: **M-503-057**

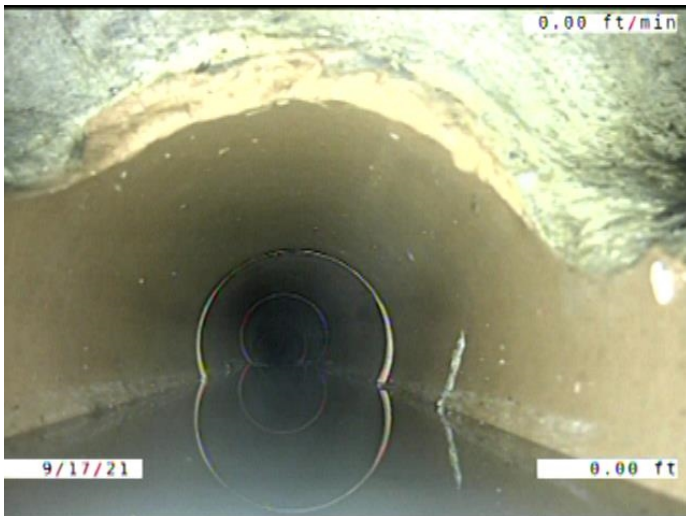
Code: **MWL**
 Description: **Miscellaneous Water Level**

Distance (ft): **.0**
 Structural Grade: **0**
 O&M Grade: **0**
 Clock Start/From:
 Clock To:
 1st Value:
 2nd Value:
 Value Percent: **10.000**
 Continuous Index:
 Within 8" of Joint: **NO**
 Remarks:

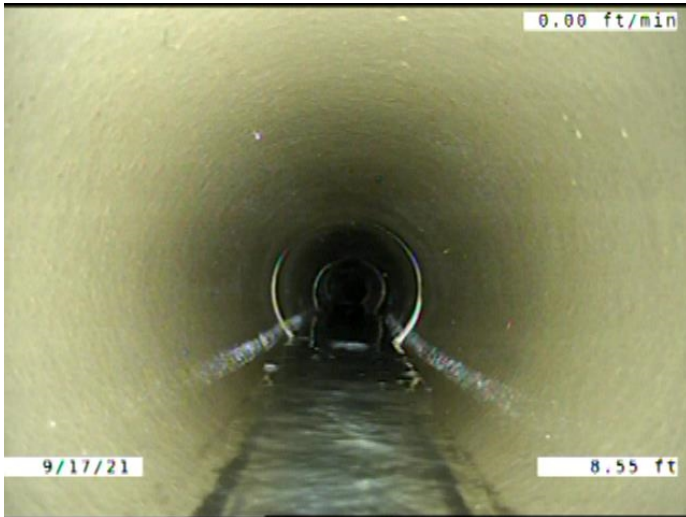
Code: **LD**
 Description: **Line Down**

Distance (ft): **8.5**
 Structural Grade: **0**
 O&M Grade: **1**
 Clock Start/From:
 Clock To:
 1st Value:
 2nd Value:
 Value Percent: **5.000**
 Continuous Index:
 Within 8" of Joint: **NO**
 Remarks:

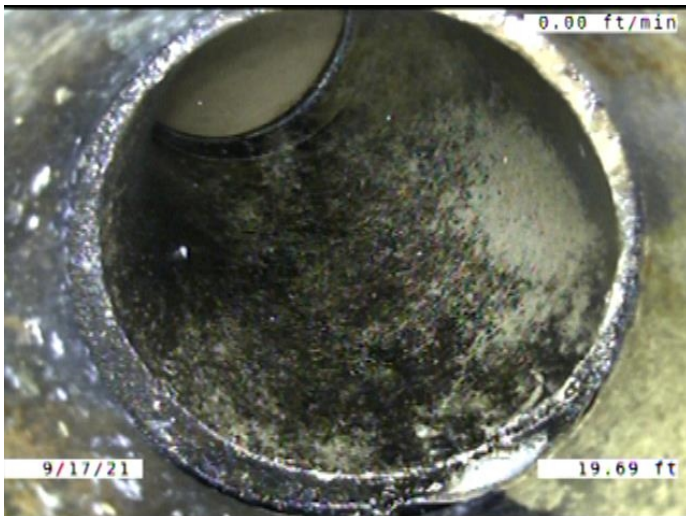
Code: **TF**
 Description: **Tap Factory**

Distance (ft): **19.7**
 Structural Grade: **0**
 O&M Grade: **0**
 Clock Start/From: **12**
 Clock To:
 1st Value: **4.000**
 2nd Value:
 Value Percent:
 Continuous Index:
 Within 8" of Joint: **YES**
 Remarks:

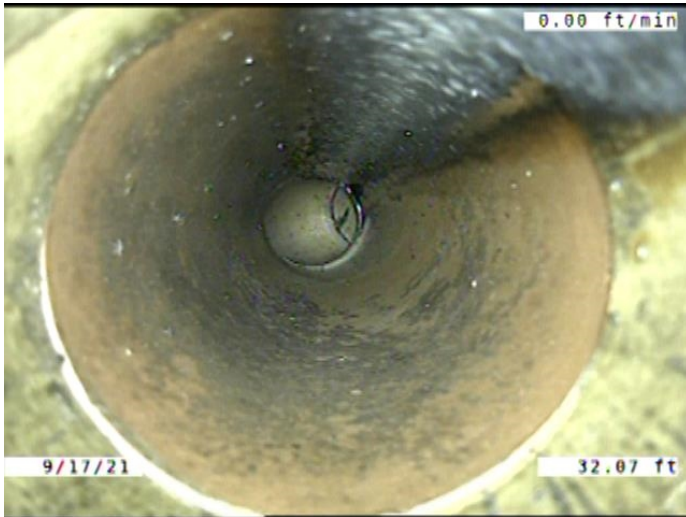
Code: **TF**
 Description: **Tap Factory**

Distance (ft): **32.1**
 Structural Grade: **0**
 O&M Grade: **0**
 Clock Start/From: **12**
 Clock To:
 1st Value: **4.000**
 2nd Value:
 Value Percent:
 Continuous Index:
 Within 8" of Joint: **YES**
 Remarks:

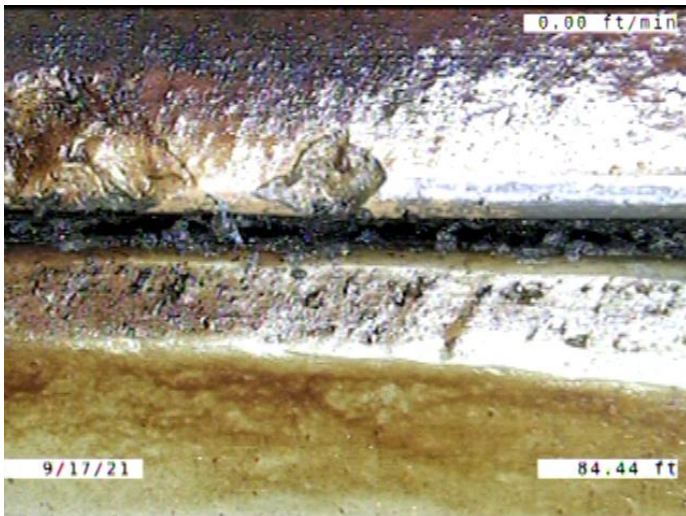
Code: **ISJ**
 Description: **Infiltration Stain Joint**

Distance (ft): **84.4**
 Structural Grade: **0**
 O&M Grade: **1**
 Clock Start/From: **7**
 Clock To: **5**
 1st Value:
 2nd Value:
 Value Percent:
 Continuous Index:
 Within 8" of Joint: **YES**
 Remarks:

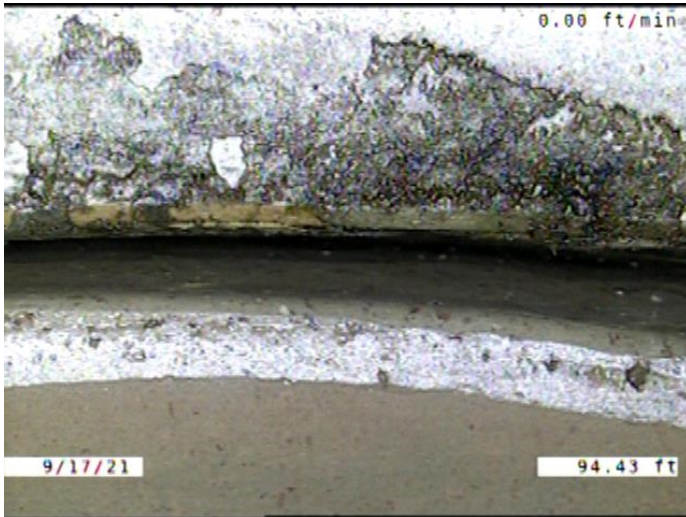
Code: **ISJ**
 Description: **Infiltration Stain Joint**

Distance (ft): **94.4**
 Structural Grade: **0**
 O&M Grade: **1**
 Clock Start/From: **8**
 Clock To: **12**
 1st Value:
 2nd Value:
 Value Percent:
 Continuous Index:
 Within 8" of Joint: **YES**
 Remarks:

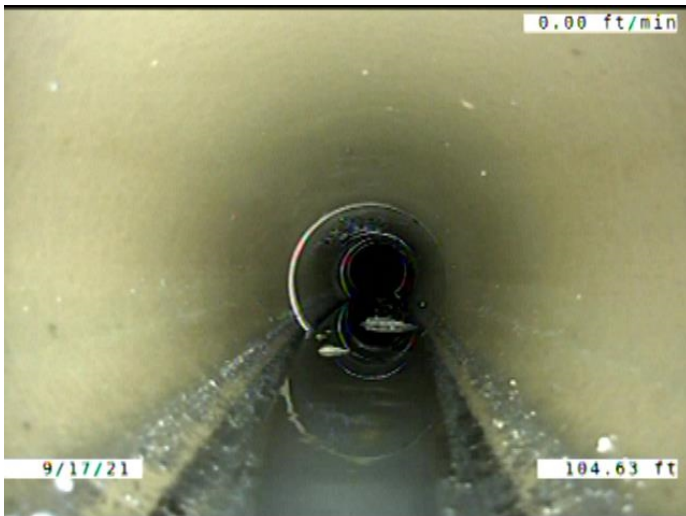
Code: **MWLS**
 Description: **Miscellaneous Water Level Sag**

Distance (ft): **104.6**
 Structural Grade: **2**
 O&M Grade: **0**
 Clock Start/From:
 Clock To:
 1st Value:
 2nd Value:
 Value Percent: **5.000**
 Continuous Index: **S01**
 Within 8" of Joint: **NO**
 Remarks:

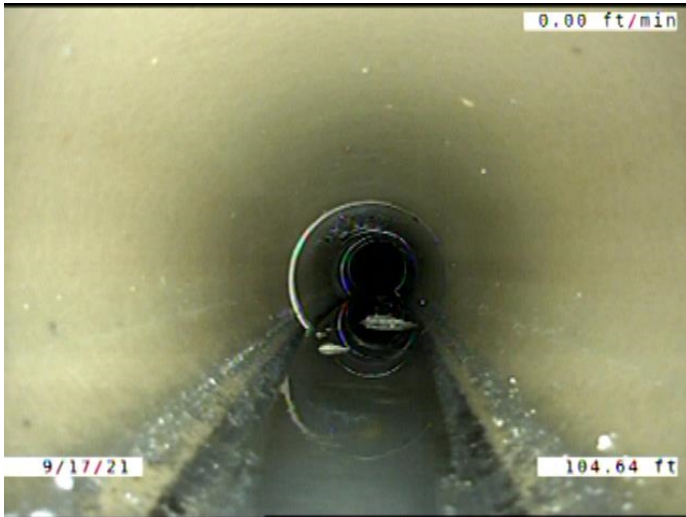
Code: **DSF**
Description: **Deposits Settled Fine**

Distance (ft): **104.6**
Structural Grade: **0**
O&M Grade: **2**
Clock Start/From: **5**
Clock To: **7**
1st Value:
2nd Value:
Value Percent: **5.000**
Continuous Index: **S02**
Within 8" of Joint: **YES**
Remarks:

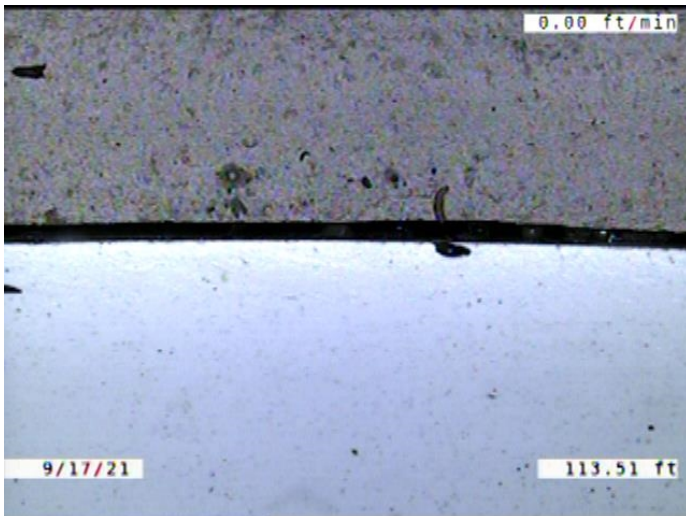
Code: **MMC**
Description: **Miscellaneous Material Change**

Distance (ft): **113.5**
Structural Grade: **0**
O&M Grade: **0**
Clock Start/From:
Clock To:
1st Value:
2nd Value:
Value Percent:
Continuous Index:
Within 8" of Joint: **NO**
Remarks: **VCP TO PVC**

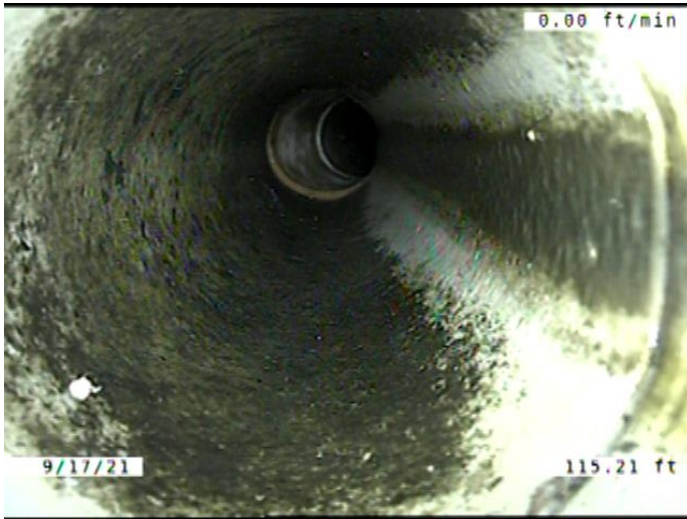
Code: **TF**
Description: **Tap Factory**

Distance (ft): **115.2**
Structural Grade: **0**
O&M Grade: **0**
Clock Start/From: **2**
Clock To:
1st Value: **4.000**
2nd Value:
Value Percent:
Continuous Index:
Within 8" of Joint: **YES**
Remarks:

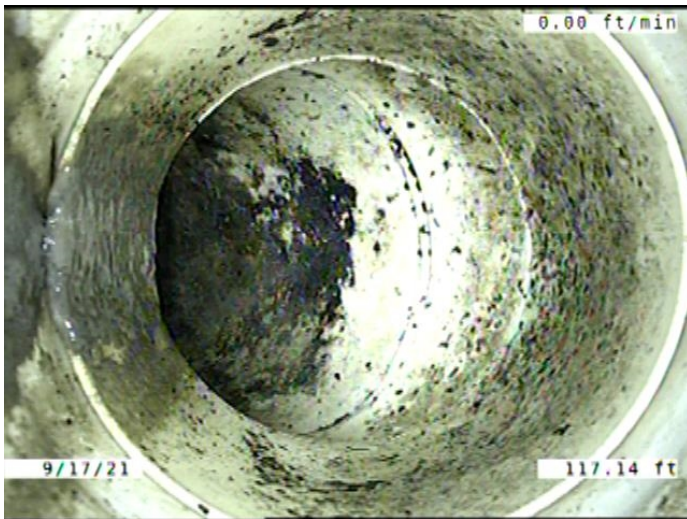
Code: **TF**
Description: **Tap Factory**

Distance (ft): **117.1**
Structural Grade: **0**
O&M Grade: **0**
Clock Start/From: **11**
Clock To:
1st Value: **4.000**
2nd Value:
Value Percent:
Continuous Index:
Within 8" of Joint: **YES**
Remarks:

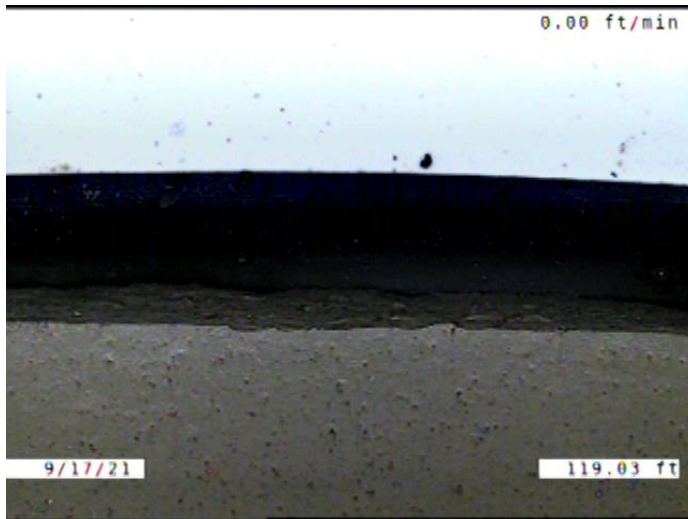
Code: **MMC**
Description: **Miscellaneous Material Change**

Distance (ft): **119.0**
Structural Grade: **0**
O&M Grade: **0**
Clock Start/From:
Clock To:
1st Value:
2nd Value:
Value Percent:
Continuous Index:
Within 8" of Joint: **NO**
Remarks: **PVC TO VCP**

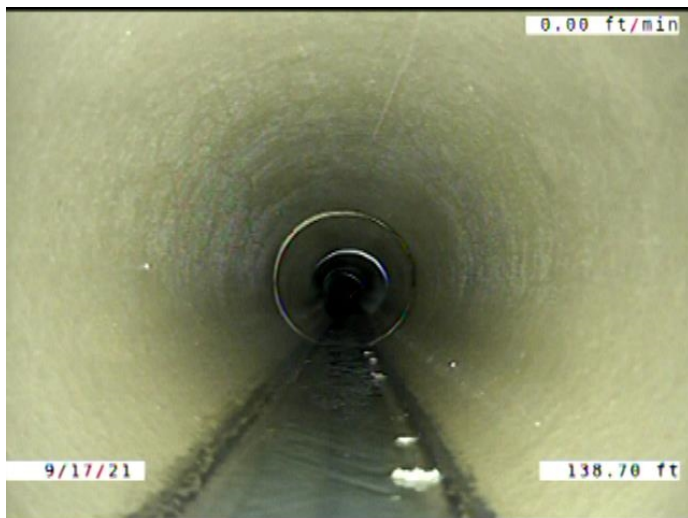
Code: **MWLS**
Description: **Miscellaneous Water Level Sag**

Distance (ft): **138.7**
Structural Grade: **2**
O&M Grade: **0**
Clock Start/From:
Clock To:
1st Value:
2nd Value:
Value Percent: **5.000**
Continuous Index: **F01**
Within 8" of Joint: **NO**
Remarks:

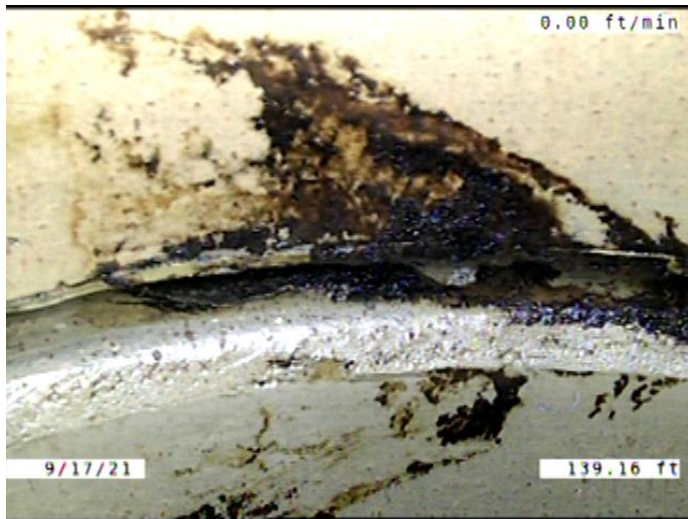
Code: **ISJ**
Description: **Infiltration Stain Joint**

Distance (ft): **139.2**
Structural Grade: **0**
O&M Grade: **1**
Clock Start/From: **8**
Clock To: **10**
1st Value:
2nd Value:
Value Percent:
Continuous Index:
Within 8" of Joint: **YES**
Remarks:

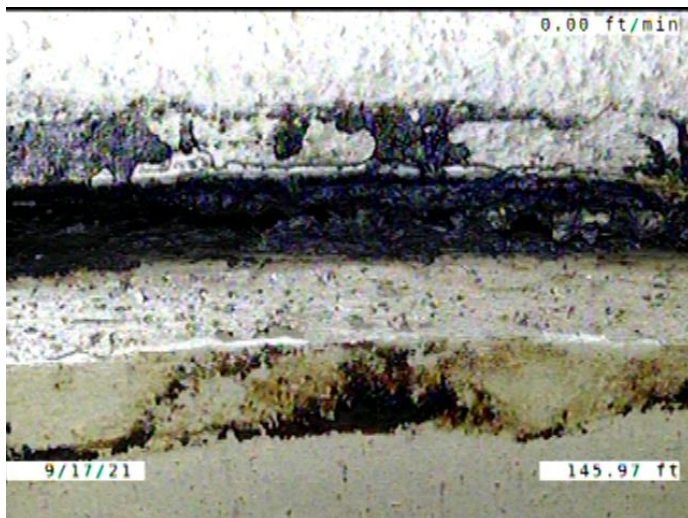
Code: **ISJ**
Description: **Infiltration Stain Joint**

Distance (ft): **146.0**
Structural Grade: **0**
O&M Grade: **1**
Clock Start/From: **9**
Clock To: **4**
1st Value:
2nd Value:
Value Percent:
Continuous Index:
Within 8" of Joint: **YES**
Remarks:

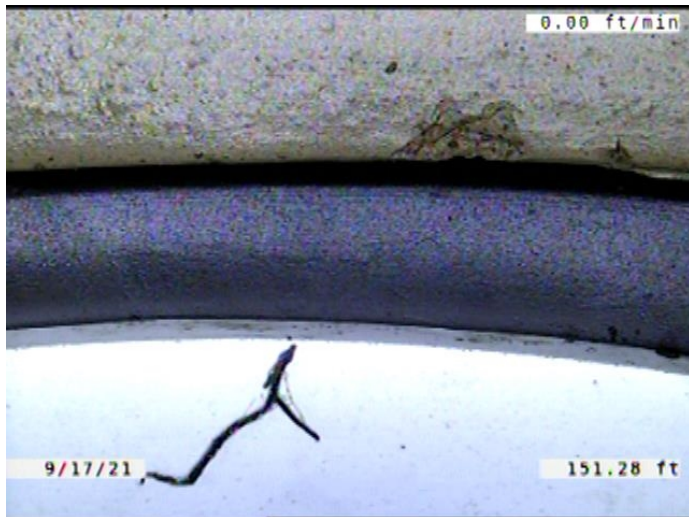
Code: **MMC**
 Description: **Miscellaneous Material Change**

Distance (ft): **151.3**
 Structural Grade: **0**
 O&M Grade: **0**
 Clock Start/From:
 Clock To:
 1st Value:
 2nd Value:
 Value Percent:
 Continuous Index:
 Within 8" of Joint: **NO**
 Remarks: **VCP TO PVC**

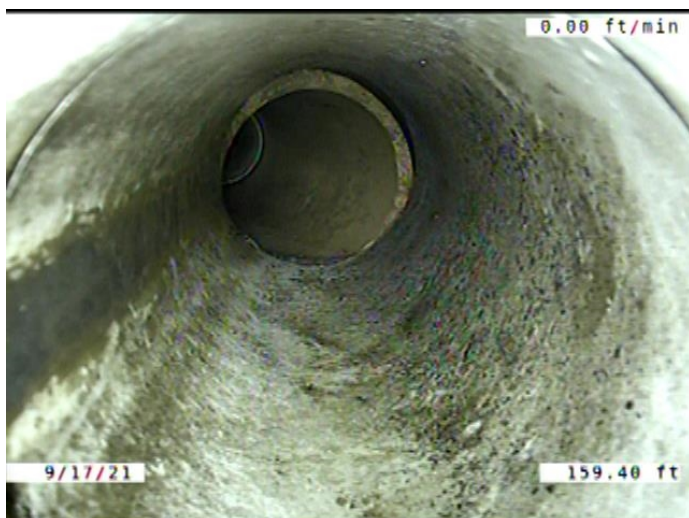
Code: **TF**
 Description: **Tap Factory**

Distance (ft): **159.4**
 Structural Grade: **0**
 O&M Grade: **0**
 Clock Start/From: **10**
 Clock To:
 1st Value: **4.000**
 2nd Value:
 Value Percent:
 Continuous Index:
 Within 8" of Joint: **YES**
 Remarks:

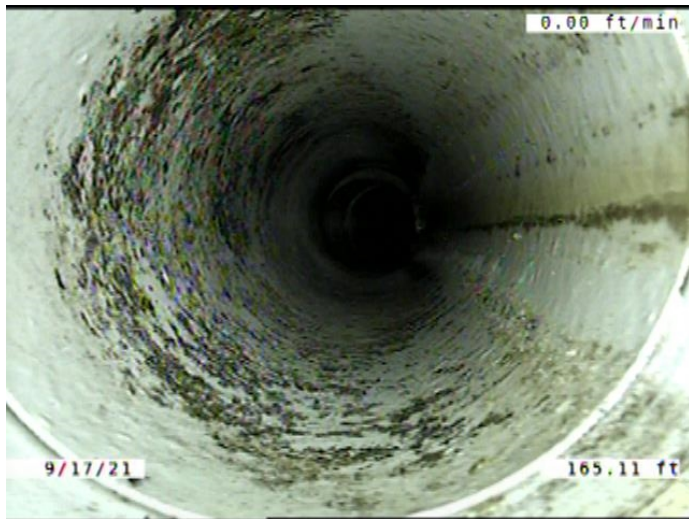
Code: **TF**
 Description: **Tap Factory**

Distance (ft): **165.1**
 Structural Grade: **0**
 O&M Grade: **0**
 Clock Start/From: **2**
 Clock To:
 1st Value: **4.000**
 2nd Value:
 Value Percent:
 Continuous Index:
 Within 8" of Joint: **YES**
 Remarks:

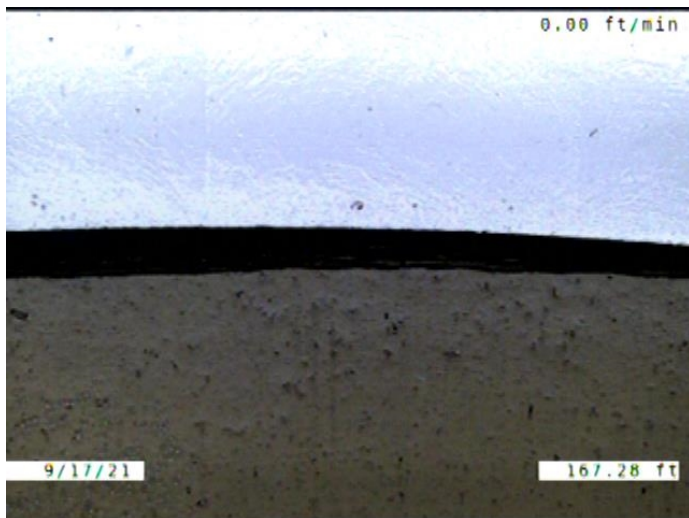
Code: **MMC**
 Description: **Miscellaneous Material Change**

Distance (ft): **167.3**
 Structural Grade: **0**
 O&M Grade: **0**
 Clock Start/From:
 Clock To:
 1st Value:
 2nd Value:
 Value Percent:
 Continuous Index:
 Within 8" of Joint: **NO**
 Remarks: **PVC TO VCP**

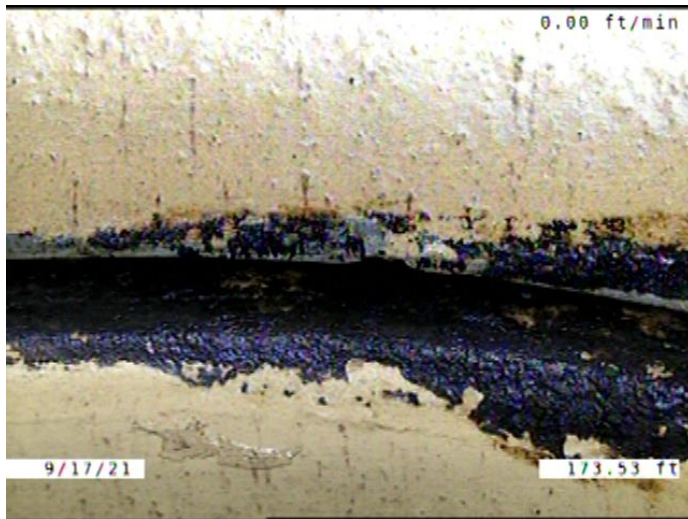
Code: **ISJ**
 Description: **Infiltration Stain Joint**

Distance (ft): **173.5**
 Structural Grade: **0**
 O&M Grade: **1**
 Clock Start/From: **1**
 Clock To: **5**
 1st Value:
 2nd Value:
 Value Percent:
 Continuous Index:
 Within 8" of Joint: **YES**
 Remarks:

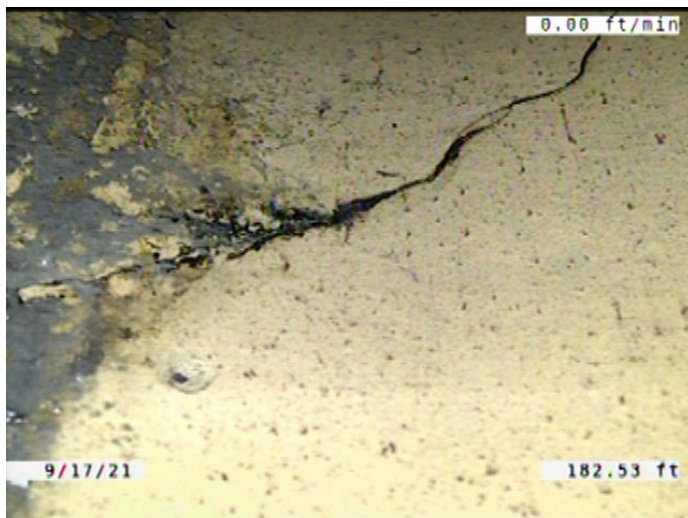
Code: **CM**
 Description: **Crack Multiple**

Distance (ft): **182.5**
 Structural Grade: **3**
 O&M Grade: **0**
 Clock Start/From: **2**
 Clock To: **5**
 1st Value:
 2nd Value:
 Value Percent:
 Continuous Index:
 Within 8" of Joint: **YES**
 Remarks:

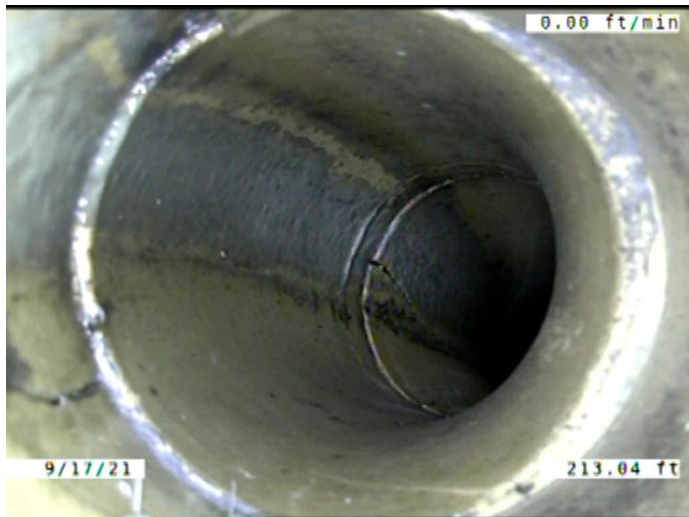
Code: **TF**
 Description: **Tap Factory**

Distance (ft): **213.0**
 Structural Grade: **0**
 O&M Grade: **0**
 Clock Start/From: **11**
 Clock To:
 1st Value: **4.000**
 2nd Value:
 Value Percent:
 Continuous Index:
 Within 8" of Joint: **YES**
 Remarks:

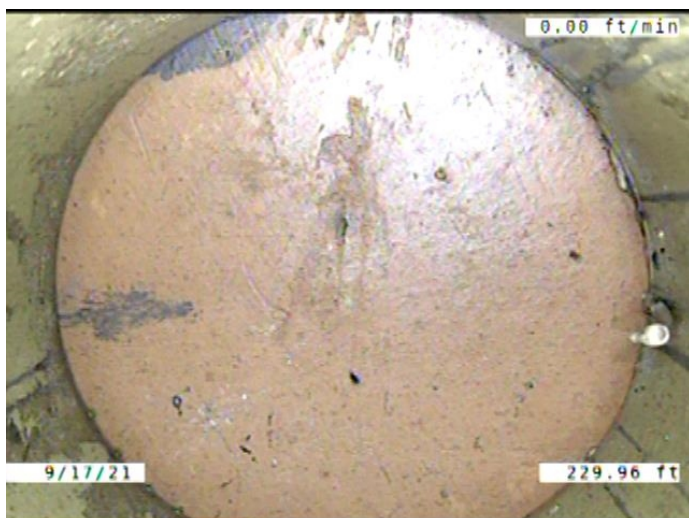
Code: **TFC**
 Description: **Tap Factory Capped**

Distance (ft): **230.0**
 Structural Grade: **0**
 O&M Grade: **0**
 Clock Start/From: **1**
 Clock To:
 1st Value: **4.000**
 2nd Value:
 Value Percent:
 Continuous Index:
 Within 8" of Joint: **YES**
 Remarks:

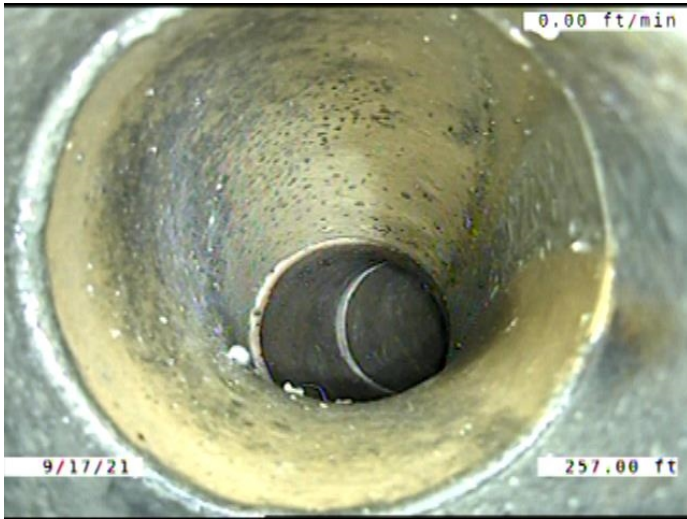
Code: **TF**
Description: **Tap Factory**

Distance (ft): **257.0**
Structural Grade: **0**
O&M Grade: **0**
Clock Start/From: **2**
Clock To:
1st Value: **4.000**
2nd Value:
Value Percent:
Continuous Index:
Within 8" of Joint: **YES**
Remarks:

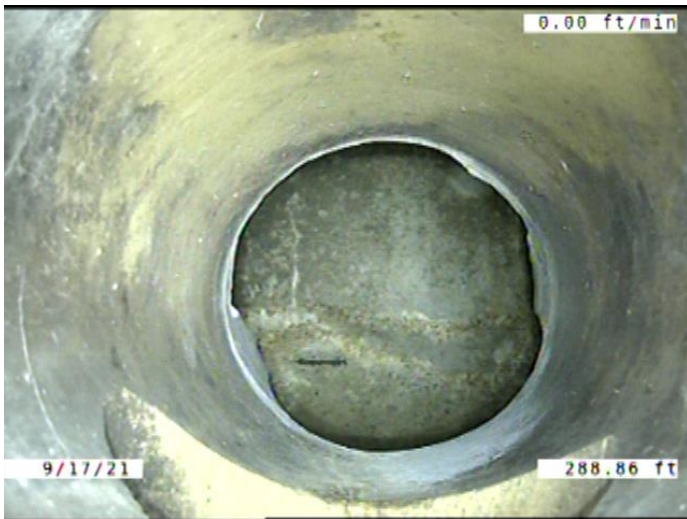
Code: **DSF**
Description: **Deposits Settled Fine**

Distance (ft): **288.9**
Structural Grade: **0**
O&M Grade: **2**
Clock Start/From: **5**
Clock To: **7**
1st Value:
2nd Value:
Value Percent: **5.000**
Continuous Index: **F02**
Within 8" of Joint: **YES**
Remarks:

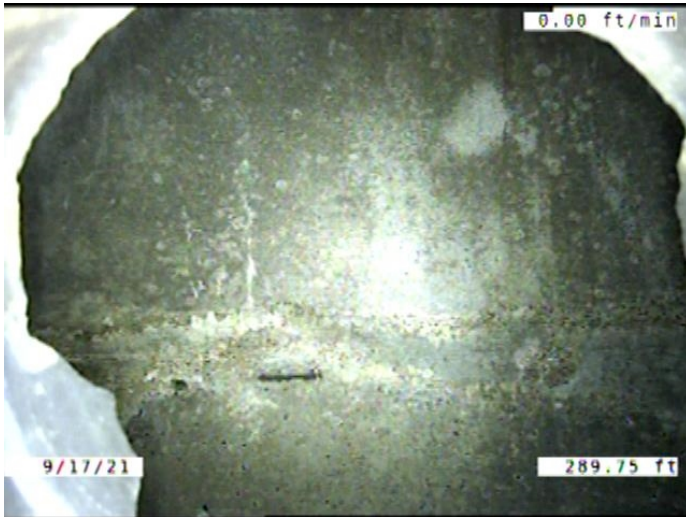
Code:	AMH
Description:	Manhole
Distance (ft):	289.7
Structural Grade:	0
O&M Grade:	0
Clock Start/From:	
Clock To:	
1st Value:	
2nd Value:	
Value Percent:	
Continuous Index:	
Within 8" of Joint:	NO
Remarks:	M-503-058
