## Profile/Photo Observation Report

Street:	<b>W 40th ave</b>	Flow Control:	<b>Not Controlled</b>
City:	<b>Hobart, IN</b>	Year Renewed:	
Location:	<b>Other</b>	Tape/Media #:	
Purpose:	<b>Not Known</b>	Dia/Height:	<b>10"</b>
Use:	<b>Sanitary</b>	Material:	<b>VCP</b>
Drain Area:	<b>NA</b>	Lining:	
Category:	<b>NA</b>		
Comment:

Location Details:		Direction of Survey:	<b>Downstream</b>
US MH:	<b>M-503-058</b>	DS MH:	<b>M-503-059</b>
		Total Length Surveyed (ft):	<b>12.0</b>

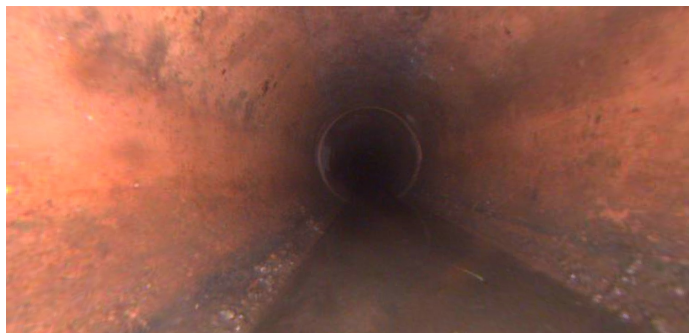
Code: **AMH**  
 Description: **Manhole**  
 Distance (ft): **.0**  
 Structural Grade: **0**  
 O&M Grade: **0**  
 Clock Start/From:  
 Clock To:  
 1st Value:  
 2nd Value:  
 Value Percent:  
 Continuous Index:  
 Within 8" of Joint: **NO**  
 Remarks: **M-503-058**

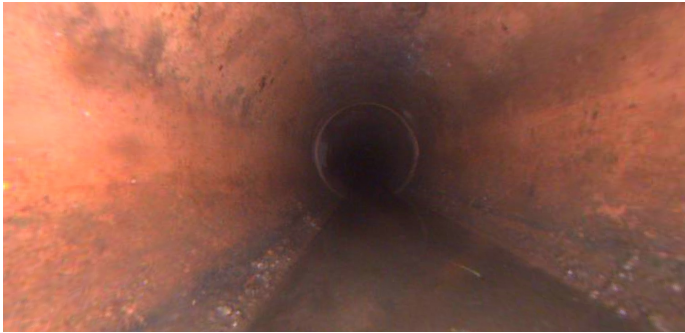
Code:	<b>MWL</b>
Description:	<b>Water Level</b>

Distance (ft):	<b>.0</b>
Structural Grade:	<b>0</b>
O&M Grade:	<b>0</b>
Clock Start/From:	
Clock To:	
1st Value:	
2nd Value:	
Value Percent:	<b>5.000</b>
Continuous Index:	
Within 8" of Joint:	<b>NO</b>
Remarks:

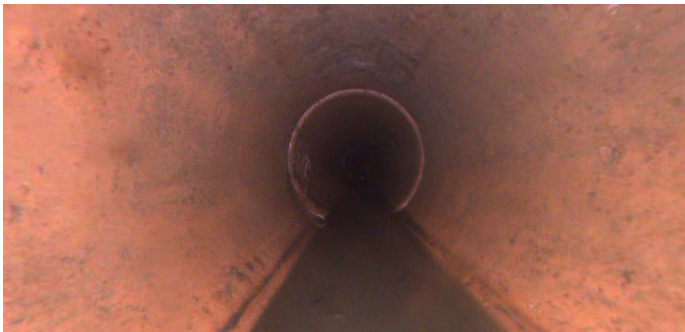
Code:	<b>MSA</b>
Description:	<b>Abandoned Survey</b>

Distance (ft):	<b>12.0</b>
Structural Grade:	<b>0</b>
O&M Grade:	<b>0</b>
Clock Start/From:	
Clock To:	
1st Value:	
2nd Value:	
Value Percent:	
Continuous Index:	
Within 8" of Joint:	<b>NO</b>
Remarks:	<b>unknown</b>
