## Profile/Photo Observation Report

Street:	<b>ALLEY BETWEEN W 38TH PL &amp; W 38</b>	Flow Control:	<b>Not Controlled</b>
City:	<b>Hobart, IN</b>	Year Renewed:	
Location:	<b>Other</b>	Tape/Media #:	
Purpose:	<b>Not Known</b>	Dia/Height:	<b>10"</b>
Use:	<b>Sanitary</b>	Material:	<b>VCP</b>
Drain Area:	<b>NA</b>	Lining:	
Category:	<b>NA</b>		
Comment:

Location Details:		Direction of Survey:	<b>Upstream</b>
US MH:	<b>M-503-058</b>	DS MH:	<b>M-503-059</b>
		Total Length Surveyed (ft):	<b>2.2</b>

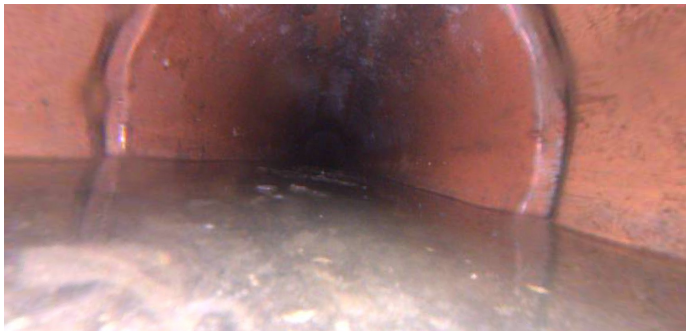
Code: **AMH**  
Description: **Manhole**

Distance (ft): **.0**  
Structural Grade: **0**  
O&M Grade: **0**  
Clock Start/From:  
Clock To:  
1st Value:  
2nd Value:  
Value Percent:  
Continuous Index:  
Within 8" of Joint: **NO**  
Remarks: **M-503-058**

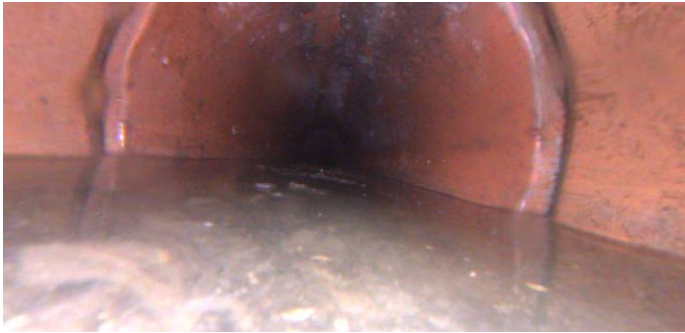
Code:	<b>MWL</b>
Description:	<b>Water Level</b>

Distance (ft):	<b>.0</b>
Structural Grade:	<b>0</b>
O&M Grade:	<b>0</b>
Clock Start/From:	
Clock To:	
1st Value:	
2nd Value:	
Value Percent:	<b>30.000</b>
Continuous Index:	
Within 8" of Joint:	<b>NO</b>
Remarks:

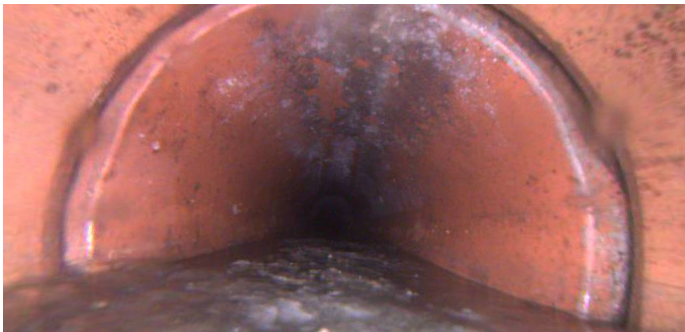
Code:	<b>MSA</b>
Description:	<b>Abandoned Survey</b>

Distance (ft):	<b>2.2</b>
Structural Grade:	<b>0</b>
O&M Grade:	<b>0</b>
Clock Start/From:	
Clock To:	
1st Value:	
2nd Value:	
Value Percent:	
Continuous Index:	
Within 8" of Joint:	<b>NO</b>
Remarks:	<b>debris under water</b>
