Profile/Photo Observation Report

Date:	09/17/2021	Weather:		Coding:	PACP 7.0
Pipe Length (ft):	238.3	Owner:	City of Hobart	Pre Clean:	Light Cleaning
P.O.#:	YES502259	Surveyor:	S. Bucklin	PSR:	P-503-059-058
Customer:	City of Hobart	Clean Date:	08/24/2021	Shape:	C

Street:	North Virginia Street	Flow Control:	Not Controlled
City:	Hobart, IN	Year Renewed:	
Location:	Alley	Tape/Media #:	
Purpose:	Routine Assessment	Dia/Height:	10"
Use:	Sanitary Sewage Pipe	Material:	VCP
Drain Area:		Lining:	None
Category:	NA		
Comment:			
Location Details:		Direction of Survey:	Downstream
US MH:	M-503-058	DS MH:	M-503-059
		Total Length Surveyed (ft):	238.3

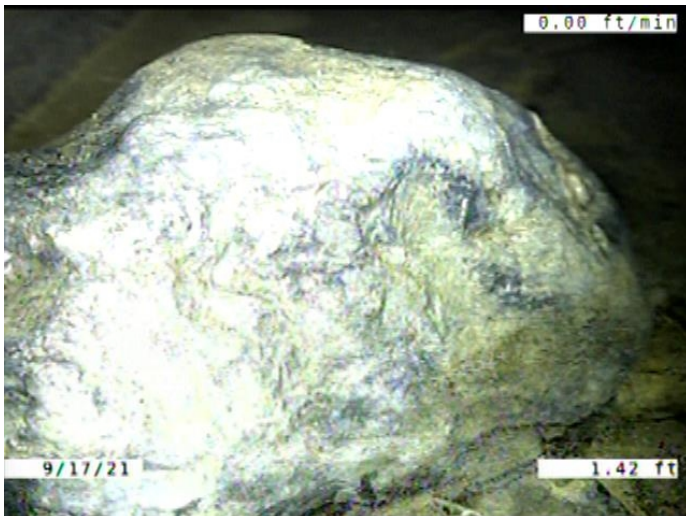
Code: **OBR**
 Description: **Obstruction Rocks**

Distance (ft): **1.4**
 Structural Grade: **0**
 O&M Grade: **2**
 Clock Start/From: **6**
 Clock To: **7**
 1st Value:
 2nd Value:
 Value Percent: **5.000**
 Continuous Index:
 Within 8" of Joint: **NO**
 Remarks:

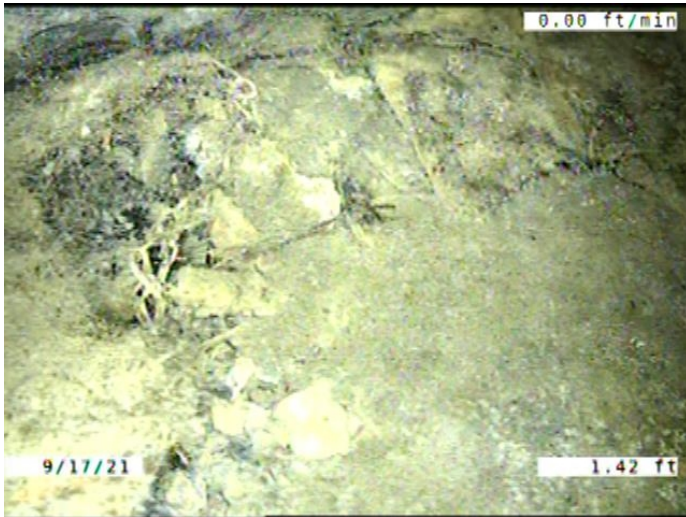
Code: **DSF**
 Description: **Deposits Settled Fine**

Distance (ft): **1.4**
 Structural Grade: **0**
 O&M Grade: **2**
 Clock Start/From: **5**
 Clock To: **7**
 1st Value:
 2nd Value:
 Value Percent: **5.000**
 Continuous Index: **S01**
 Within 8" of Joint: **YES**
 Remarks:

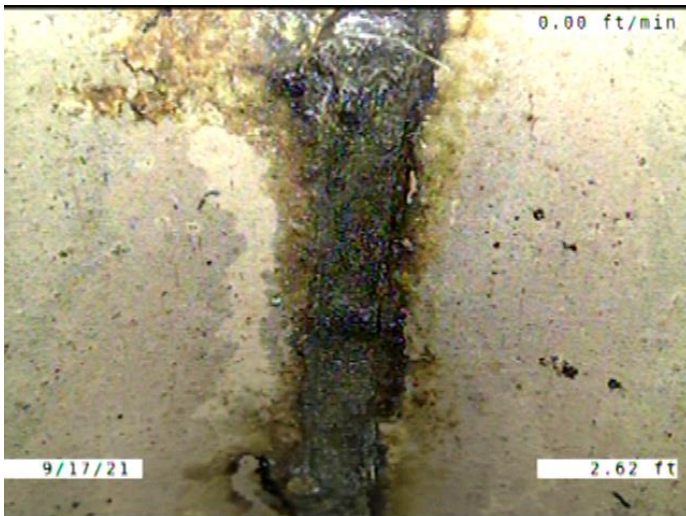
Code: **ISB**
 Description: **Infiltration Stain Barrel**

Distance (ft): **2.6**
 Structural Grade: **0**
 O&M Grade: **1**
 Clock Start/From: **11**
 Clock To: **12**
 1st Value:
 2nd Value:
 Value Percent:
 Continuous Index:
 Within 8" of Joint: **NO**
 Remarks:

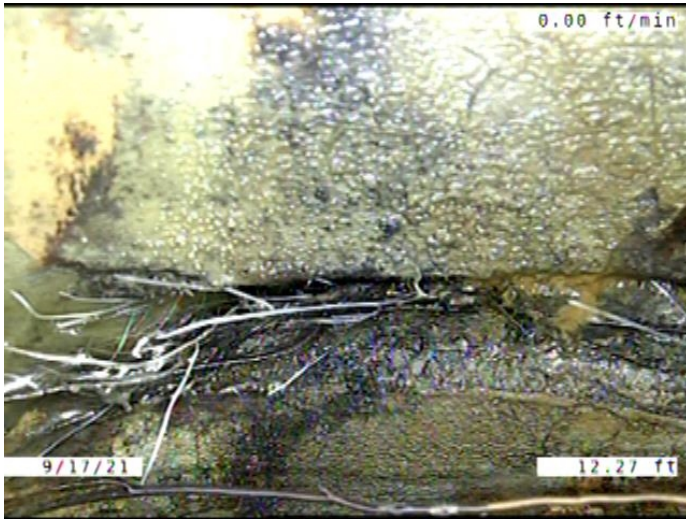
Code: **RFJ**
 Description: **Roots Fine Joint**

Distance (ft): **12.3**
 Structural Grade: **0**
 O&M Grade: **1**
 Clock Start/From: **7**
 Clock To: **10**
 1st Value:
 2nd Value:
 Value Percent:
 Continuous Index:
 Within 8" of Joint: **YES**
 Remarks:

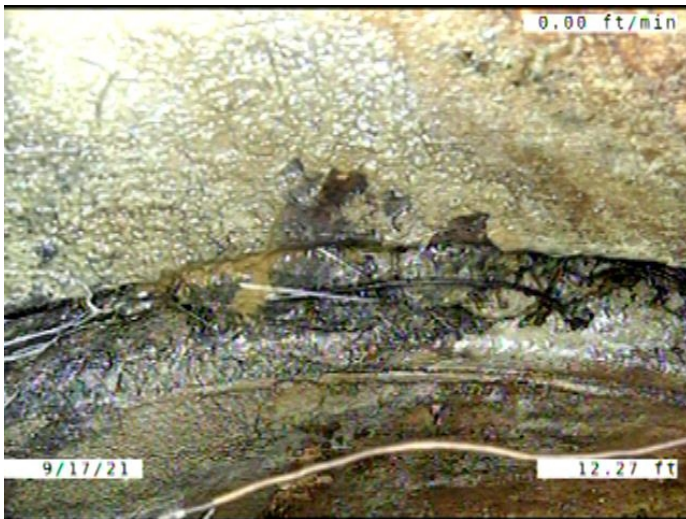
Code: **ISJ**
 Description: **Infiltration Stain Joint**

Distance (ft): **12.3**
 Structural Grade: **0**
 O&M Grade: **1**
 Clock Start/From: **7**
 Clock To: **10**
 1st Value:
 2nd Value:
 Value Percent:
 Continuous Index:
 Within 8" of Joint: **YES**
 Remarks:

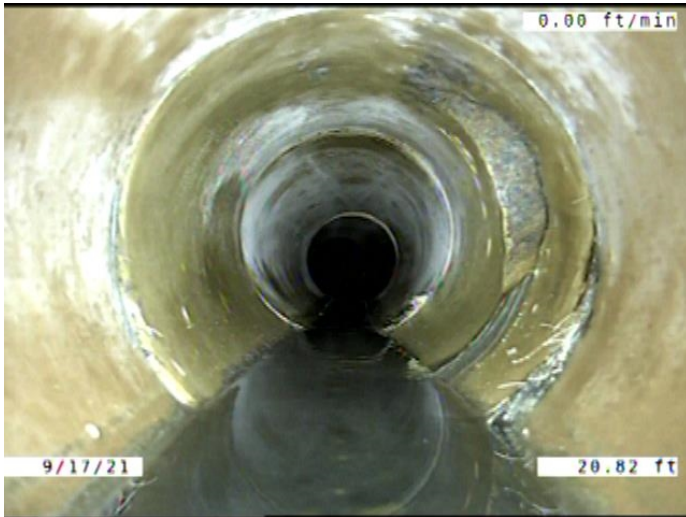
Code: **MWLS**
 Description: **Miscellaneous Water Level Sag**

Distance (ft): **20.8**
 Structural Grade: **2**
 O&M Grade: **0**
 Clock Start/From:
 Clock To:
 1st Value:
 2nd Value:
 Value Percent: **5.000**
 Continuous Index:
 Within 8" of Joint: **NO**
 Remarks:

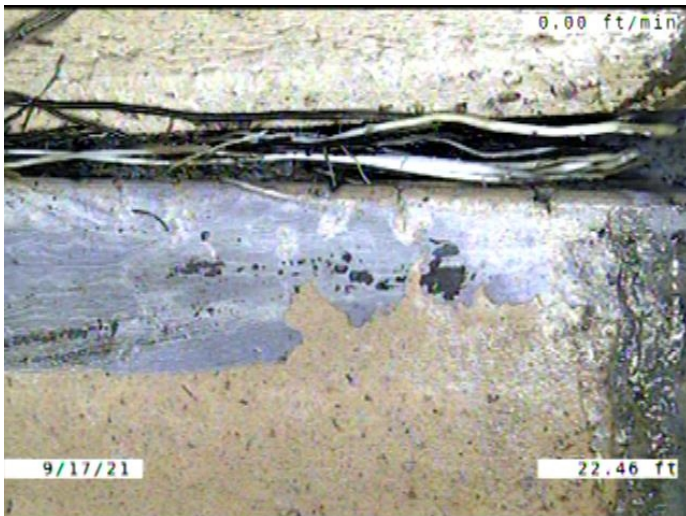
Code: **RFJ**
 Description: **Roots Fine Joint**

Distance (ft): **22.5**
 Structural Grade: **0**
 O&M Grade: **1**
 Clock Start/From: **8**
 Clock To: **4**
 1st Value:
 2nd Value:
 Value Percent:
 Continuous Index:
 Within 8" of Joint: **YES**
 Remarks:

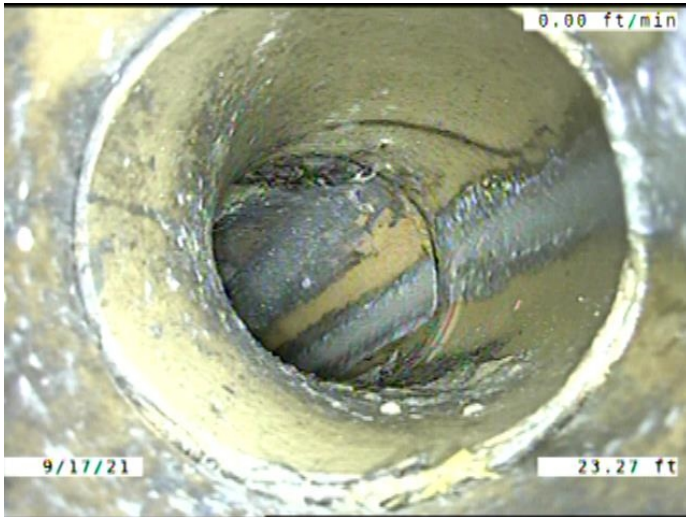
Code:	TF
Description:	Tap Factory
Distance (ft):	23.3
Structural Grade:	0
O&M Grade:	0
Clock Start/From:	2
Clock To:	
1st Value:	4.000
2nd Value:	
Value Percent:	
Continuous Index:	
Within 8" of Joint:	YES
Remarks:	CONSTANTLY RUNNING WATER

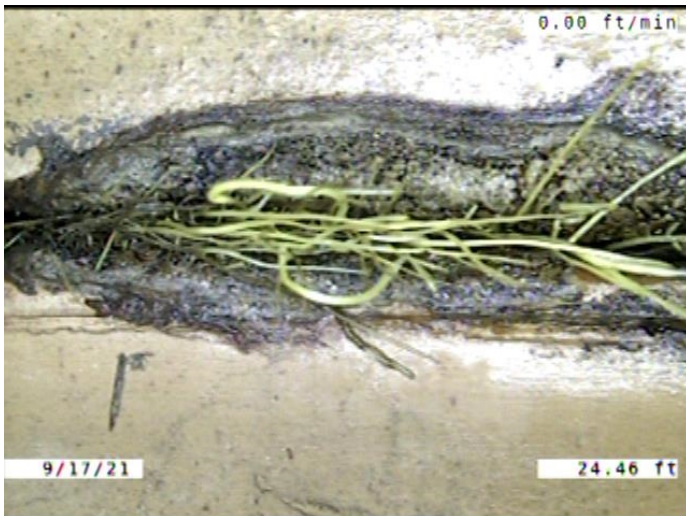
Code:	RFJ
Description:	Roots Fine Joint
Distance (ft):	24.5
Structural Grade:	0
O&M Grade:	1
Clock Start/From:	2
Clock To:	5
1st Value:	
2nd Value:	
Value Percent:	
Continuous Index:	
Within 8" of Joint:	YES
Remarks:

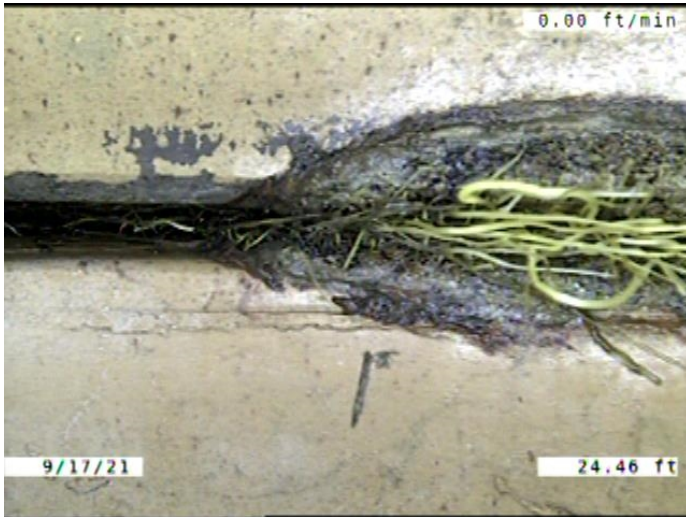
Code: **ISJ**
 Description: **Infiltration Stain Joint**

Distance (ft): **24.5**
 Structural Grade: **0**
 O&M Grade: **1**
 Clock Start/From: **4**
 Clock To: **5**
 1st Value:
 2nd Value:
 Value Percent:
 Continuous Index:
 Within 8" of Joint: **YES**
 Remarks:

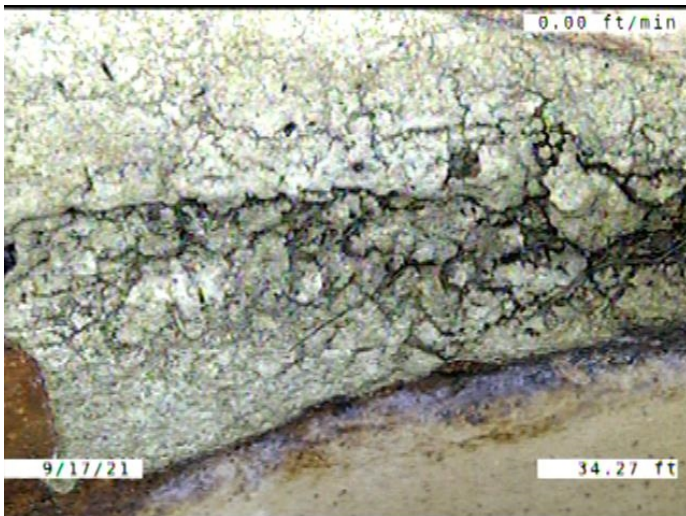
Code: **DAE**
 Description: **Deposits Attached Encrustation**

Distance (ft): **34.3**
 Structural Grade: **0**
 O&M Grade: **2**
 Clock Start/From: **7**
 Clock To: **5**
 1st Value:
 2nd Value:
 Value Percent: **5.000**
 Continuous Index:
 Within 8" of Joint: **YES**
 Remarks:

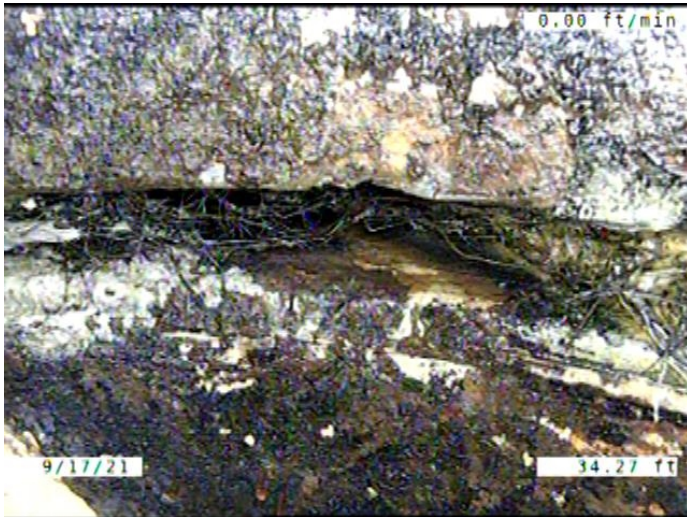
Code: **RFJ**
 Description: **Roots Fine Joint**

Distance (ft): **34.3**
 Structural Grade: **0**
 O&M Grade: **1**
 Clock Start/From: **7**
 Clock To: **5**
 1st Value:
 2nd Value:
 Value Percent:
 Continuous Index:
 Within 8" of Joint: **YES**
 Remarks:

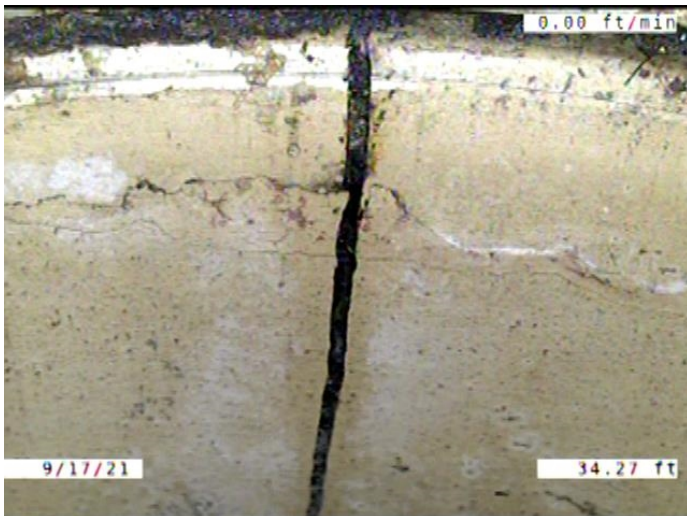
Code: **FM**
 Description: **Fracture Multiple**

Distance (ft): **34.3**
 Structural Grade: **4**
 O&M Grade: **0**
 Clock Start/From: **12**
 Clock To: **12**
 1st Value:
 2nd Value:
 Value Percent:
 Continuous Index:
 Within 8" of Joint: **YES**
 Remarks:

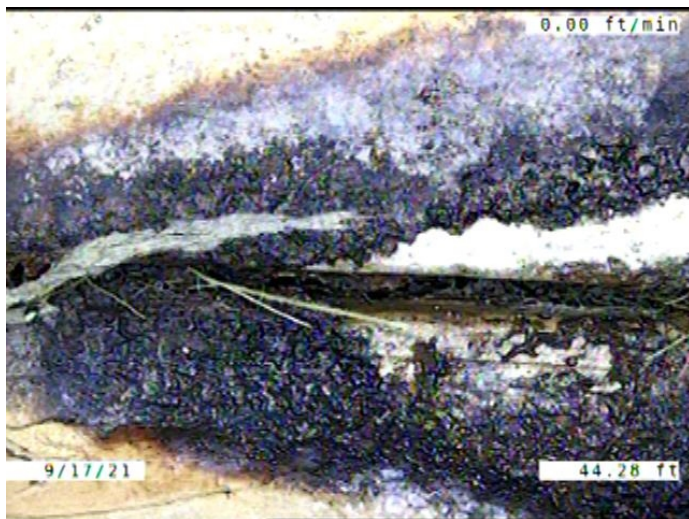
Code: **DAE**
 Description: **Deposits Attached Encrustation**

Distance (ft): **44.3**
 Structural Grade: **0**
 O&M Grade: **2**
 Clock Start/From: **1**
 Clock To: **5**
 1st Value:
 2nd Value:
 Value Percent: **5.000**
 Continuous Index:
 Within 8" of Joint: **YES**
 Remarks:

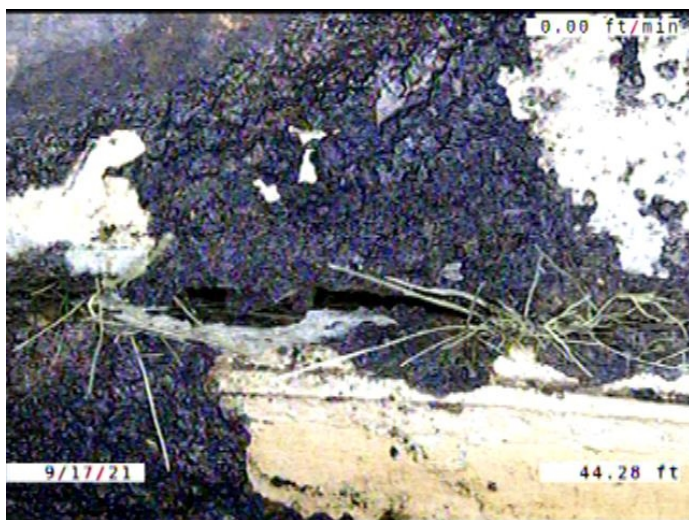
Code: **RFJ**
 Description: **Roots Fine Joint**

Distance (ft): **44.3**
 Structural Grade: **0**
 O&M Grade: **1**
 Clock Start/From: **9**
 Clock To: **4**
 1st Value:
 2nd Value:
 Value Percent:
 Continuous Index:
 Within 8" of Joint: **YES**
 Remarks:

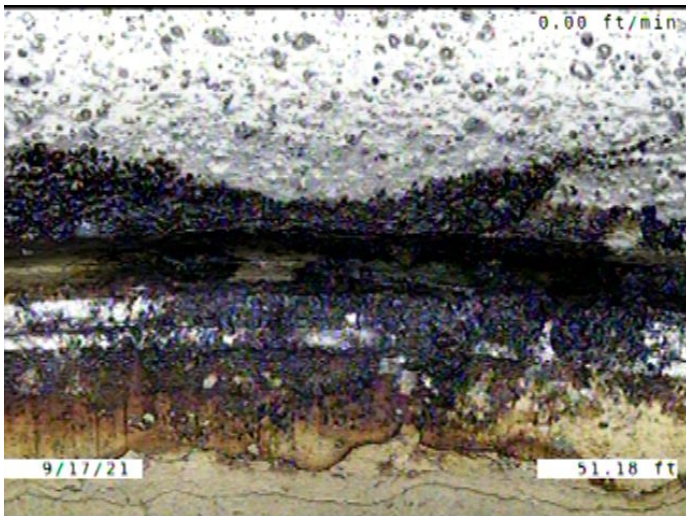
Code: **ISJ**
 Description: **Infiltration Stain Joint**

Distance (ft): **51.2**
 Structural Grade: **0**
 O&M Grade: **1**
 Clock Start/From: **7**
 Clock To: **5**
 1st Value:
 2nd Value:
 Value Percent:
 Continuous Index:
 Within 8" of Joint: **YES**
 Remarks:

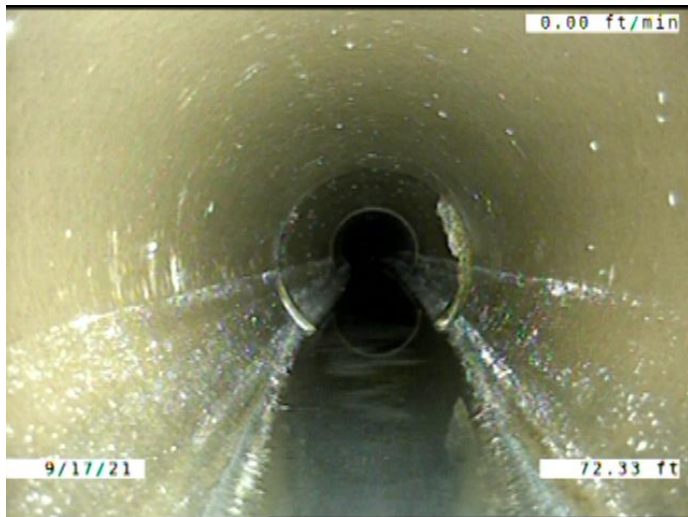
Code: **MWLS**
 Description: **Miscellaneous Water Level Sag**

Distance (ft): **72.3**
 Structural Grade: **2**
 O&M Grade: **0**
 Clock Start/From:
 Clock To:
 1st Value:
 2nd Value:
 Value Percent: **5.000**
 Continuous Index: **S03**
 Within 8" of Joint: **NO**
 Remarks:

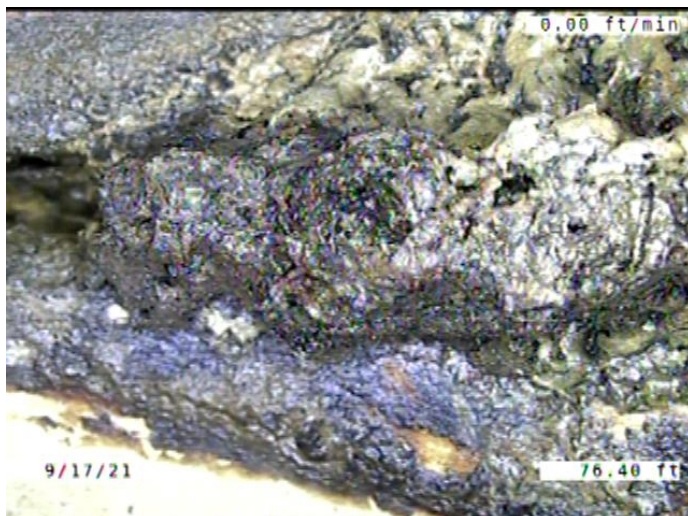
Code: **DAE**
 Description: **Deposits Attached Encrustation**

Distance (ft): **76.4**
 Structural Grade: **0**
 O&M Grade: **2**
 Clock Start/From: **8**
 Clock To: **4**
 1st Value:
 2nd Value:
 Value Percent: **5.000**
 Continuous Index:
 Within 8" of Joint: **YES**
 Remarks:

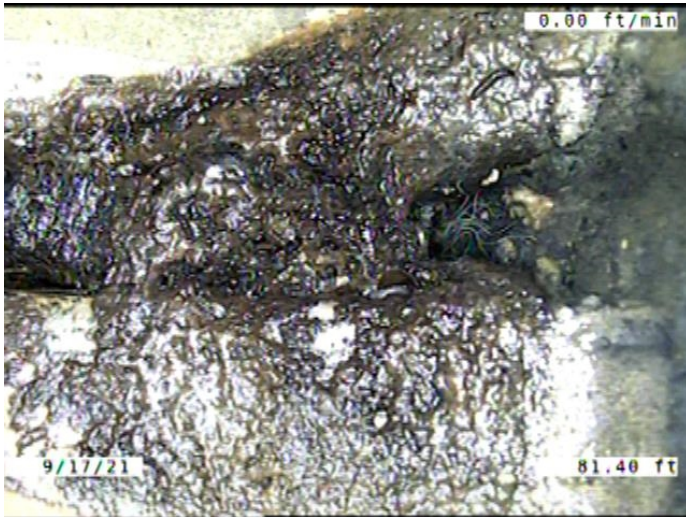
Code: **DAE**
 Description: **Deposits Attached Encrustation**

Distance (ft): **81.4**
 Structural Grade: **0**
 O&M Grade: **2**
 Clock Start/From: **8**
 Clock To: **9**
 1st Value:
 2nd Value:
 Value Percent: **5.000**
 Continuous Index:
 Within 8" of Joint: **YES**
 Remarks:

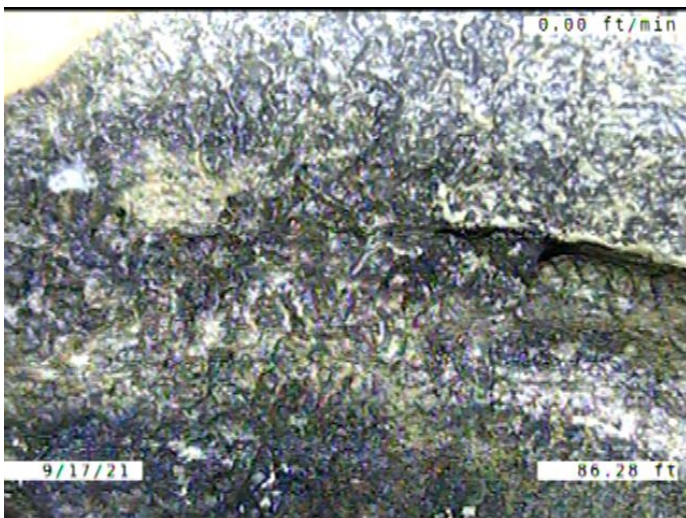
Code: **DAE**
 Description: **Deposits Attached Encrustation**

Distance (ft): **86.3**
 Structural Grade: **0**
 O&M Grade: **2**
 Clock Start/From: **9**
 Clock To: **5**
 1st Value:
 2nd Value:
 Value Percent: **5.000**
 Continuous Index:
 Within 8" of Joint: **YES**
 Remarks:

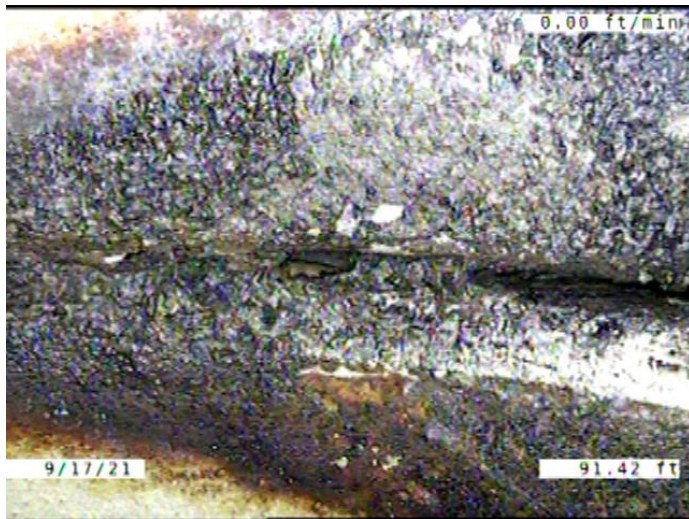
Code: **DAE**
Description: **Deposits Attached Encrustation**

Distance (ft): **91.4**
Structural Grade: **0**
O&M Grade: **2**
Clock Start/From: **8**
Clock To: **4**
1st Value:
2nd Value:
Value Percent: **5.000**
Continuous Index:
Within 8" of Joint: **YES**
Remarks:

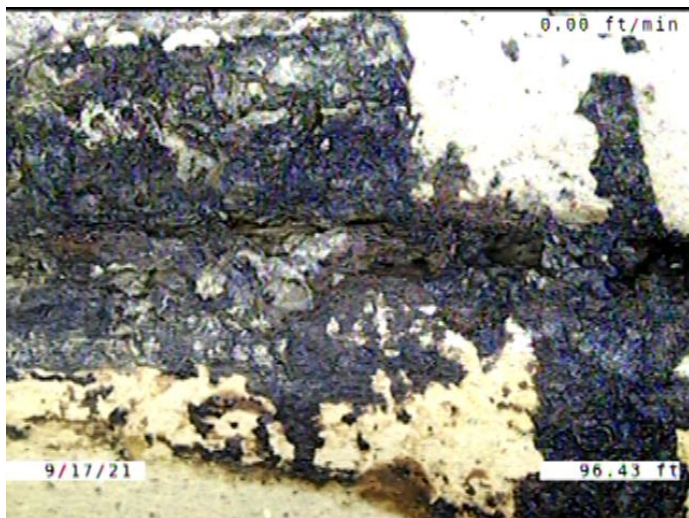
Code: **DAE**
Description: **Deposits Attached Encrustation**

Distance (ft): **96.4**
Structural Grade: **0**
O&M Grade: **2**
Clock Start/From: **7**
Clock To: **5**
1st Value:
2nd Value:
Value Percent: **5.000**
Continuous Index:
Within 8" of Joint: **YES**
Remarks:

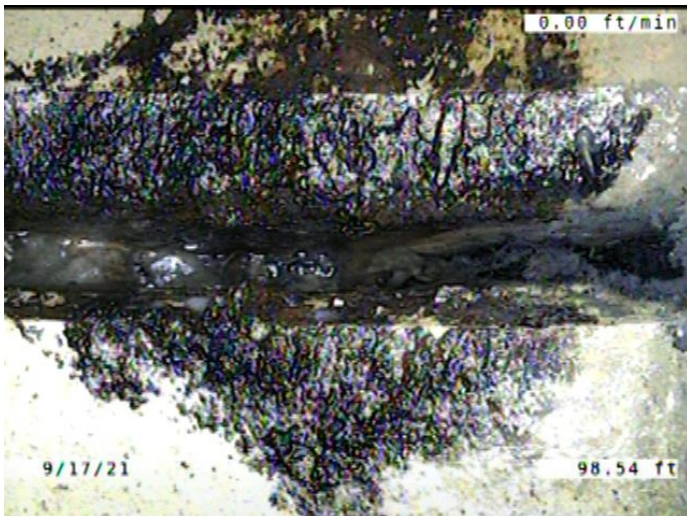
Code: **ISJ**
 Description: **Infiltration Stain Joint**

Distance (ft): **98.5**
 Structural Grade: **0**
 O&M Grade: **1**
 Clock Start/From: **7**
 Clock To: **8**
 1st Value:
 2nd Value:
 Value Percent:
 Continuous Index:
 Within 8" of Joint: **YES**
 Remarks:

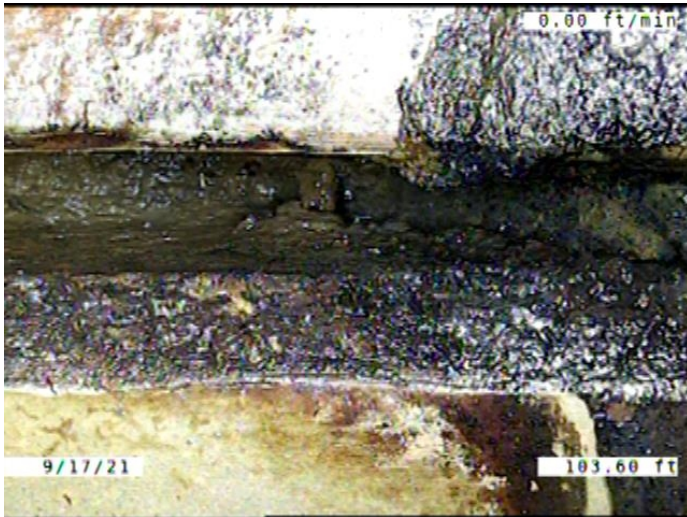
Code: **DAE**
 Description: **Deposits Attached Encrustation**

Distance (ft): **103.6**
 Structural Grade: **0**
 O&M Grade: **2**
 Clock Start/From: **2**
 Clock To: **5**
 1st Value:
 2nd Value:
 Value Percent: **5.000**
 Continuous Index:
 Within 8" of Joint: **YES**
 Remarks:

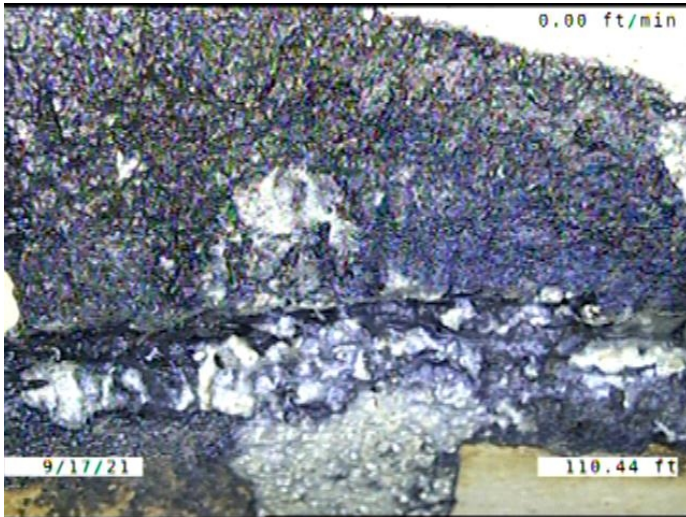
Code:	DAE
Description:	Deposits Attached Encrustation
Distance (ft):	110.4
Structural Grade:	0
O&M Grade:	2
Clock Start/From:	7
Clock To:	11
1st Value:	
2nd Value:	
Value Percent:	5.000
Continuous Index:	
Within 8" of Joint:	YES
Remarks:

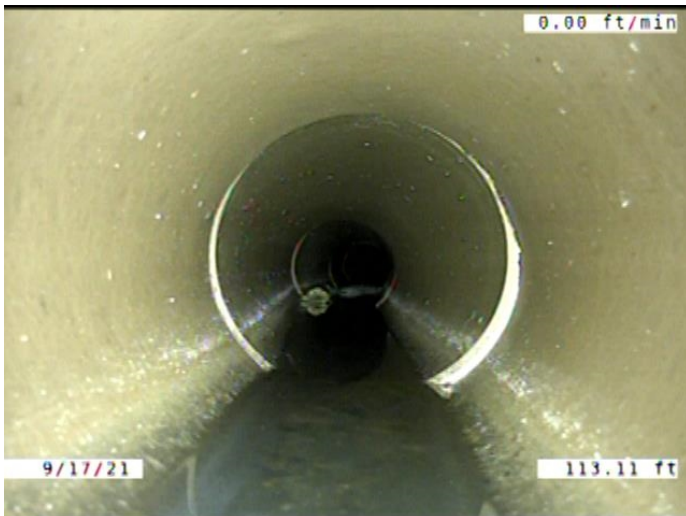
Code:	MWLS
Description:	Miscellaneous Water Level Sag
Distance (ft):	113.1
Structural Grade:	2
O&M Grade:	0
Clock Start/From:	
Clock To:	
1st Value:	
2nd Value:	
Value Percent:	5.000
Continuous Index:	F03
Within 8" of Joint:	NO
Remarks:

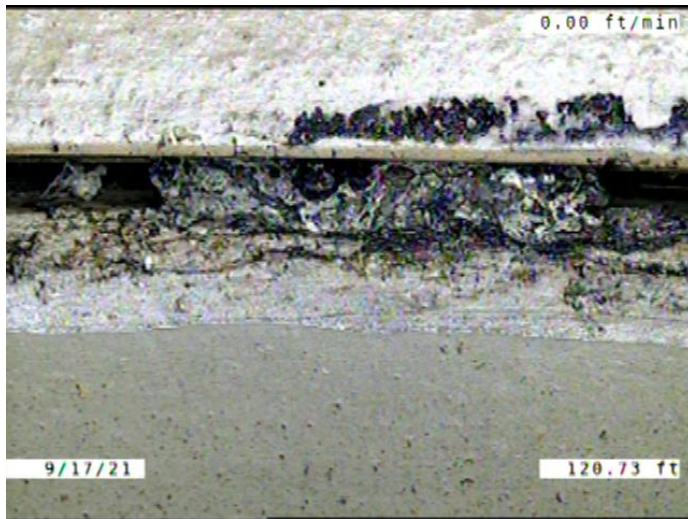
Code: **ISJ**
 Description: **Infiltration Stain Joint**

Distance (ft): **120.7**
 Structural Grade: **0**
 O&M Grade: **1**
 Clock Start/From: **10**
 Clock To: **2**
 1st Value:
 2nd Value:
 Value Percent:
 Continuous Index:
 Within 8" of Joint: **YES**
 Remarks:

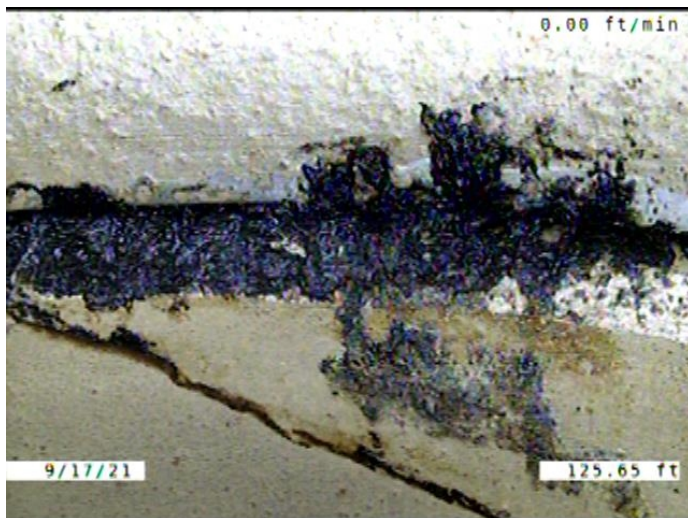
Code: **ISJ**
 Description: **Infiltration Stain Joint**

Distance (ft): **125.7**
 Structural Grade: **0**
 O&M Grade: **1**
 Clock Start/From: **10**
 Clock To: **4**
 1st Value:
 2nd Value:
 Value Percent:
 Continuous Index:
 Within 8" of Joint: **YES**
 Remarks:

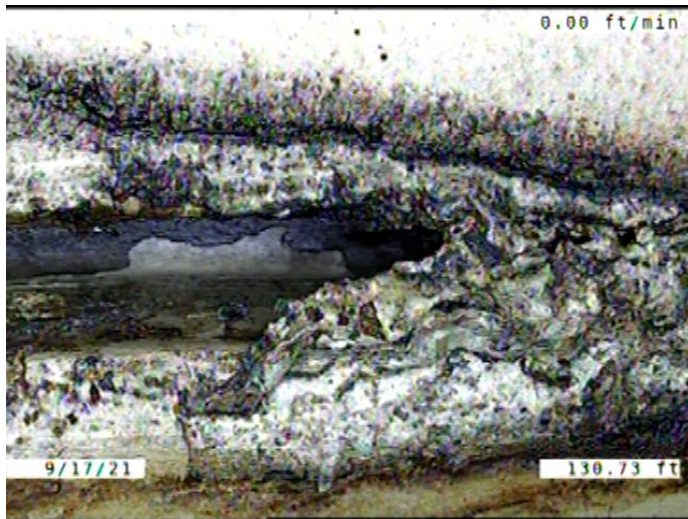
Code: **DAE**
 Description: **Deposits Attached Encrustation**

Distance (ft): **130.7**
 Structural Grade: **0**
 O&M Grade: **2**
 Clock Start/From: **7**
 Clock To: **1**
 1st Value:
 2nd Value:
 Value Percent: **5.000**
 Continuous Index:
 Within 8" of Joint: **YES**
 Remarks:

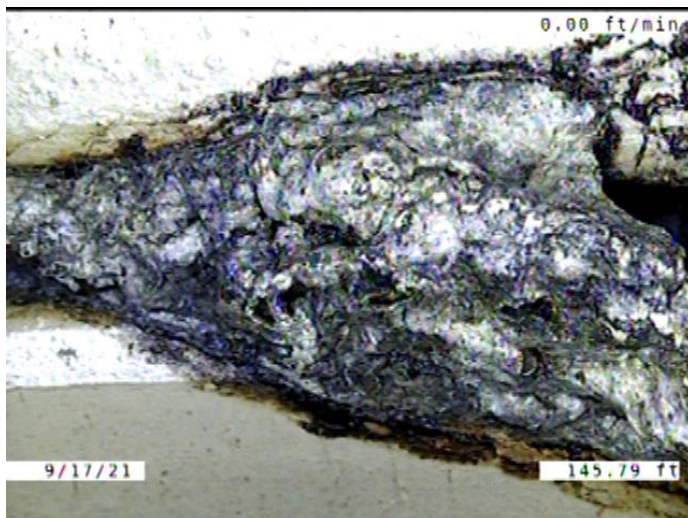
Code: **DAE**
 Description: **Deposits Attached Encrustation**

Distance (ft): **145.8**
 Structural Grade: **0**
 O&M Grade: **2**
 Clock Start/From: **9**
 Clock To: **4**
 1st Value:
 2nd Value:
 Value Percent: **5.000**
 Continuous Index:
 Within 8" of Joint: **YES**
 Remarks:

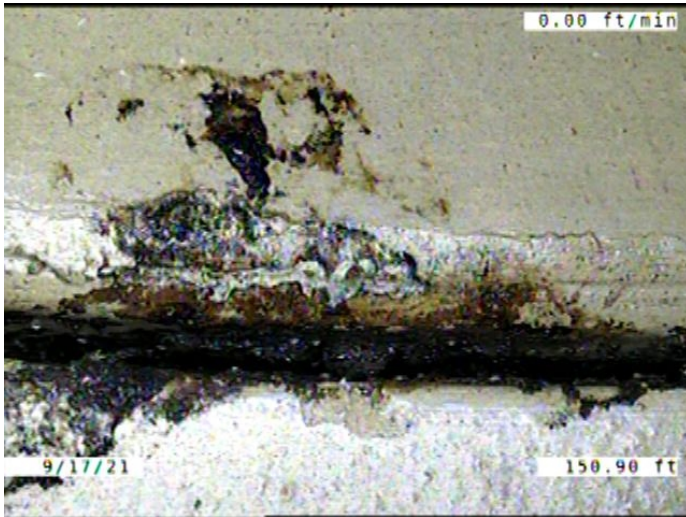
Code: **ISJ**
 Description: **Infiltration Stain Joint**

Distance (ft): **150.9**
 Structural Grade: **0**
 O&M Grade: **1**
 Clock Start/From: **2**
 Clock To: **4**
 1st Value:
 2nd Value:
 Value Percent:
 Continuous Index:
 Within 8" of Joint: **YES**
 Remarks:

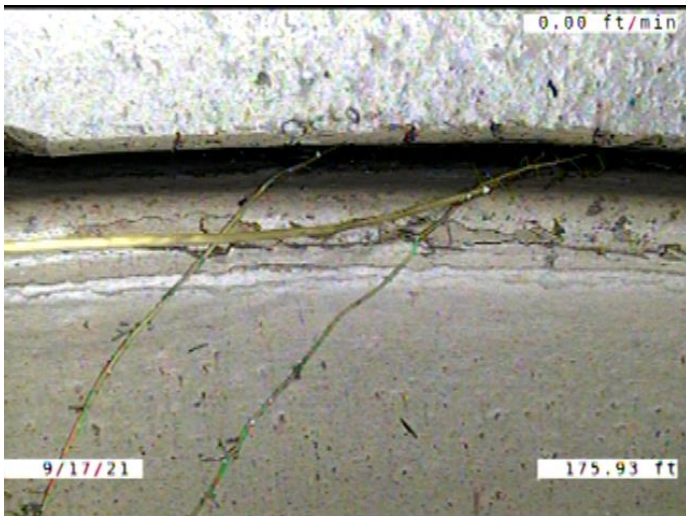
Code: **RFJ**
 Description: **Roots Fine Joint**

Distance (ft): **175.9**
 Structural Grade: **0**
 O&M Grade: **1**
 Clock Start/From: **9**
 Clock To: **10**
 1st Value:
 2nd Value:
 Value Percent:
 Continuous Index:
 Within 8" of Joint: **YES**
 Remarks:

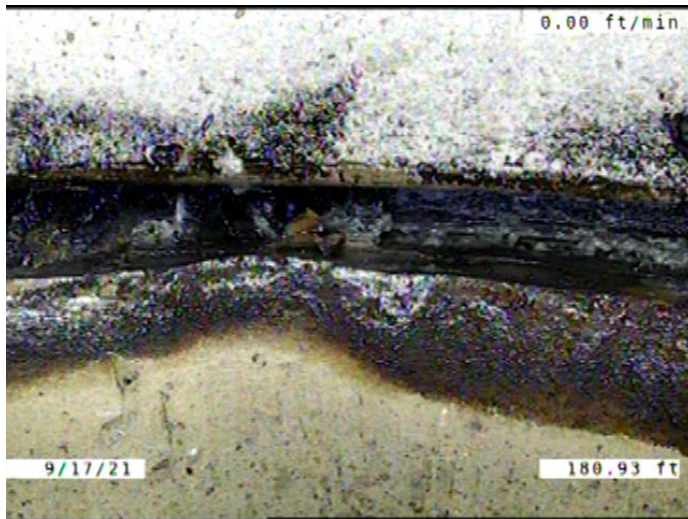
Code: **ISJ**
Description: **Infiltration Stain Joint**

Distance (ft): **180.9**
Structural Grade: **0**
O&M Grade: **1**
Clock Start/From: **9**
Clock To: **3**
1st Value:
2nd Value:
Value Percent:
Continuous Index:
Within 8" of Joint: **YES**
Remarks:

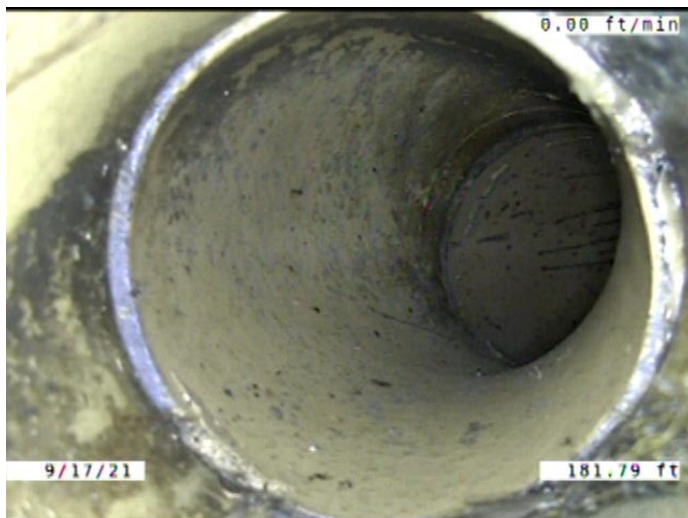
Code: **TF**
Description: **Tap Factory**

Distance (ft): **181.8**
Structural Grade: **0**
O&M Grade: **0**
Clock Start/From: **1**
Clock To:
1st Value: **4.000**
2nd Value:
Value Percent:
Continuous Index:
Within 8" of Joint: **YES**
Remarks: **ROOTS GROWING FROM THE JOINTS**

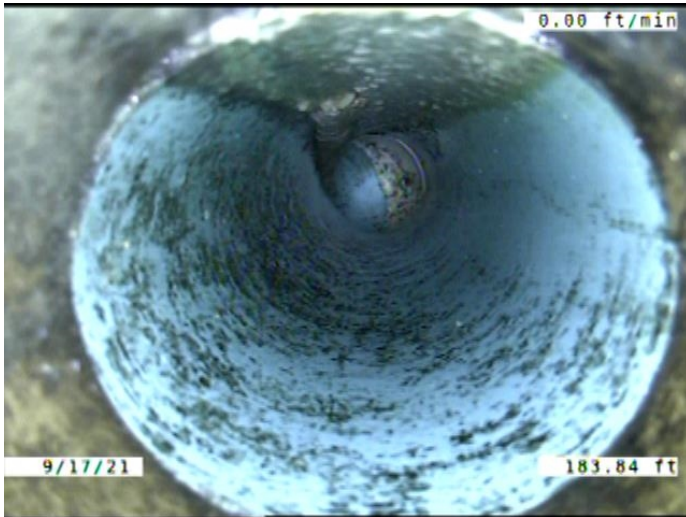
Code: **TF**
 Description: **Tap Factory**

Distance (ft): **183.8**
 Structural Grade: **0**
 O&M Grade: **0**
 Clock Start/From: **12**
 Clock To:
 1st Value: **4.000**
 2nd Value:
 Value Percent:
 Continuous Index:
 Within 8" of Joint: **YES**
 Remarks: **CONSTANTLY RUNNING WATER**

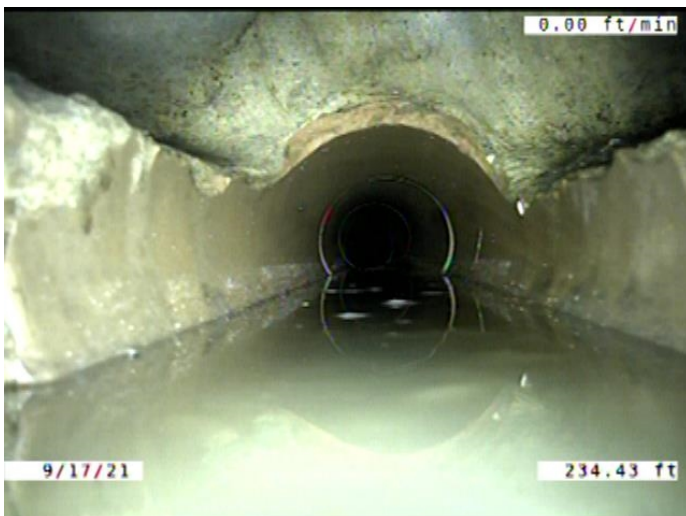
Code: **DSF**
 Description: **Deposits Settled Fine**

Distance (ft): **234.4**
 Structural Grade: **0**
 O&M Grade: **2**
 Clock Start/From: **5**
 Clock To: **7**
 1st Value:
 2nd Value:
 Value Percent: **5.000**
 Continuous Index: **F01**
 Within 8" of Joint: **YES**
 Remarks:
