Profile/Photo Observation Report

Date:	09/17/2021	Weather:		Coding:	PACP 7.0
Pipe Length (ft):	238.3	Owner:	City of Hobart	Pre Clean:	Light Cleaning
P.O.#:	YES502259	Surveyor:	S. Bucklin	PSR:	P-503-059-058
Customer:	City of Hobart	Clean Date:	08/24/2021	Shape:	C

Street:	North Virginia Street	Flow Control:	Not Controlled
City:	Hobart, IN	Year Renewed:	
Location:	Alley	Tape/Media #:	
Purpose:	Routine Assessment	Dia/Height:	10"
Use:	Sanitary Sewage Pipe	Material:	VCP
Drain Area:		Lining:	None
Category:	NA		
Comment:			
Location Details:		Direction of Survey:	Downstream
US MH:	M-503-058	DS MH:	M-503-059
		Total Length Surveyed (ft):	238.3

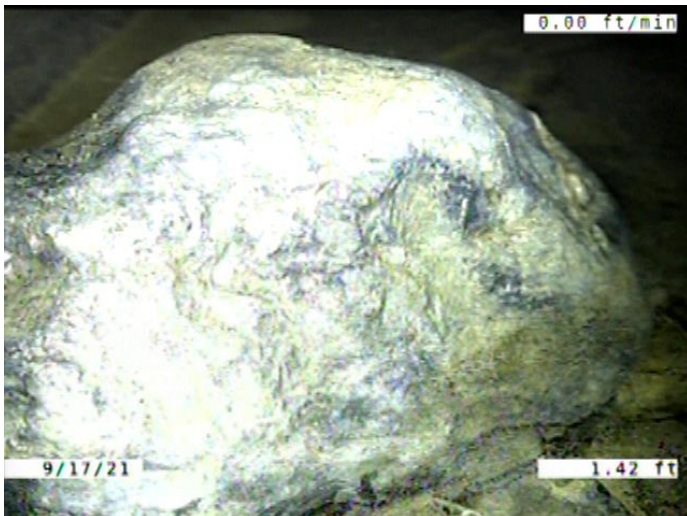
Code: **OBR**
 Description: **Obstruction Rocks**

Distance (ft): **1.4**
 Structural Grade: **0**
 O&M Grade: **2**
 Clock Start/From: **6**
 Clock To: **7**
 1st Value:
 2nd Value:
 Value Percent: **5.000**
 Continuous Index:
 Within 8" of Joint: **NO**
 Remarks:

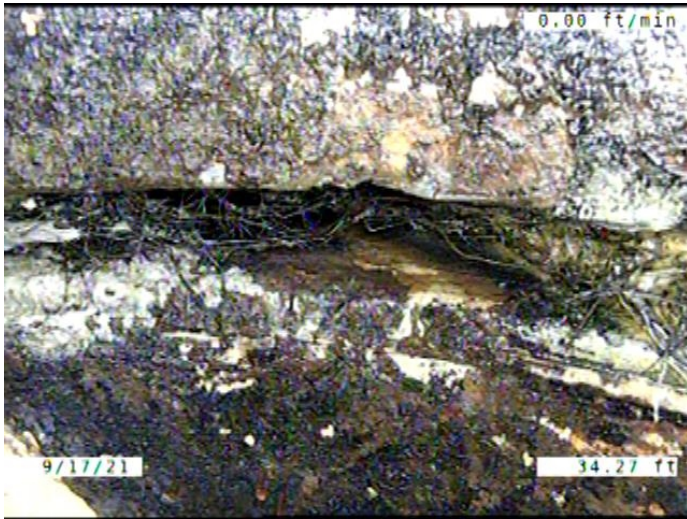
Code: **RFJ**
 Description: **Roots Fine Joint**

Distance (ft): **34.3**
 Structural Grade: **0**
 O&M Grade: **1**
 Clock Start/From: **7**
 Clock To: **5**
 1st Value:
 2nd Value:
 Value Percent:
 Continuous Index:
 Within 8" of Joint: **YES**
 Remarks:

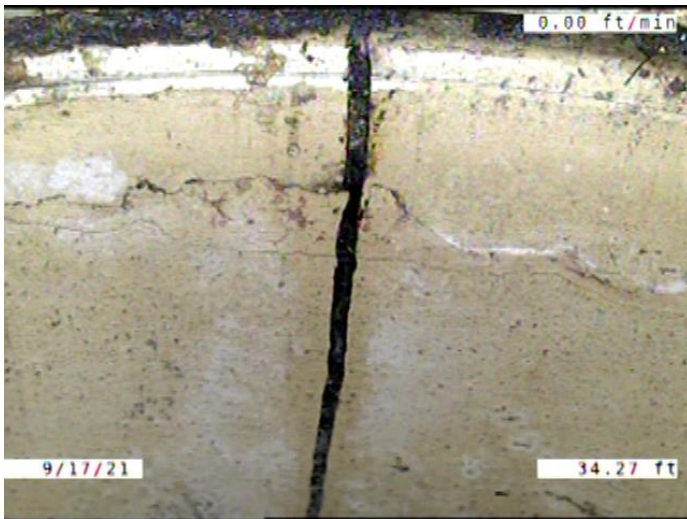
Code: **FM**
 Description: **Fracture Multiple**

Distance (ft): **34.3**
 Structural Grade: **4**
 O&M Grade: **0**
 Clock Start/From: **12**
 Clock To: **12**
 1st Value:
 2nd Value:
 Value Percent:
 Continuous Index:
 Within 8" of Joint: **YES**
 Remarks:

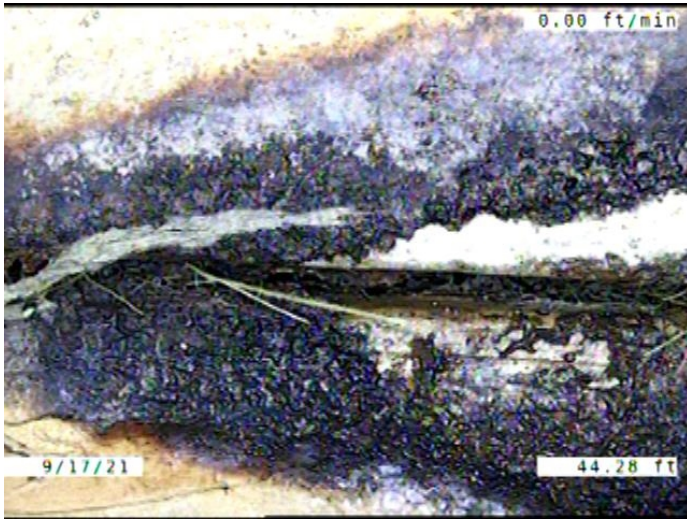
Code: **DAE**
Description: **Deposits Attached Encrustation**

Distance (ft): **44.3**
Structural Grade: **0**
O&M Grade: **2**
Clock Start/From: **1**
Clock To: **5**
1st Value:
2nd Value:
Value Percent: **5.000**
Continuous Index:
Within 8" of Joint: **YES**
Remarks:

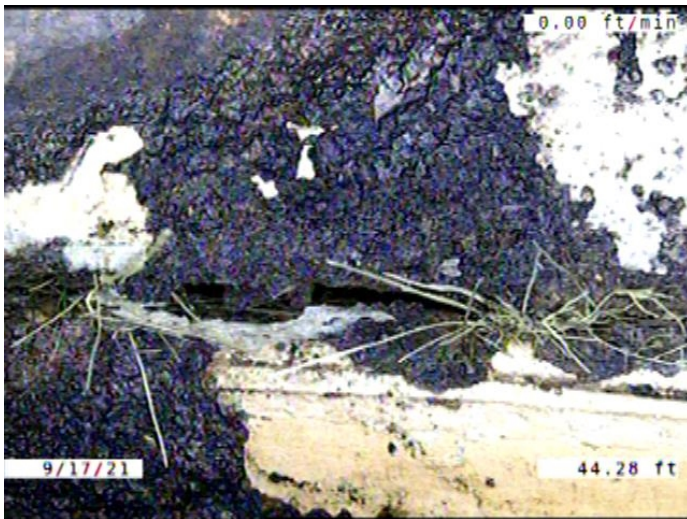
Code: **RFJ**
Description: **Roots Fine Joint**

Distance (ft): **44.3**
Structural Grade: **0**
O&M Grade: **1**
Clock Start/From: **9**
Clock To: **4**
1st Value:
2nd Value:
Value Percent:
Continuous Index:
Within 8" of Joint: **YES**
Remarks:

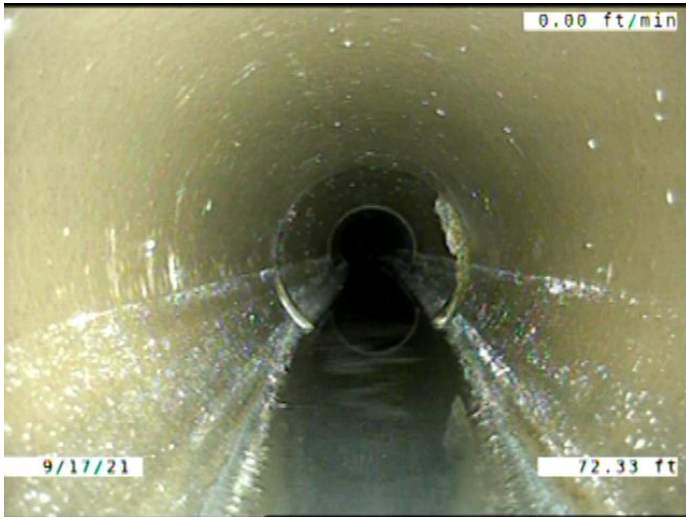
Code: **MWLS**
 Description: **Miscellaneous Water Level Sag**

Distance (ft): **72.3**
 Structural Grade: **2**
 O&M Grade: **0**
 Clock Start/From:
 Clock To:
 1st Value:
 2nd Value:
 Value Percent: **5.000**
 Continuous Index: **S03**
 Within 8" of Joint: **NO**
 Remarks:

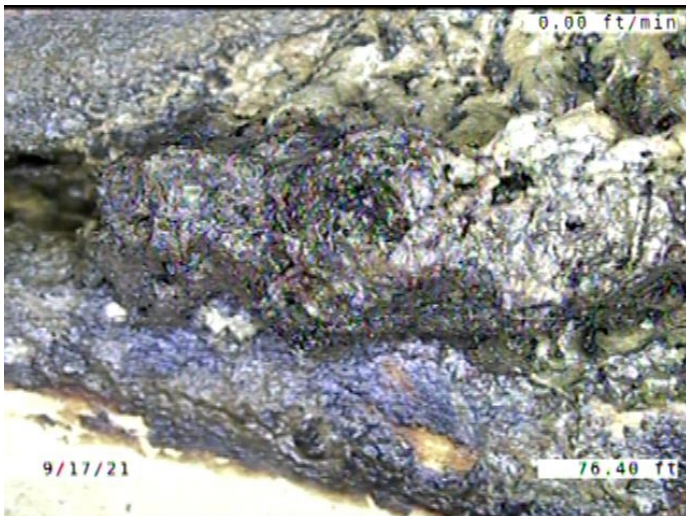
Code: **DAE**
 Description: **Deposits Attached Encrustation**

Distance (ft): **76.4**
 Structural Grade: **0**
 O&M Grade: **2**
 Clock Start/From: **8**
 Clock To: **4**
 1st Value:
 2nd Value:
 Value Percent: **5.000**
 Continuous Index:
 Within 8" of Joint: **YES**
 Remarks:

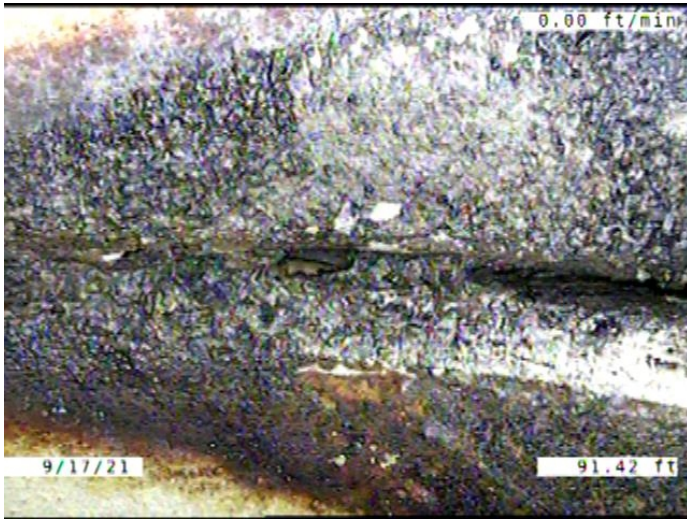
Code: **DAE**
 Description: **Deposits Attached Encrustation**

Distance (ft): **91.4**
 Structural Grade: **0**
 O&M Grade: **2**
 Clock Start/From: **8**
 Clock To: **4**
 1st Value:
 2nd Value:
 Value Percent: **5.000**
 Continuous Index:
 Within 8" of Joint: **YES**
 Remarks:

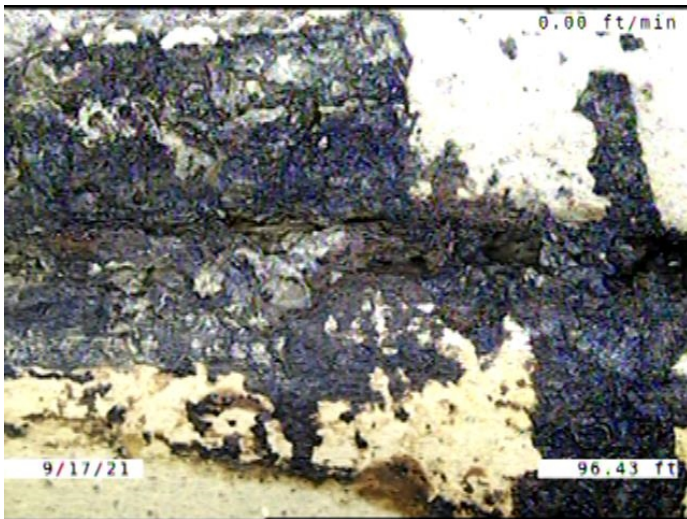
Code: **DAE**
 Description: **Deposits Attached Encrustation**

Distance (ft): **96.4**
 Structural Grade: **0**
 O&M Grade: **2**
 Clock Start/From: **7**
 Clock To: **5**
 1st Value:
 2nd Value:
 Value Percent: **5.000**
 Continuous Index:
 Within 8" of Joint: **YES**
 Remarks:

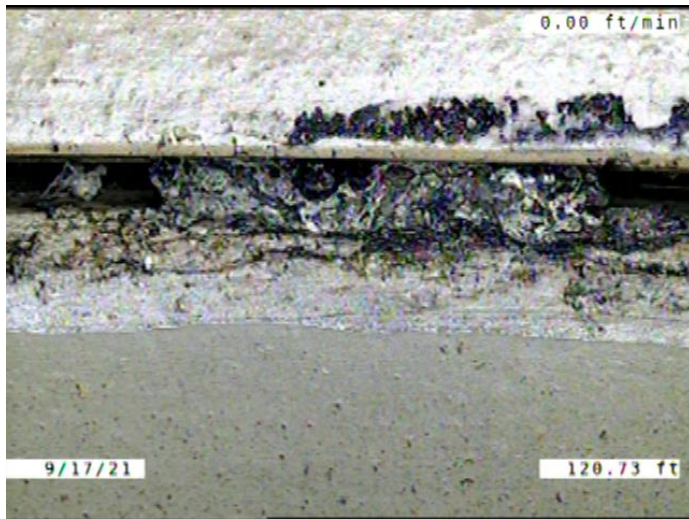
Code: **ISJ**
 Description: **Infiltration Stain Joint**

Distance (ft): **120.7**
 Structural Grade: **0**
 O&M Grade: **1**
 Clock Start/From: **10**
 Clock To: **2**
 1st Value:
 2nd Value:
 Value Percent:
 Continuous Index:
 Within 8" of Joint: **YES**
 Remarks:

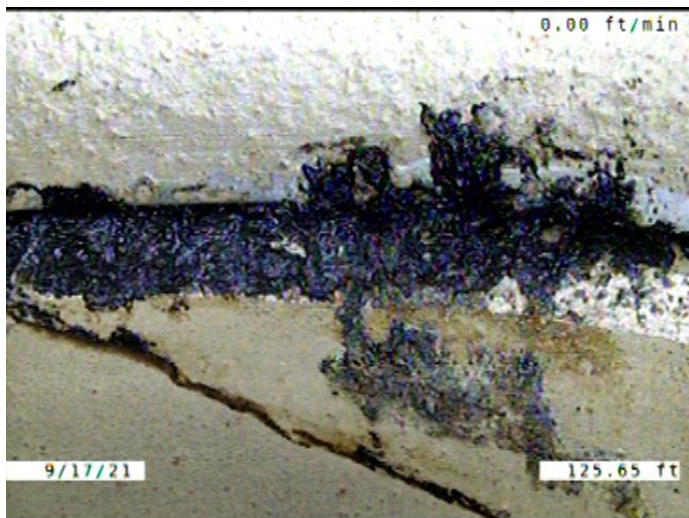
Code: **ISJ**
 Description: **Infiltration Stain Joint**

Distance (ft): **125.7**
 Structural Grade: **0**
 O&M Grade: **1**
 Clock Start/From: **10**
 Clock To: **4**
 1st Value:
 2nd Value:
 Value Percent:
 Continuous Index:
 Within 8" of Joint: **YES**
 Remarks:

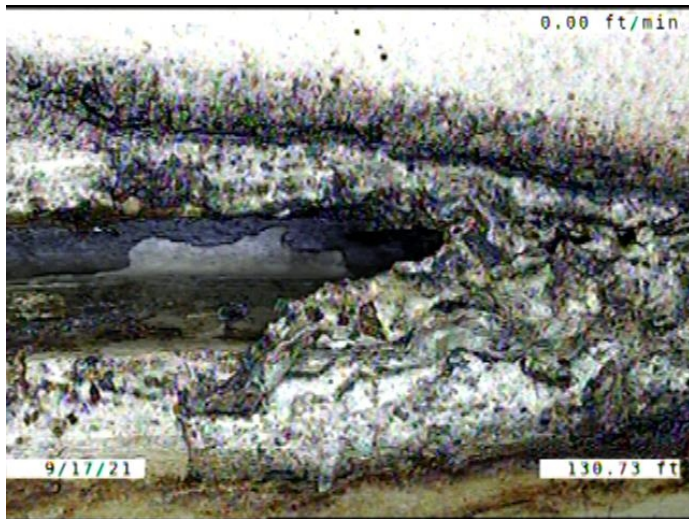
Code: **DAE**
 Description: **Deposits Attached Encrustation**

Distance (ft): **130.7**
 Structural Grade: **0**
 O&M Grade: **2**
 Clock Start/From: **7**
 Clock To: **1**
 1st Value:
 2nd Value:
 Value Percent: **5.000**
 Continuous Index:
 Within 8" of Joint: **YES**
 Remarks:

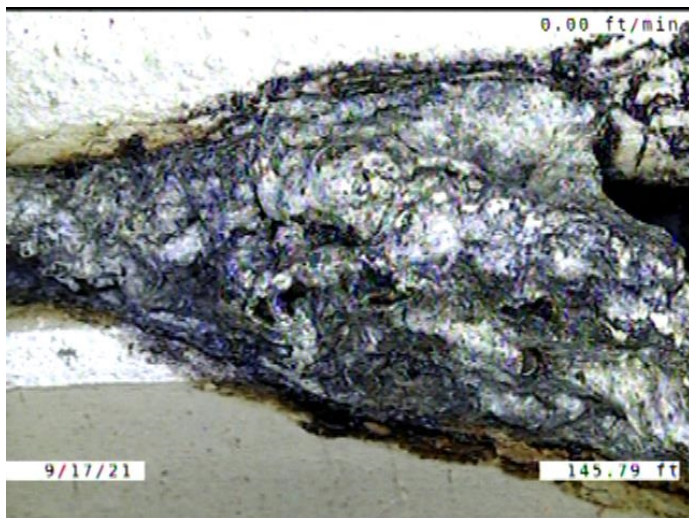
Code: **DAE**
 Description: **Deposits Attached Encrustation**

Distance (ft): **145.8**
 Structural Grade: **0**
 O&M Grade: **2**
 Clock Start/From: **9**
 Clock To: **4**
 1st Value:
 2nd Value:
 Value Percent: **5.000**
 Continuous Index:
 Within 8" of Joint: **YES**
 Remarks:

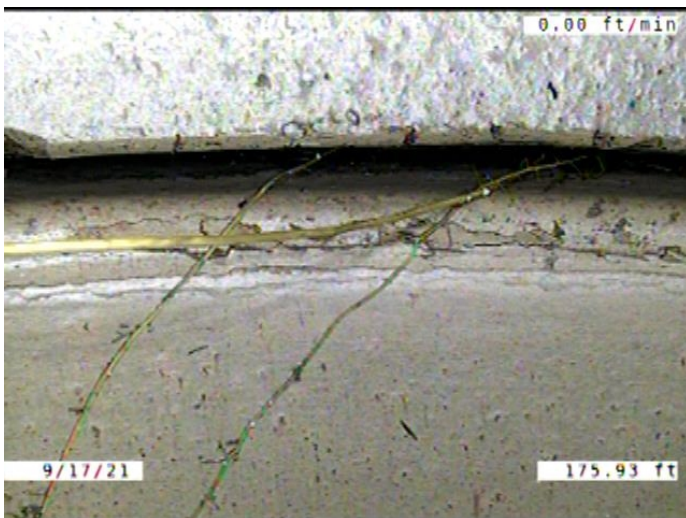
Code: **RFJ**
 Description: **Roots Fine Joint**

Distance (ft): **175.9**
 Structural Grade: **0**
 O&M Grade: **1**
 Clock Start/From: **9**
 Clock To: **10**
 1st Value:
 2nd Value:
 Value Percent:
 Continuous Index:
 Within 8" of Joint: **YES**
 Remarks:

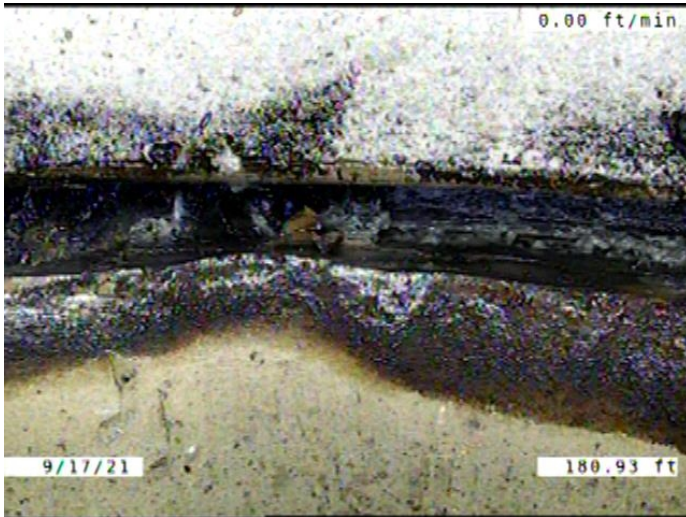
Code: **ISJ**
Description: **Infiltration Stain Joint**

Distance (ft): **180.9**
Structural Grade: **0**
O&M Grade: **1**
Clock Start/From: **9**
Clock To: **3**
1st Value:
2nd Value:
Value Percent:
Continuous Index:
Within 8" of Joint: **YES**
Remarks:

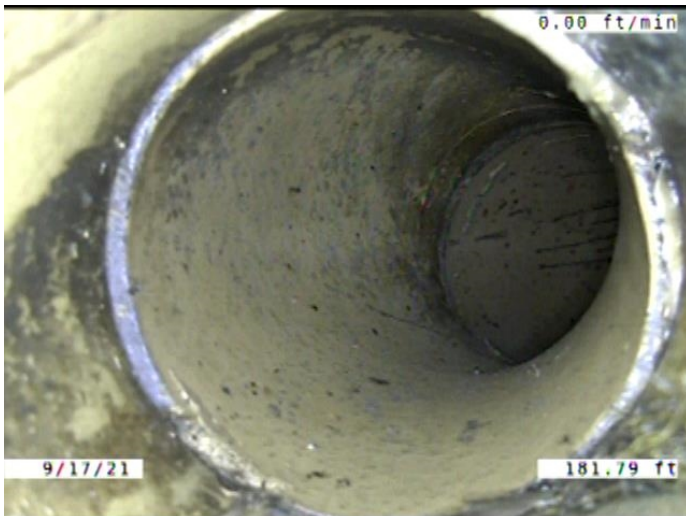
Code: **TF**
Description: **Tap Factory**

Distance (ft): **181.8**
Structural Grade: **0**
O&M Grade: **0**
Clock Start/From: **1**
Clock To:
1st Value: **4.000**
2nd Value:
Value Percent:
Continuous Index:
Within 8" of Joint: **YES**
Remarks: **ROOTS GROWING FROM THE JOINTS**

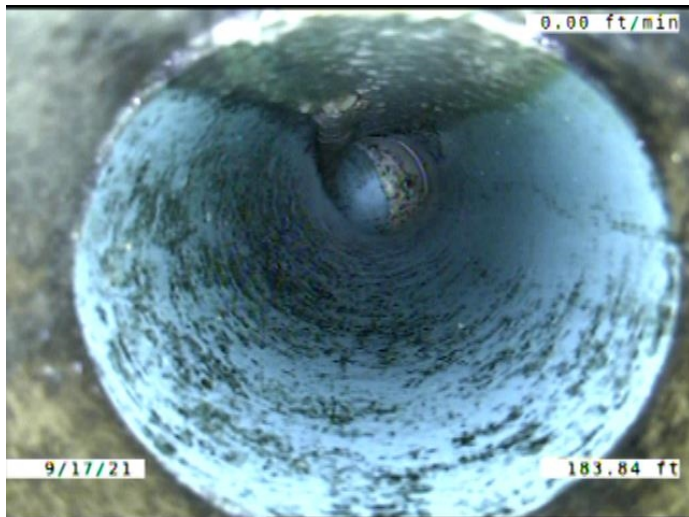
Code: **TF**
 Description: **Tap Factory**

Distance (ft): **183.8**
 Structural Grade: **0**
 O&M Grade: **0**
 Clock Start/From: **12**
 Clock To:
 1st Value: **4.000**
 2nd Value:
 Value Percent:
 Continuous Index:
 Within 8" of Joint: **YES**
 Remarks: **CONSTANTLY RUNNING WATER**

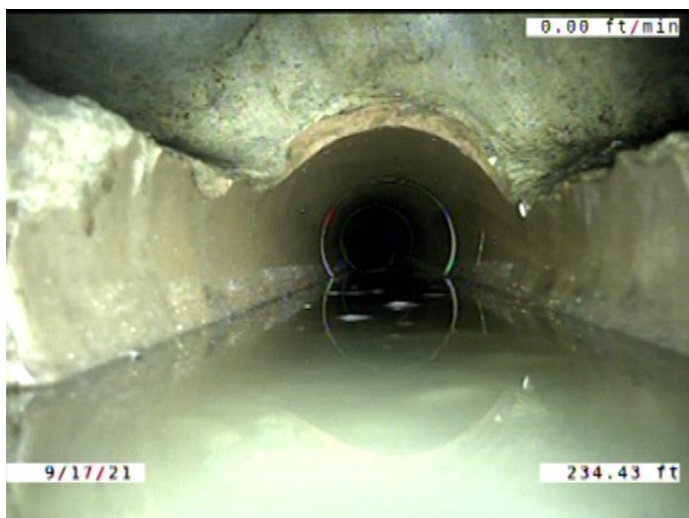
Code: **DSF**
 Description: **Deposits Settled Fine**

Distance (ft): **234.4**
 Structural Grade: **0**
 O&M Grade: **2**
 Clock Start/From: **5**
 Clock To: **7**
 1st Value:
 2nd Value:
 Value Percent: **5.000**
 Continuous Index: **F01**
 Within 8" of Joint: **YES**
 Remarks:
