## Profile/Photo Observation Report

Street:	<b>N VIRGINIA ST</b>	Flow Control:	<b>Not Controlled</b>
City:	<b>Hobart, IN</b>	Year Renewed:	
Location:	<b>Other</b>	Tape/Media #:	
Purpose:	<b>Not Known</b>	Dia/Height:	<b>10"</b>
Use:	<b>Sanitary</b>	Material:	<b>VCP</b>
Drain Area:	<b>NA</b>	Lining:	
Category:	<b>NA</b>		
Comment:

Location Details:		Direction of Survey:	<b>Downstream</b>
US MH:	<b>M-503-061</b>	DS MH:	<b>M-503-060</b>
		Total Length Surveyed (ft):	<b>4.3</b>

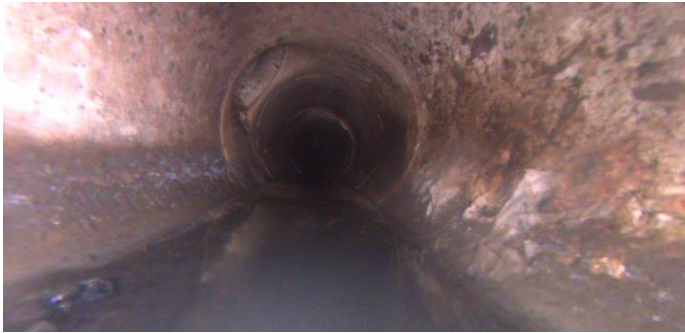
Code:	<b>MWL</b>
Description:	<b>Water Level</b>

Distance (ft):	<b>.0</b>
Structural Grade:	<b>0</b>
O&M Grade:	<b>0</b>
Clock Start/From:	
Clock To:	
1st Value:	
2nd Value:	
Value Percent:	<b>10.000</b>
Continuous Index:	
Within 8" of Joint:	<b>NO</b>
Remarks:

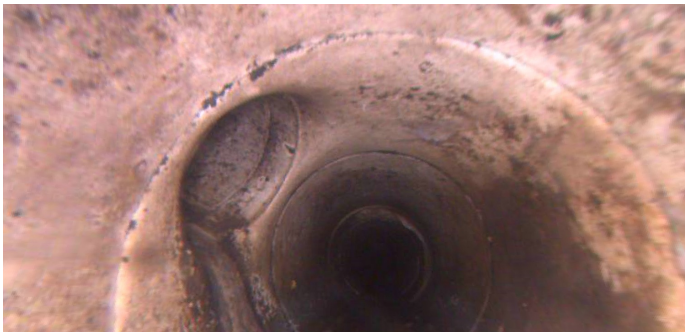
Code:	<b>TF</b>
Description:	<b>Tap Factory</b>

Distance (ft):	<b>3.3</b>
Structural Grade:	<b>0</b>
O&M Grade:	<b>0</b>
Clock Start/From:	<b>10</b>
Clock To:	
1st Value:	<b>4.000</b>
2nd Value:	
Value Percent:	
Continuous Index:	
Within 8" of Joint:	
Remarks:

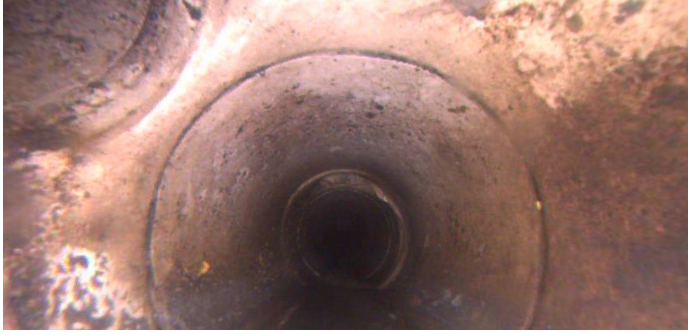
Code:	<b>MSA</b>
Description:	<b>Abandoned Survey</b>
Distance (ft):	<b>4.3</b>
Structural Grade:	<b>0</b>
O&M Grade:	<b>0</b>
Clock Start/From:	
Clock To:	
1st Value:	
2nd Value:	
Value Percent:	
Continuous Index:	
Within 8" of Joint:	<b>NO</b>
Remarks:	<b>unknown</b>
