Profile/Photo Observation Report

Street:	W 40th ave	Flow Control:	Not Controlled
City:	Hobart, IN	Year Renewed:	
Location:	Other	Tape/Media #:	
Purpose:	Not Known	Dia/Height:	10"
Use:	Sanitary	Material:	VCP
Drain Area:	NA	Lining:	
Category:	NA		
Comment:

Location Details:		Direction of Survey:	Downstream
US MH:	M-503-061	DS MH:	M-503-060
		Total Length Surveyed (ft):	4.3

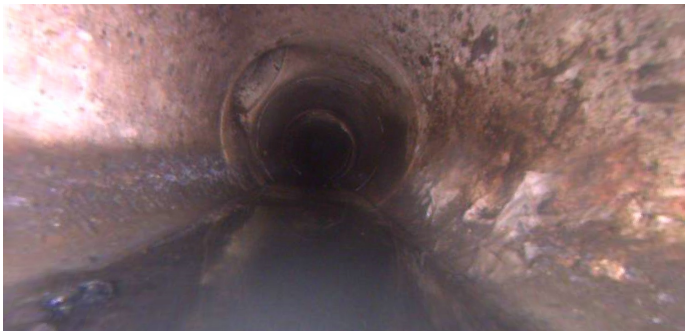
Code: **AMH**
Description: **Manhole**

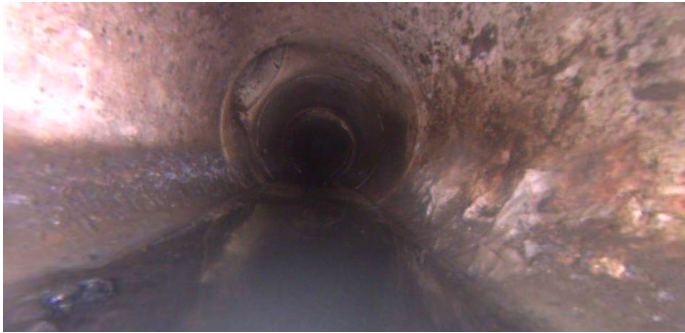
Code:	MWL
Description:	Water Level

Distance (ft):	.0
Structural Grade:	0
O&M Grade:	0
Clock Start/From:	
Clock To:	
1st Value:	
2nd Value:	
Value Percent:	10.000
Continuous Index:	
Within 8" of Joint:	NO
Remarks:

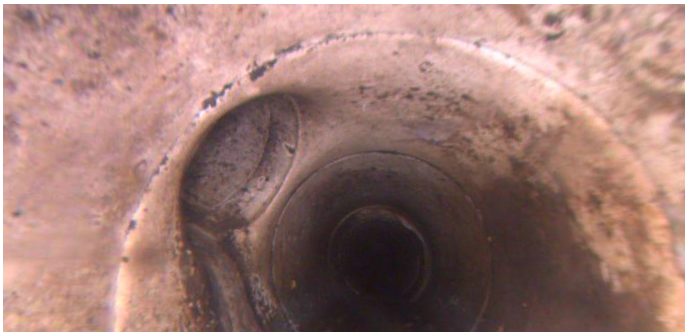
Code:	TF
Description:	Tap Factory

Distance (ft):	3.3
Structural Grade:	0
O&M Grade:	0
Clock Start/From:	10
Clock To:	
1st Value:	4.000
2nd Value:	
Value Percent:	
Continuous Index:	
Within 8" of Joint:	
Remarks:

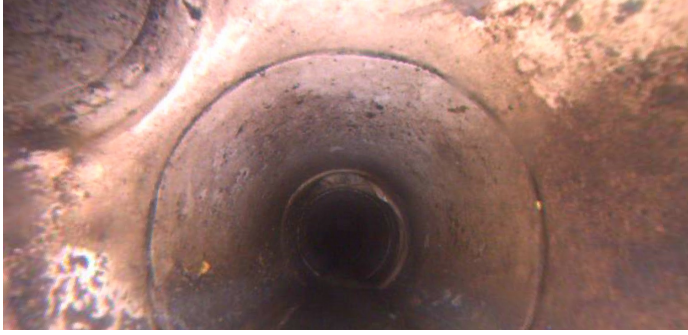
Code:	MSA
Description:	Abandoned Survey
Distance (ft):	4.3
Structural Grade:	0
O&M Grade:	0
Clock Start/From:	
Clock To:	
1st Value:	
2nd Value:	
Value Percent:	
Continuous Index:	
Within 8" of Joint:	NO
Remarks:	unknown
