Profile/Photo Observation Report

Date:	04/13/2018	Weather:		Coding:	PACP 6.0
Pipe Length (ft):	267.4	Owner:	NA	Pre Clean:	Not Known
P.O.#:		Surveyor:	Jen Costello	PSR:	P-503-061-062
Customer:		Clean Date:	01/01/1900	Shape:	C

Street:	ALLEY BETWEEN W 38TH PL & W 38	Flow Control:	Not Controlled
City:	Hobart, IN	Year Renewed:	
Location:	Other	Tape/Media #:	
Purpose:	Not Known	Dia/Height:	10"
Use:	Sanitary	Material:	VCP
Drain Area:	NA	Lining:	
Category:	NA		
Comment:

Location Details:		Direction of Survey:	Downstream
US MH:	M-503-062	DS MH:	M-503-061
		Total Length Surveyed (ft):	164.9

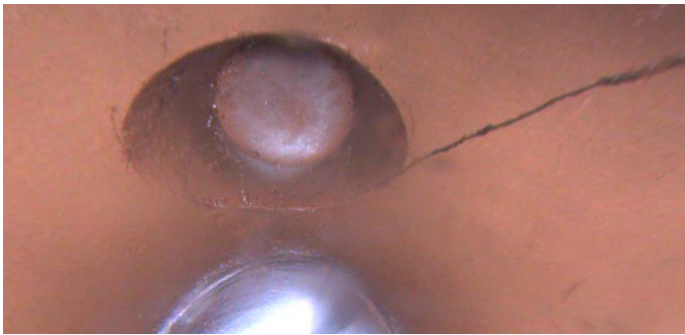
Code:	TFC
Description:	Tap Factory Capped

Distance (ft):	4.1
Structural Grade:	0
O&M Grade:	0
Clock Start/From:	12
Clock To:	
1st Value:	4.000
2nd Value:	
Value Percent:	
Continuous Index:	
Within 8" of Joint:	
Remarks:

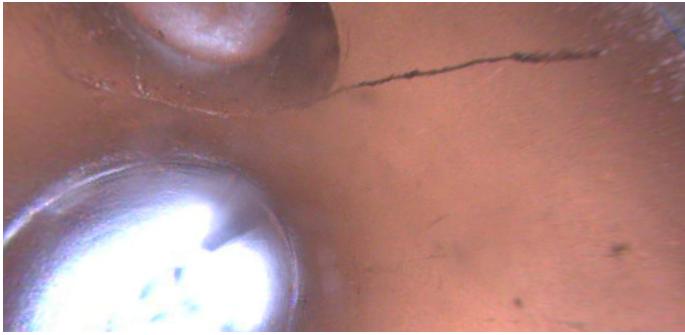
Code: **FS**
Description: **Fracture Spiral**

Distance (ft): **4.1**
Structural Grade: **3**
O&M Grade: **0**
Clock Start/From: **11**
Clock To: **12**
1st Value:
2nd Value:
Value Percent:
Continuous Index:
Within 8" of Joint:
Remarks:

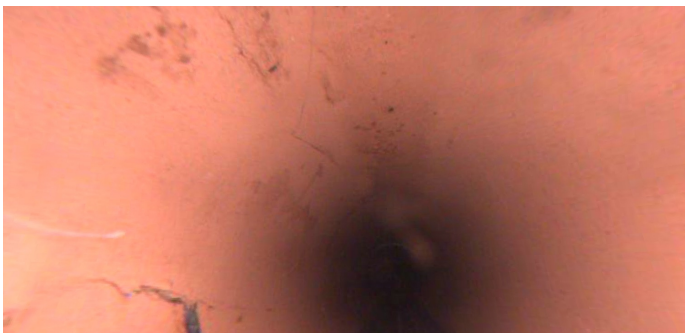
Code: **FM**
Description: **Fracture Multiple**

Distance (ft): **24.2**
Structural Grade: **4**
O&M Grade: **0**
Clock Start/From: **12**
Clock To: **4**
1st Value:
2nd Value:
Value Percent:
Continuous Index:
Within 8" of Joint:
Remarks:

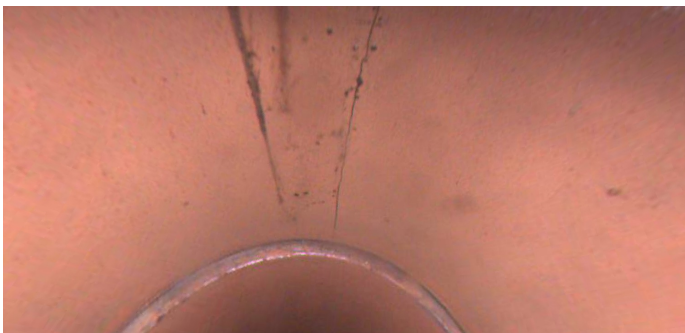
Code: **FL**
Description: **Fracture Longitudinal**

Distance (ft): **30.8**
Structural Grade: **3**
O&M Grade: **0**
Clock Start/From: **12**
Clock To:
1st Value:
2nd Value:
Value Percent:
Continuous Index:
Within 8" of Joint: **YES**
Remarks:

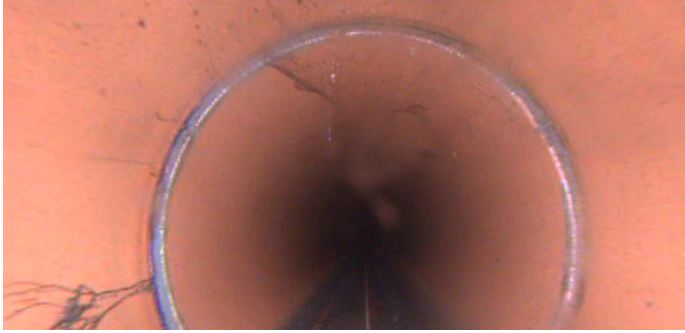
Code: **RFJ**
Description: **Roots Fine Joint**

Distance (ft): **76.0**
Structural Grade: **0**
O&M Grade: **1**
Clock Start/From: **12**
Clock To: **4**
1st Value:
2nd Value:
Value Percent:
Continuous Index:
Within 8" of Joint: **YES**
Remarks:

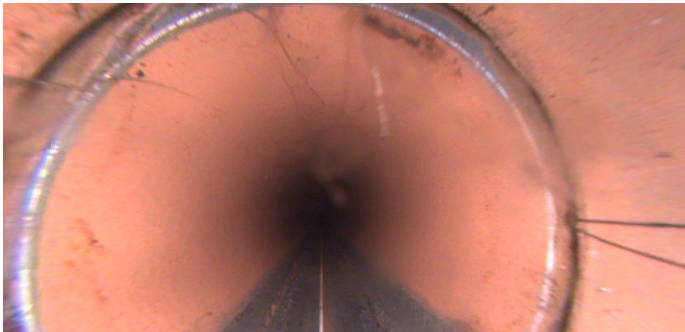
Code: **RFJ**
Description: **Roots Fine Joint**

Distance (ft): **80.8**
Structural Grade: **0**
O&M Grade: **1**
Clock Start/From: **8**
Clock To: **4**
1st Value:
2nd Value:
Value Percent:
Continuous Index: **S01**
Within 8" of Joint: **YES**
Remarks:

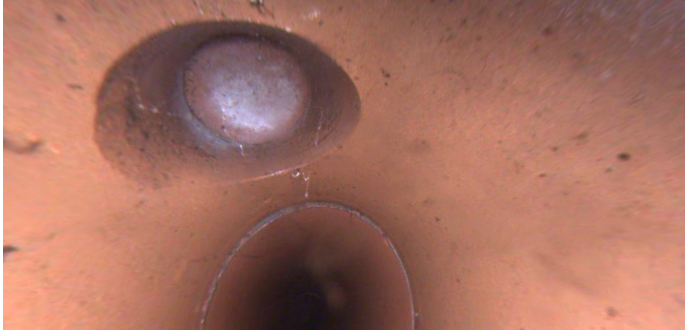
Code: **TFC**
Description: **Tap Factory Capped**

Distance (ft): **86.5**
Structural Grade: **0**
O&M Grade: **0**
Clock Start/From: **1**
Clock To:
1st Value: **4.000**
2nd Value:
Value Percent:
Continuous Index:
Within 8" of Joint:
Remarks:

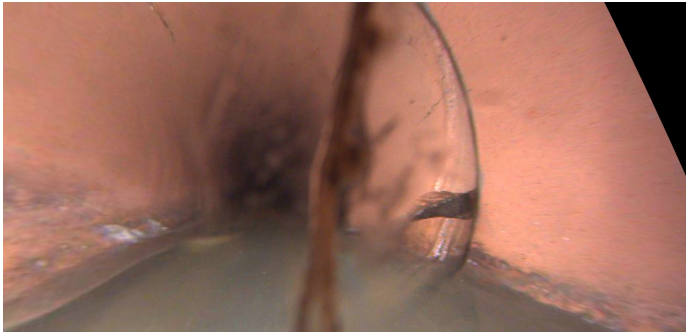
Code: **FS**
Description: **Fracture Spiral**

Distance (ft): **163.8**
Structural Grade: **3**
O&M Grade: **0**
Clock Start/From: **4**
Clock To: **5**
1st Value:
2nd Value:
Value Percent:
Continuous Index:
Within 8" of Joint: **YES**
Remarks:

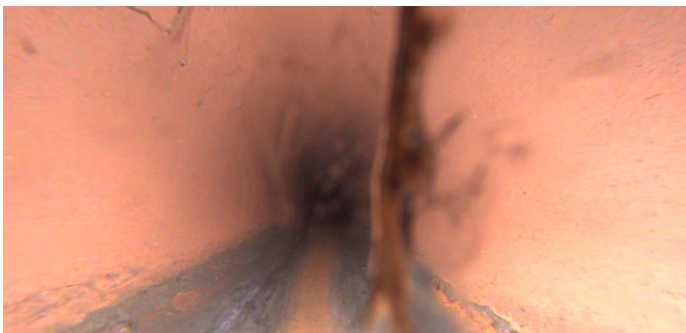
Code: **RFJ**
Description: **Roots Fine Joint**

Distance (ft): **164.9**
Structural Grade: **0**
O&M Grade: **1**
Clock Start/From: **8**
Clock To: **4**
1st Value:
2nd Value:
Value Percent:
Continuous Index: **F01**
Within 8" of Joint: **YES**
Remarks:

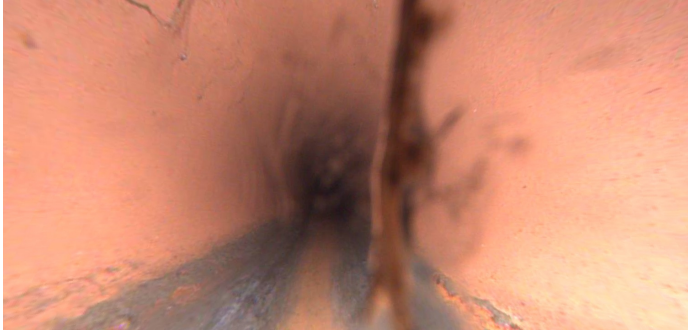
Code:	MSA
Description:	Abandoned Survey
Distance (ft):	164.9
Structural Grade:	0
O&M Grade:	0
Clock Start/From:	
Clock To:	
1st Value:	
2nd Value:	
Value Percent:	
Continuous Index:	
Within 8" of Joint:	NO
Remarks:	UNKNOWN
