Profile/Photo Observation Report

Date:	04/13/2018	Weather:		Coding:	PACP 6.0
Pipe Length (ft):	267.4	Owner:	NA	Pre Clean:	Not Known
P.O.#:		Surveyor:	Jen Costello	PSR:	P-503-061-062
Customer:		Clean Date:	01/01/1900	Shape:	C

Street:	W 40th ave	Flow Control:	Not Controlled
City:	Hobart, IN	Year Renewed:	
Location:	Other	Tape/Media #:	
Purpose:	Not Known	Dia/Height:	10"
Use:	Sanitary	Material:	VCP
Drain Area:	NA	Lining:	
Category:	NA		
Comment:

Location Details:		Direction of Survey:	Downstream
US MH:	M-503-062	DS MH:	M-503-061
		Total Length Surveyed (ft):	164.9

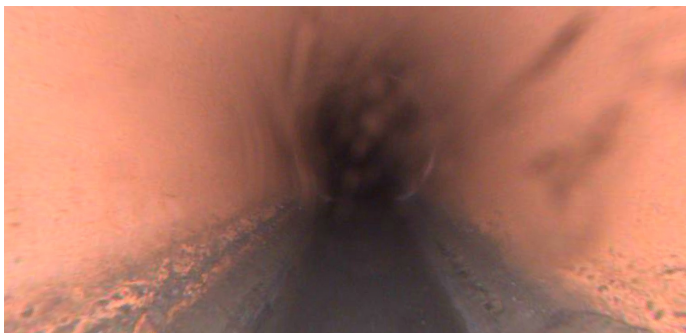
Code: **AMH**
Description: **Manhole**

Distance (ft): **.0**
Structural Grade: **0**
O&M Grade: **0**
Clock Start/From:
Clock To:
1st Value:
2nd Value:
Value Percent:
Continuous Index:
Within 8" of Joint: **NO**
Remarks: **M-503-062**

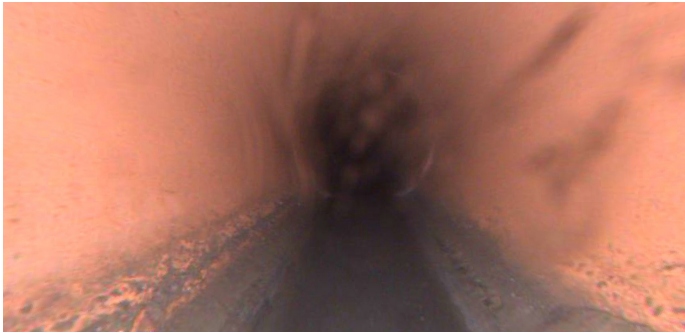
Code:	MWL
Description:	Water Level

Distance (ft):	.0
Structural Grade:	0
O&M Grade:	0
Clock Start/From:	
Clock To:	
1st Value:	
2nd Value:	
Value Percent:	5.000
Continuous Index:	
Within 8" of Joint:	NO
Remarks:

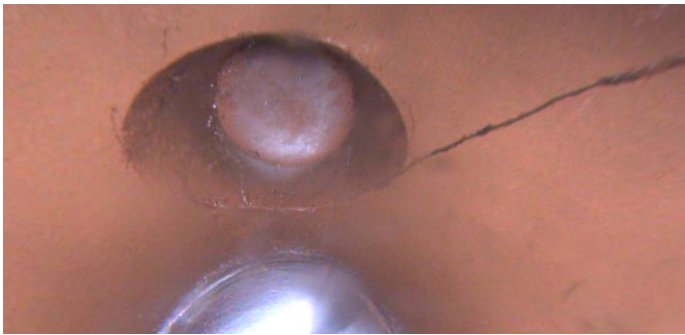
Code:	TFC
Description:	Tap Factory Capped

Distance (ft):	4.1
Structural Grade:	0
O&M Grade:	0
Clock Start/From:	12
Clock To:	
1st Value:	4.000
2nd Value:	
Value Percent:	
Continuous Index:	
Within 8" of Joint:	
Remarks:

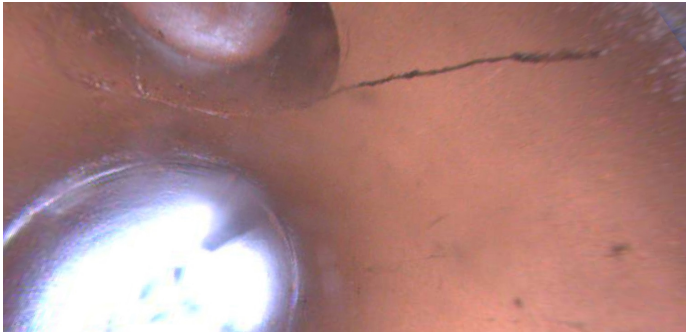
Code: **FS**
Description: **Fracture Spiral**

Distance (ft): **4.1**
Structural Grade: **3**
O&M Grade: **0**
Clock Start/From: **11**
Clock To: **12**
1st Value:
2nd Value:
Value Percent:
Continuous Index:
Within 8" of Joint:
Remarks:

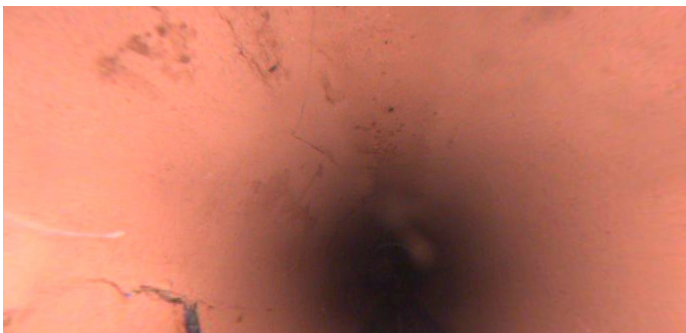
Code: **FM**
Description: **Fracture Multiple**

Distance (ft): **24.2**
Structural Grade: **4**
O&M Grade: **0**
Clock Start/From: **12**
Clock To: **4**
1st Value:
2nd Value:
Value Percent:
Continuous Index:
Within 8" of Joint:
Remarks:

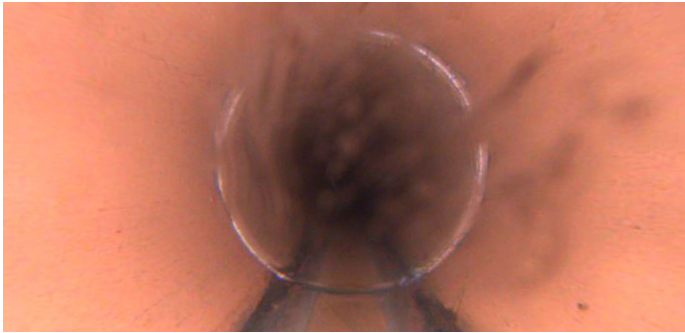
Code: **MGO**
Description: **General Observation**

Distance (ft): **24.2**
Structural Grade: **0**
O&M Grade: **0**
Clock Start/From:
Clock To:
1st Value:
2nd Value:
Value Percent:
Continuous Index:
Within 8" of Joint: **NO**
Remarks: **REAR CAMERA**

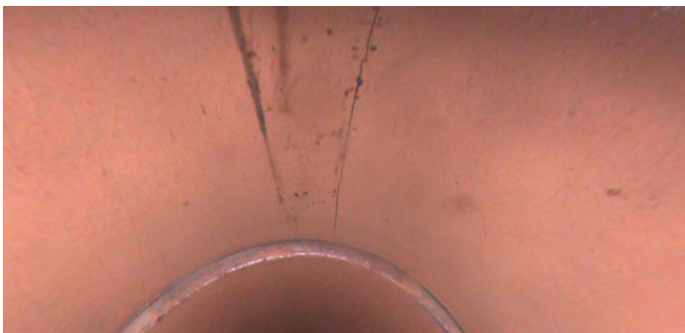
Code: **FL**
Description: **Fracture Longitudinal**

Distance (ft): **30.8**
Structural Grade: **3**
O&M Grade: **0**
Clock Start/From: **12**
Clock To:
1st Value:
2nd Value:
Value Percent:
Continuous Index:
Within 8" of Joint: **YES**
Remarks:

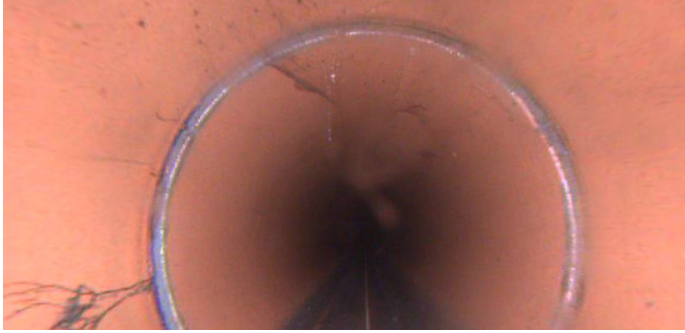
Code: **RFJ**
Description: **Roots Fine Joint**

Distance (ft): **76.0**
Structural Grade: **0**
O&M Grade: **1**
Clock Start/From: **12**
Clock To: **4**
1st Value:
2nd Value:
Value Percent:
Continuous Index:
Within 8" of Joint: **YES**
Remarks:

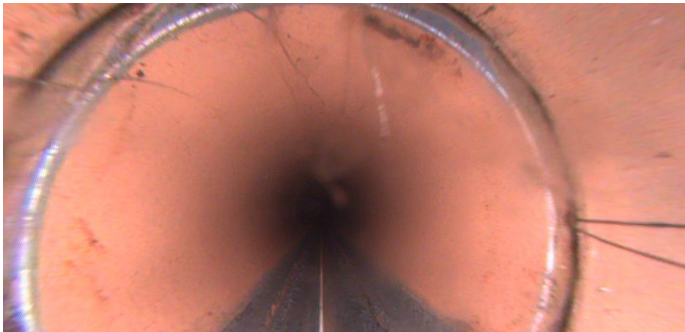
Code: **RFJ**
Description: **Roots Fine Joint**

Distance (ft): **80.8**
Structural Grade: **0**
O&M Grade: **1**
Clock Start/From: **8**
Clock To: **4**
1st Value:
2nd Value:
Value Percent:
Continuous Index: **S01**
Within 8" of Joint: **YES**
Remarks:

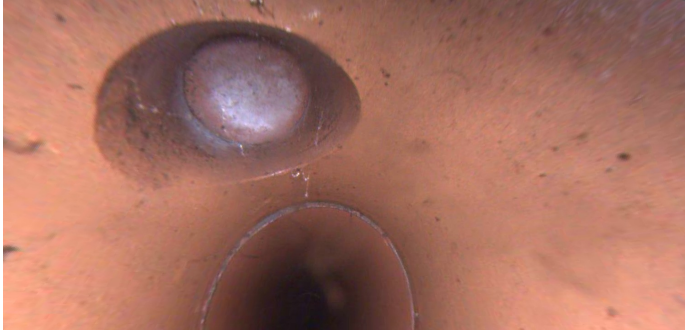
Code: **TFC**
Description: **Tap Factory Capped**

Distance (ft): **86.5**
Structural Grade: **0**
O&M Grade: **0**
Clock Start/From: **1**
Clock To:
1st Value: **4.000**
2nd Value:
Value Percent:
Continuous Index:
Within 8" of Joint:
Remarks:

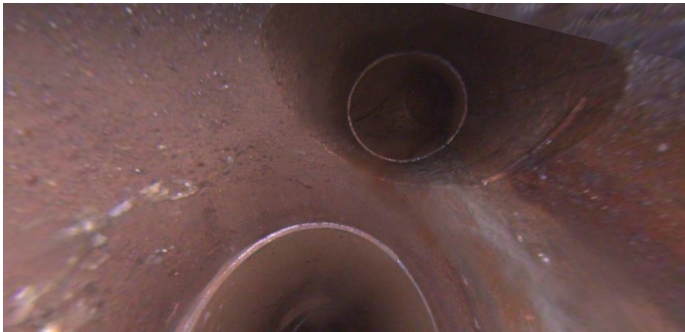
Code: **TF**
Description: **Tap Factory**

Distance (ft): **88.4**
Structural Grade: **0**
O&M Grade: **0**
Clock Start/From: **11**
Clock To:
1st Value: **4.000**
2nd Value:
Value Percent:
Continuous Index:
Within 8" of Joint:
Remarks:

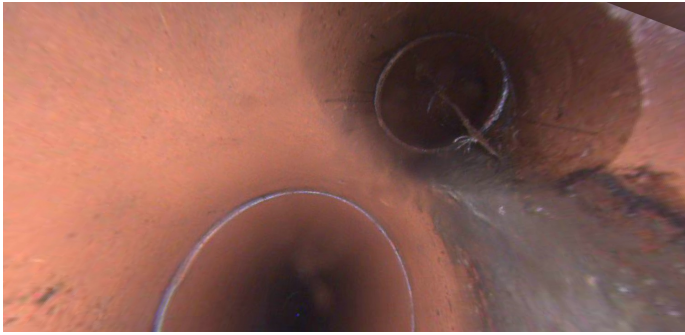
Code: **TF**
Description: **Tap Factory**

Distance (ft): **145.8**
Structural Grade: **0**
O&M Grade: **0**
Clock Start/From: **11**
Clock To:
1st Value: **4.000**
2nd Value:
Value Percent:
Continuous Index:
Within 8" of Joint:
Remarks:

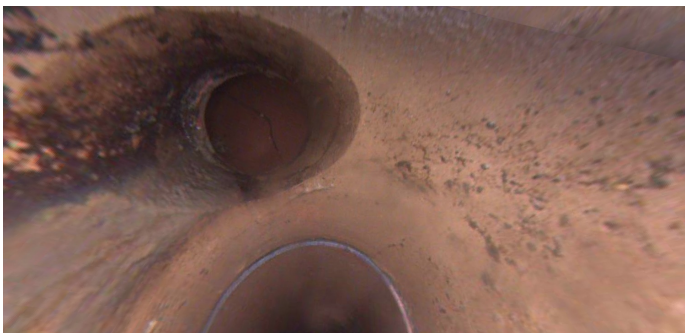
Code: **TF**
Description: **Tap Factory**

Distance (ft): **148.0**
Structural Grade: **0**
O&M Grade: **0**
Clock Start/From: **1**
Clock To:
1st Value: **4.000**
2nd Value:
Value Percent:
Continuous Index:
Within 8" of Joint:
Remarks:

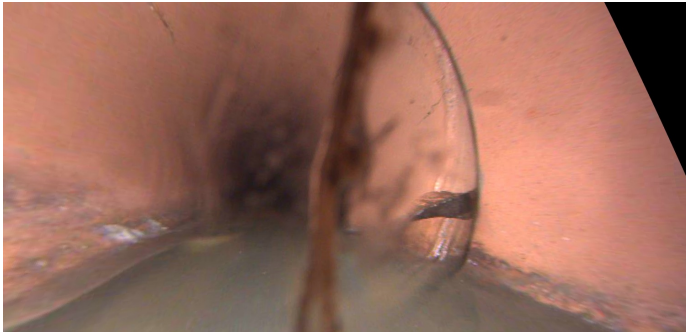
Code: **FS**
Description: **Fracture Spiral**

Distance (ft): **163.8**
Structural Grade: **3**
O&M Grade: **0**
Clock Start/From: **4**
Clock To: **5**
1st Value:
2nd Value:
Value Percent:
Continuous Index:
Within 8" of Joint: **YES**
Remarks:

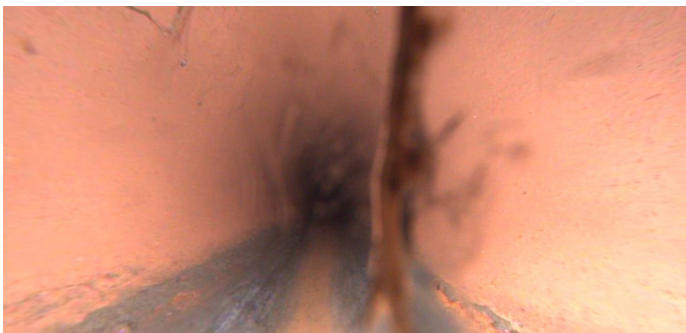
Code: **RFJ**
Description: **Roots Fine Joint**

Distance (ft): **164.9**
Structural Grade: **0**
O&M Grade: **1**
Clock Start/From: **8**
Clock To: **4**
1st Value:
2nd Value:
Value Percent:
Continuous Index: **F01**
Within 8" of Joint: **YES**
Remarks:

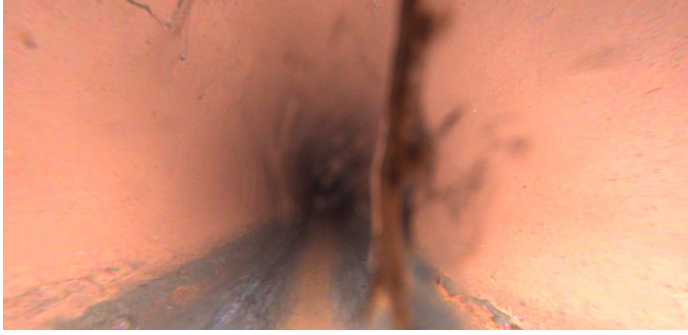
Code:	MSA
Description:	Abandoned Survey
Distance (ft):	164.9
Structural Grade:	0
O&M Grade:	0
Clock Start/From:	
Clock To:	
1st Value:	
2nd Value:	
Value Percent:	
Continuous Index:	
Within 8" of Joint:	NO
Remarks:	UNKNOWN
