Profile/Photo Observation Report

Date:	09/18/2021	Weather:		Coding:	PACP 7.0
Pipe Length (ft):	266.7	Owner:	City of Hobart	Pre Clean:	Light Cleaning
P.O.#:	YES502259	Surveyor:	S. Bucklin	PSR:	P-503-061-062
Customer:	City of Hobart	Clean Date:	08/25/2021	Shape:	C

Street:	North Wisconsin Street	Flow Control:	Not Controlled
City:	Hobart, IN	Year Renewed:	
Location:	Easement/Right of Way	Tape/Media #:	
Purpose:	Routine Assessment	Dia/Height:	10"
Use:	Sanitary Sewage Pipe	Material:	VCP
Drain Area:		Lining:	None
Category:	NA		
Comment:			
Location Details:	JUST OFF THE SW CORNER OF THE C	Direction of Survey:	Upstream
US MH:	M-503-062	DS MH:	M-503-061
		Total Length Surveyed (ft):	266.7

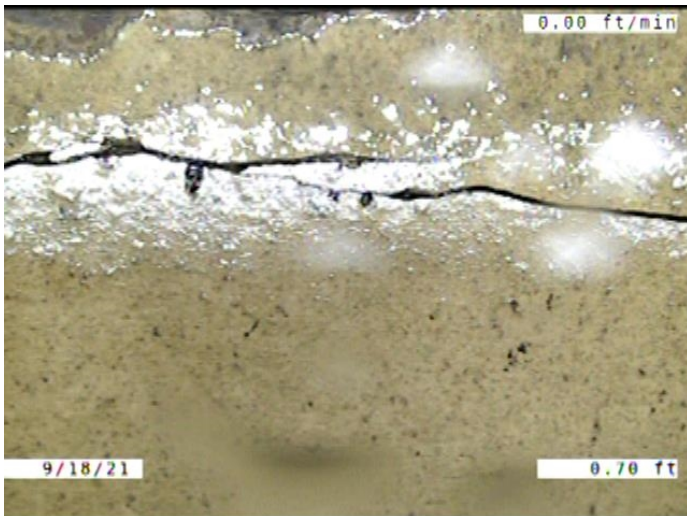
Code: **FM**
 Description: **Fracture Multiple**

Distance (ft): **.7**
 Structural Grade: **4**
 O&M Grade: **0**
 Clock Start/From: **12**
 Clock To: **12**
 1st Value:
 2nd Value:
 Value Percent:
 Continuous Index:
 Within 8" of Joint: **YES**
 Remarks:

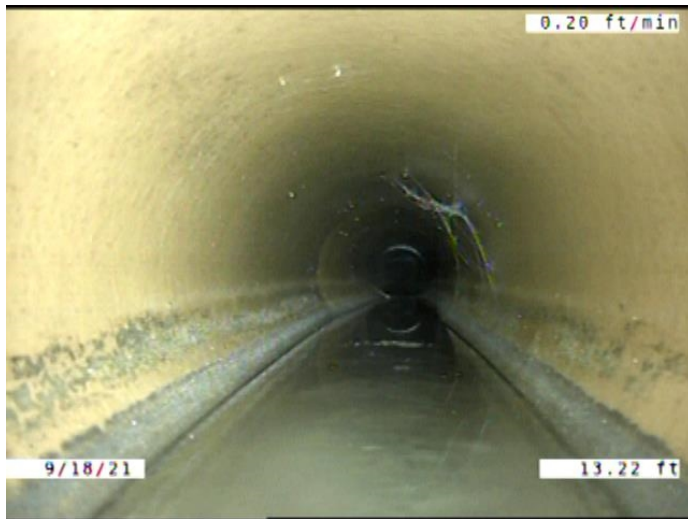
Code: **LR**
 Description: **Line Right**

Distance (ft): **13.2**
 Structural Grade: **0**
 O&M Grade: **1**
 Clock Start/From:
 Clock To:
 1st Value:
 2nd Value:
 Value Percent: **5.000**
 Continuous Index:
 Within 8" of Joint: **NO**
 Remarks:

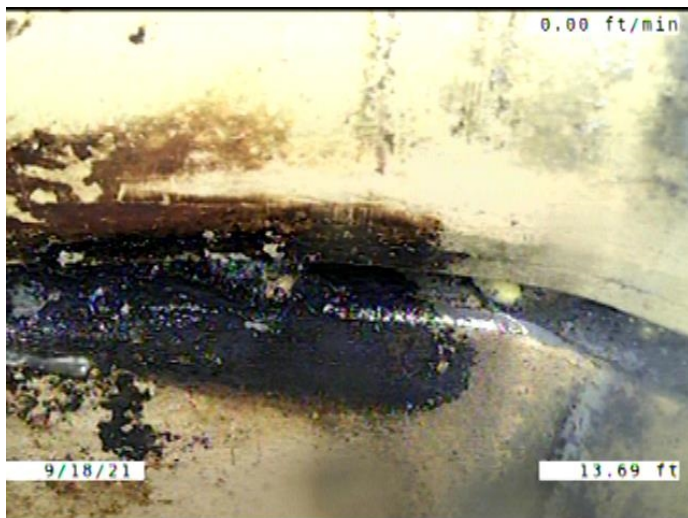
Code: **ISJ**
 Description: **Infiltration Stain Joint**

Distance (ft): **13.7**
 Structural Grade: **0**
 O&M Grade: **1**
 Clock Start/From: **1**
 Clock To: **5**
 1st Value:
 2nd Value:
 Value Percent:
 Continuous Index:
 Within 8" of Joint: **YES**
 Remarks:

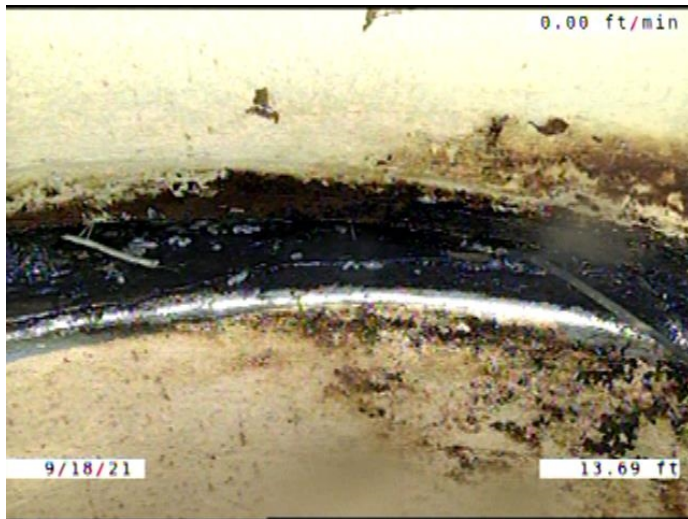
Code: **RFJ**
 Description: **Roots Fine Joint**

Distance (ft): **13.7**
 Structural Grade: **0**
 O&M Grade: **1**
 Clock Start/From: **2**
 Clock To: **3**
 1st Value:
 2nd Value:
 Value Percent:
 Continuous Index:
 Within 8" of Joint: **YES**
 Remarks:

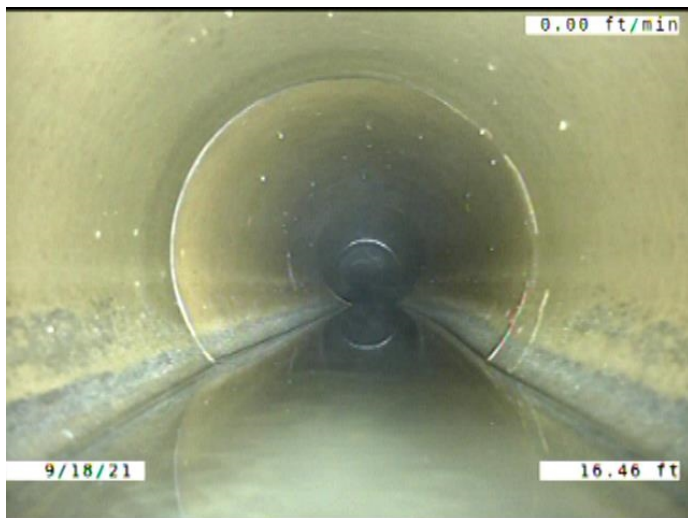
Code: **MWLS**
 Description: **Miscellaneous Water Level Sag**

Distance (ft): **16.4**
 Structural Grade: **2**
 O&M Grade: **0**
 Clock Start/From:
 Clock To:
 1st Value:
 2nd Value:
 Value Percent: **5.000**
 Continuous Index: **S01**
 Within 8" of Joint: **NO**
 Remarks:

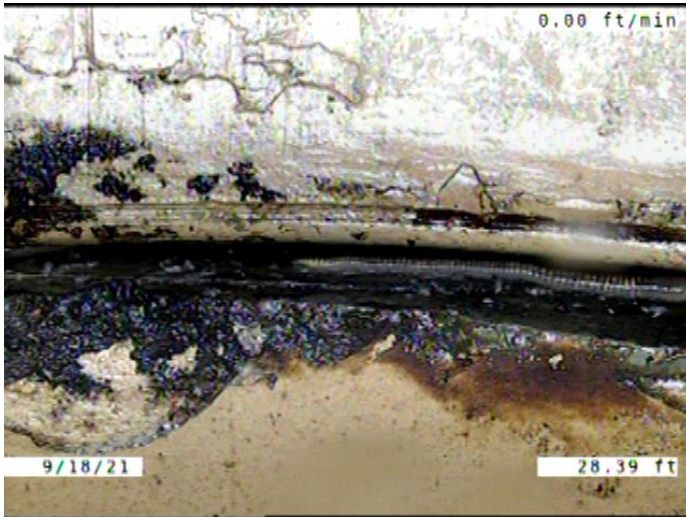
Code: **ISJ**
 Description: **Infiltration Stain Joint**

Distance (ft): **28.4**
 Structural Grade: **0**
 O&M Grade: **1**
 Clock Start/From: **2**
 Clock To: **4**
 1st Value:
 2nd Value:
 Value Percent:
 Continuous Index:
 Within 8" of Joint: **YES**
 Remarks:

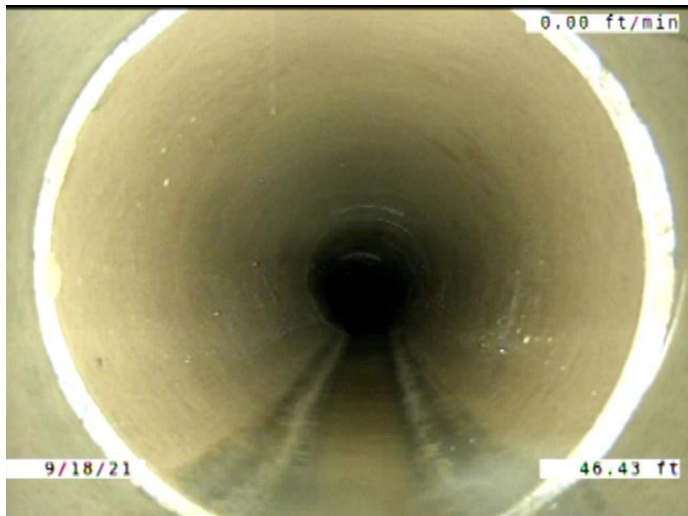
Code: **MWLS**
 Description: **Miscellaneous Water Level Sag**

Distance (ft): **46.4**
 Structural Grade: **2**
 O&M Grade: **0**
 Clock Start/From:
 Clock To:
 1st Value:
 2nd Value:
 Value Percent: **5.000**
 Continuous Index: **F01**
 Within 8" of Joint: **NO**
 Remarks:

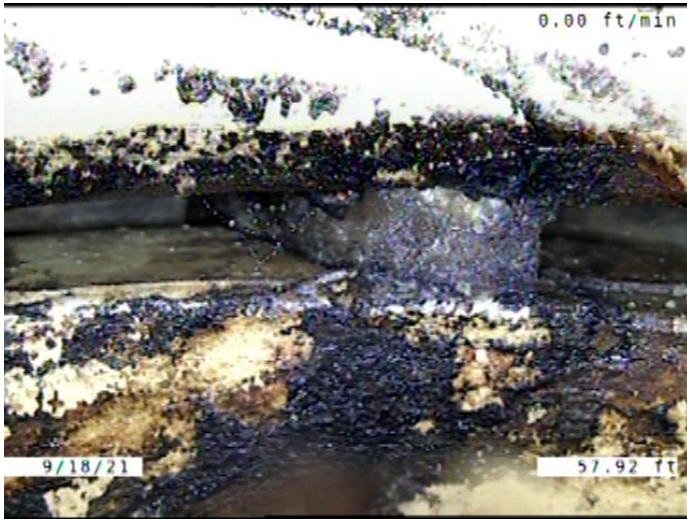
Code: **DAE**
Description: **Deposits Attached Encrustation**

Distance (ft): **57.9**
Structural Grade: **0**
O&M Grade: **2**
Clock Start/From: **7**
Clock To: **5**
1st Value:
2nd Value:
Value Percent: **5.000**
Continuous Index:
Within 8" of Joint: **YES**
Remarks:

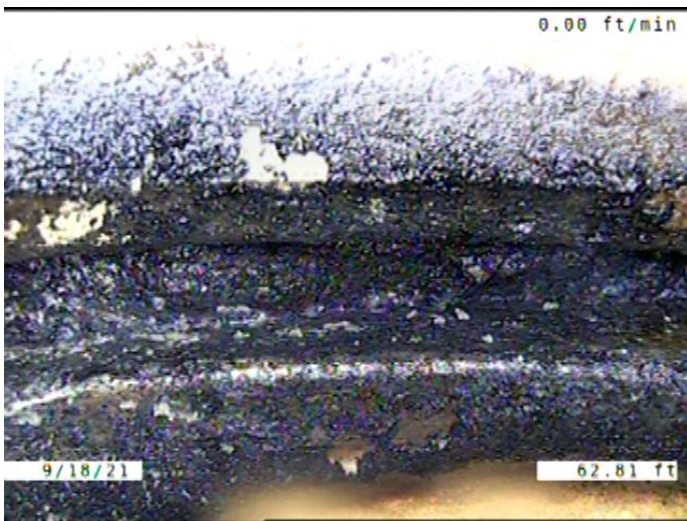
Code: **DAE**
Description: **Deposits Attached Encrustation**

Distance (ft): **62.8**
Structural Grade: **0**
O&M Grade: **2**
Clock Start/From: **8**
Clock To: **4**
1st Value:
2nd Value:
Value Percent: **5.000**
Continuous Index:
Within 8" of Joint: **YES**
Remarks:

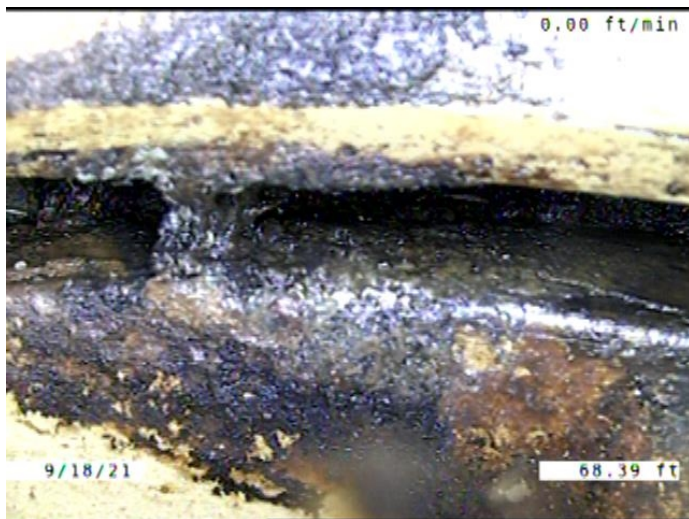
Code: **DAE**
Description: **Deposits Attached Encrustation**

Distance (ft): **68.4**
Structural Grade: **0**
O&M Grade: **2**
Clock Start/From: **8**
Clock To: **4**
1st Value:
2nd Value:
Value Percent: **5.000**
Continuous Index:
Within 8" of Joint: **YES**
Remarks:

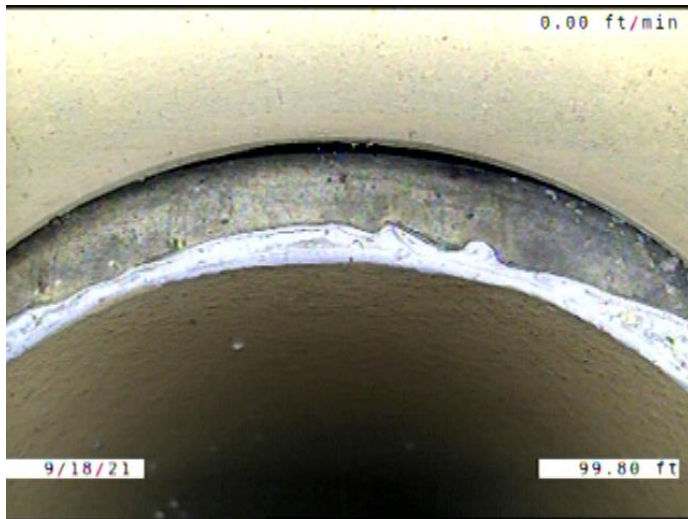
Code: **JOMD**
 Description: **Joint Offset Medium Defective**

Distance (ft): **99.8**
 Structural Grade: **3**
 O&M Grade: **0**
 Clock Start/From:
 Clock To:
 1st Value:
 2nd Value:
 Value Percent:
 Continuous Index:
 Within 8" of Joint: **NO**
 Remarks:

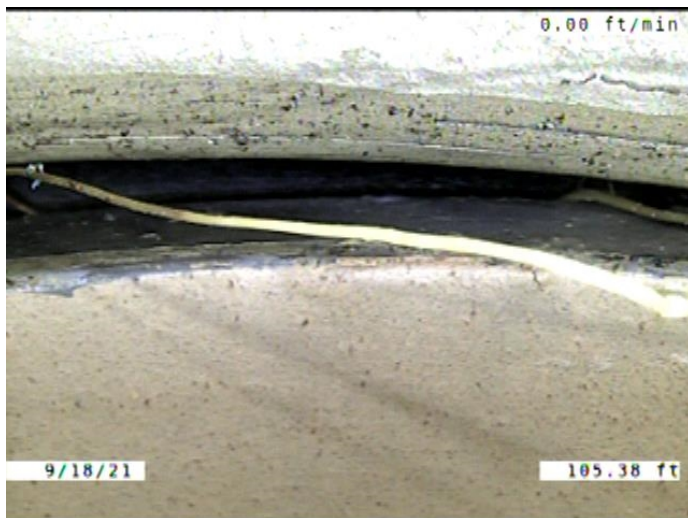
Code: **RFJ**
 Description: **Roots Fine Joint**

Distance (ft): **105.4**
 Structural Grade: **0**
 O&M Grade: **1**
 Clock Start/From: **2**
 Clock To: **4**
 1st Value:
 2nd Value:
 Value Percent:
 Continuous Index:
 Within 8" of Joint: **YES**
 Remarks:

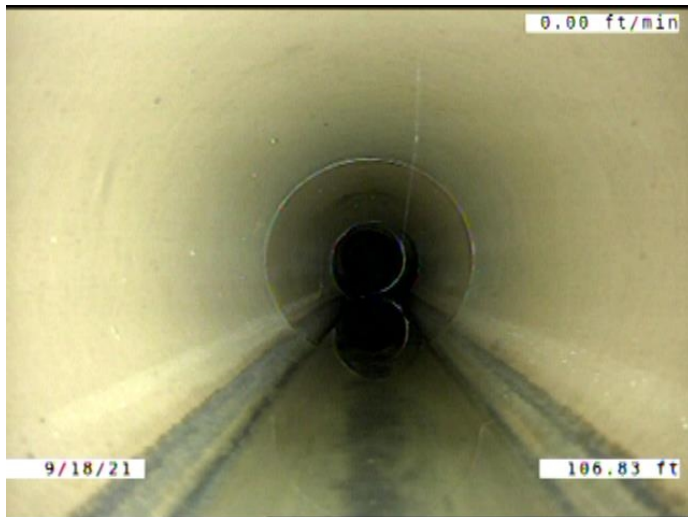
Code: **MWLS**
 Description: **Miscellaneous Water Level Sag**

Distance (ft): **106.8**
 Structural Grade: **2**
 O&M Grade: **0**
 Clock Start/From:
 Clock To:
 1st Value:
 2nd Value:
 Value Percent: **5.000**
 Continuous Index: **S02**
 Within 8" of Joint: **NO**
 Remarks:

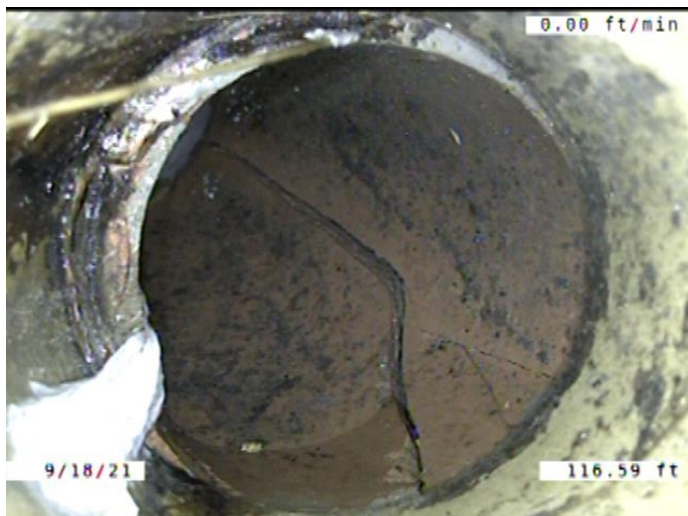
Code: **TF**
 Description: **Tap Factory**

Distance (ft): **116.6**
 Structural Grade: **0**
 O&M Grade: **0**
 Clock Start/From: **11**
 Clock To:
 1st Value: **4.000**
 2nd Value:
 Value Percent:
 Continuous Index:
 Within 8" of Joint: **YES**
 Remarks: **ROOTS GROWING OUT OF THE JOINTS. SERVICE LINE BROKEN**

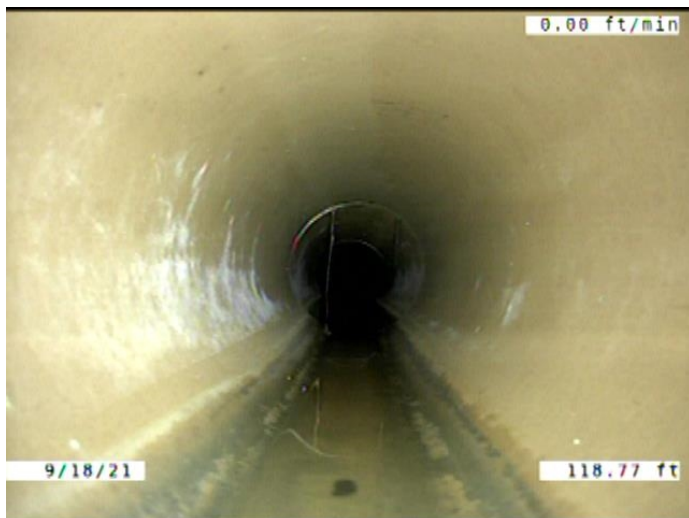
Code: **MWLS**
Description: **Miscellaneous Water Level Sag**

Distance (ft): **118.8**
Structural Grade: **2**
O&M Grade: **0**
Clock Start/From:
Clock To:
1st Value:
2nd Value:
Value Percent: **5.000**
Continuous Index: **F02**
Within 8" of Joint: **NO**
Remarks:

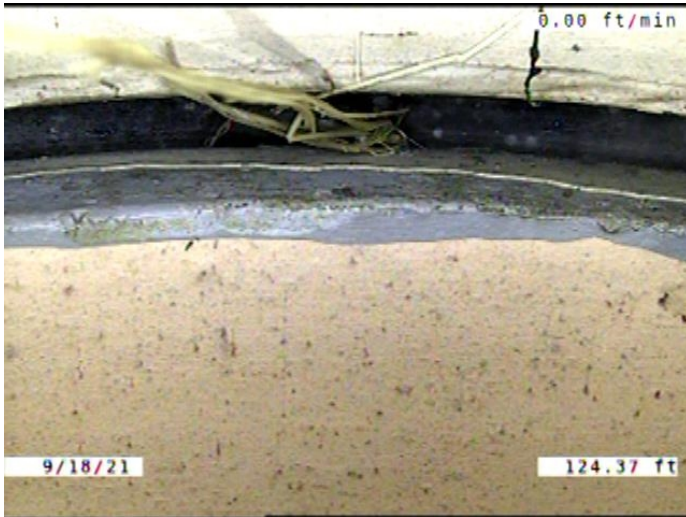
Code: **RFJ**
 Description: **Roots Fine Joint**

Distance (ft): **124.4**
 Structural Grade: **0**
 O&M Grade: **1**
 Clock Start/From: **11**
 Clock To: **2**
 1st Value:
 2nd Value:
 Value Percent:
 Continuous Index:
 Within 8" of Joint: **YES**
 Remarks:

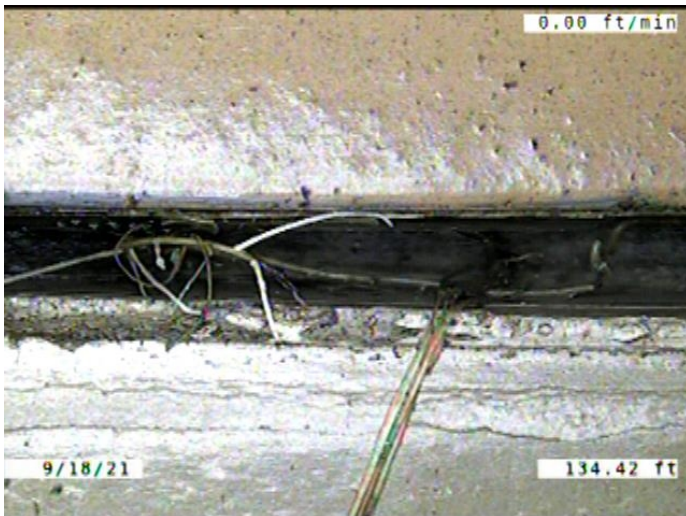
Code: **RFJ**
 Description: **Roots Fine Joint**

Distance (ft): **134.4**
 Structural Grade: **0**
 O&M Grade: **1**
 Clock Start/From: **3**
 Clock To: **5**
 1st Value:
 2nd Value:
 Value Percent:
 Continuous Index:
 Within 8" of Joint: **YES**
 Remarks:

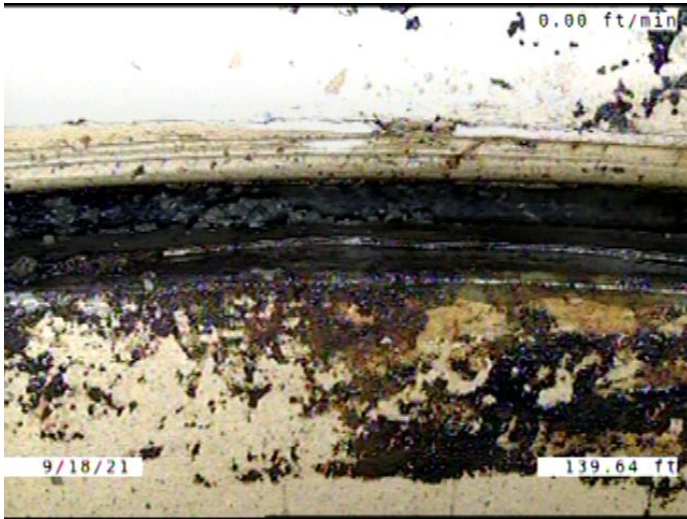
Code: **ISJ**
Description: **Infiltration Stain Joint**

Distance (ft): **139.6**
Structural Grade: **0**
O&M Grade: **1**
Clock Start/From: **8**
Clock To: **4**
1st Value:
2nd Value:
Value Percent:
Continuous Index:
Within 8" of Joint: **YES**
Remarks:

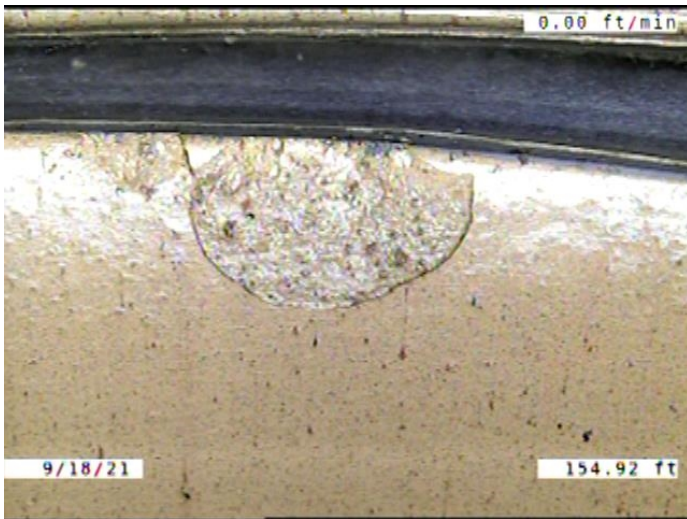
Code: **SSS**
Description: **Surface Damage Surface Spalling**

Distance (ft): **154.9**
Structural Grade: **2**
O&M Grade: **0**
Clock Start/From: **1**
Clock To:
1st Value:
2nd Value:
Value Percent:
Continuous Index:
Within 8" of Joint: **YES**
Remarks:

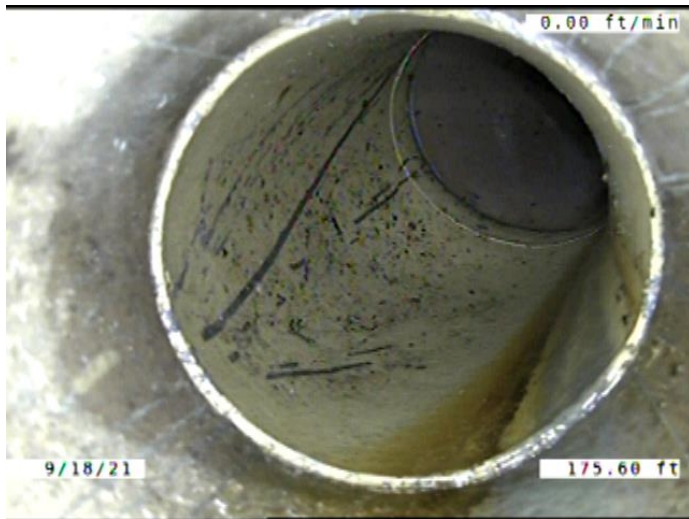
Code: **TF**
Description: **Tap Factory**

Distance (ft): **175.6**
Structural Grade: **0**
O&M Grade: **0**
Clock Start/From: **1**
Clock To:
1st Value: **4.000**
2nd Value:
Value Percent:
Continuous Index:
Within 8" of Joint: **YES**
Remarks: **CONSTANTLY RUNNING WATER**

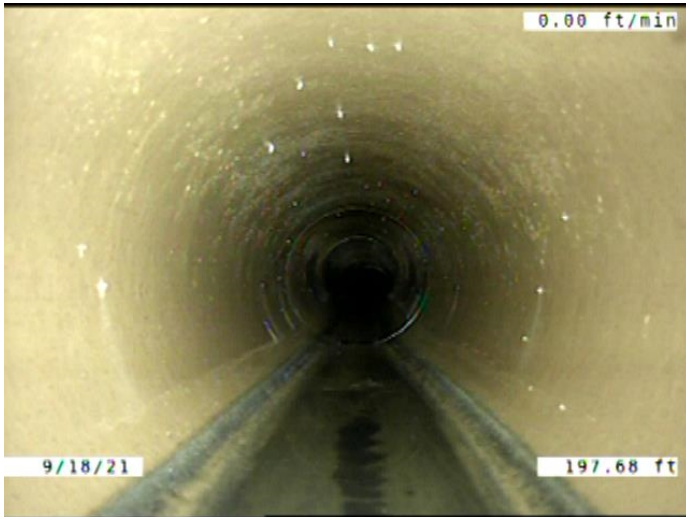
Code: **MWLS**
 Description: **Miscellaneous Water Level Sag**

Distance (ft): **197.6**
 Structural Grade: **2**
 O&M Grade: **0**
 Clock Start/From:
 Clock To:
 1st Value:
 2nd Value:
 Value Percent: **5.000**
 Continuous Index:
 Within 8" of Joint: **NO**
 Remarks:

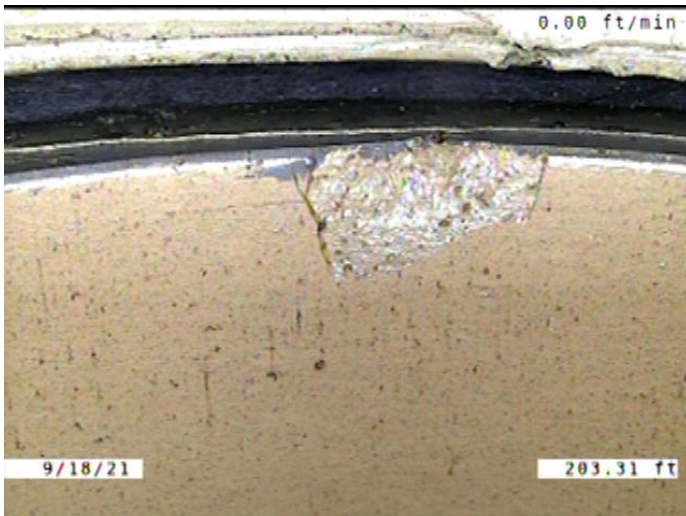
Code: **SSS**
 Description: **Surface Damage Surface Spalling**

Distance (ft): **203.3**
 Structural Grade: **2**
 O&M Grade: **0**
 Clock Start/From: **11**
 Clock To:
 1st Value:
 2nd Value:
 Value Percent:
 Continuous Index:
 Within 8" of Joint: **YES**
 Remarks:

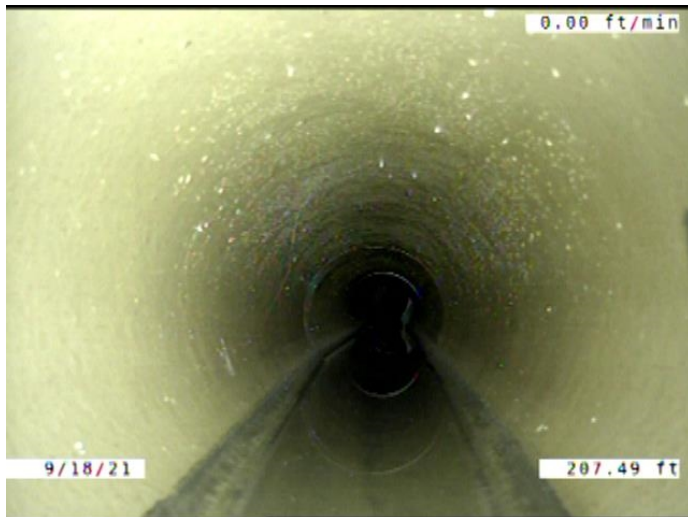
Code: **MWLS**
 Description: **Miscellaneous Water Level Sag**

Distance (ft): **207.5**
 Structural Grade: **2**
 O&M Grade: **0**
 Clock Start/From:
 Clock To:
 1st Value:
 2nd Value:
 Value Percent: **5.000**
 Continuous Index: **S03**
 Within 8" of Joint: **NO**
 Remarks:

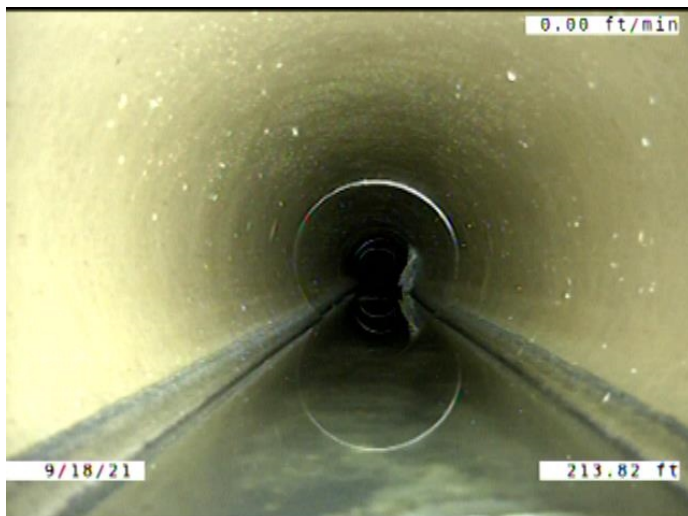
Code: **DSF**
 Description: **Deposits Settled Fine**

Distance (ft): **213.8**
 Structural Grade: **0**
 O&M Grade: **2**
 Clock Start/From: **5**
 Clock To: **7**
 1st Value:
 2nd Value:
 Value Percent: **5.000**
 Continuous Index: **S04**
 Within 8" of Joint: **YES**
 Remarks:

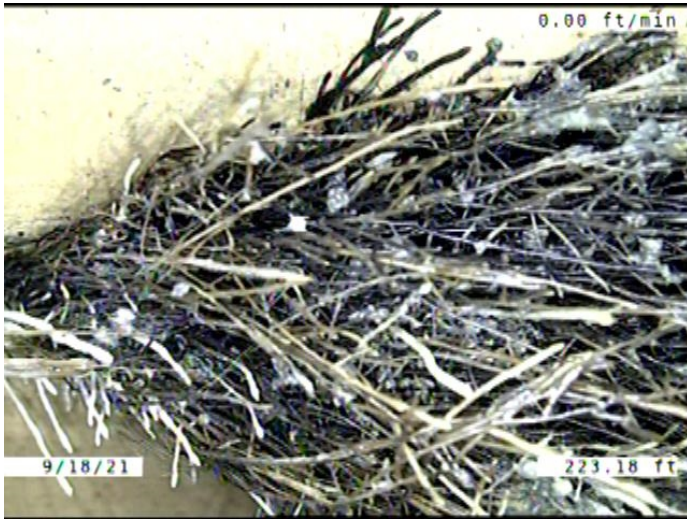
Code: **RMJ**
 Description: **Roots Medium Joint**

Distance (ft): **223.2**
 Structural Grade: **0**
 O&M Grade: **3**
 Clock Start/From: **1**
 Clock To: **4**
 1st Value:
 2nd Value:
 Value Percent: **5.000**
 Continuous Index:
 Within 8" of Joint: **YES**
 Remarks:

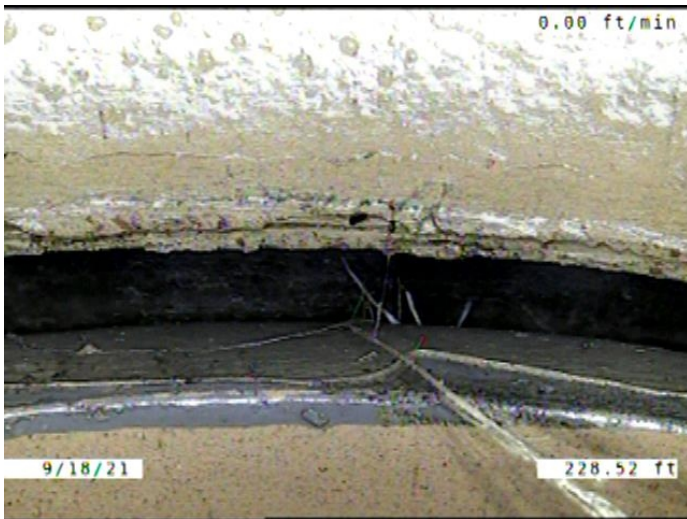
Code: **RFJ**
 Description: **Roots Fine Joint**

Distance (ft): **228.5**
 Structural Grade: **0**
 O&M Grade: **1**
 Clock Start/From: **1**
 Clock To:
 1st Value:
 2nd Value:
 Value Percent:
 Continuous Index:
 Within 8" of Joint: **YES**
 Remarks:

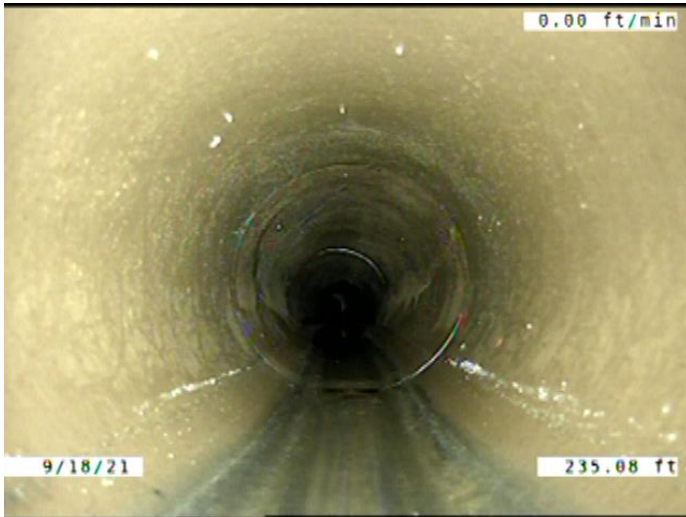
Code: **MWLS**
Description: **Miscellaneous Water Level Sag**

Distance (ft): **235.1**
Structural Grade: **2**
O&M Grade: **0**
Clock Start/From:
Clock To:
1st Value:
2nd Value:
Value Percent: **5.000**
Continuous Index: **F03**
Within 8" of Joint: **NO**
Remarks:

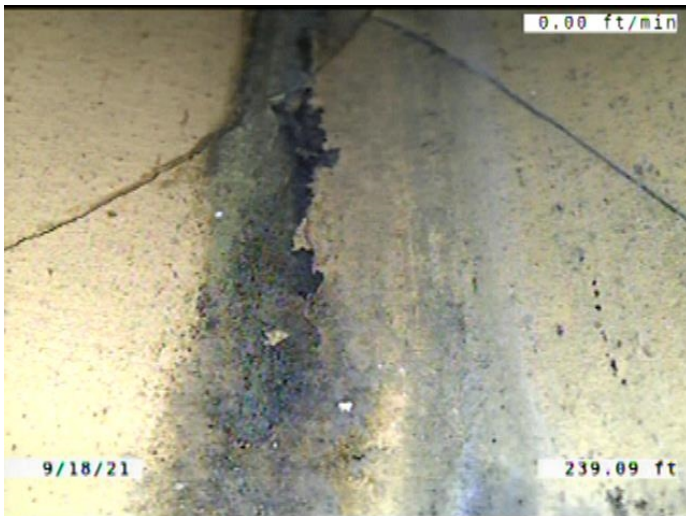
Code: **FM**
Description: **Fracture Multiple**

Distance (ft): **239.1**
Structural Grade: **4**
O&M Grade: **0**
Clock Start/From: **12**
Clock To: **12**
1st Value:
2nd Value:
Value Percent:
Continuous Index: **S05**
Within 8" of Joint: **YES**
Remarks:

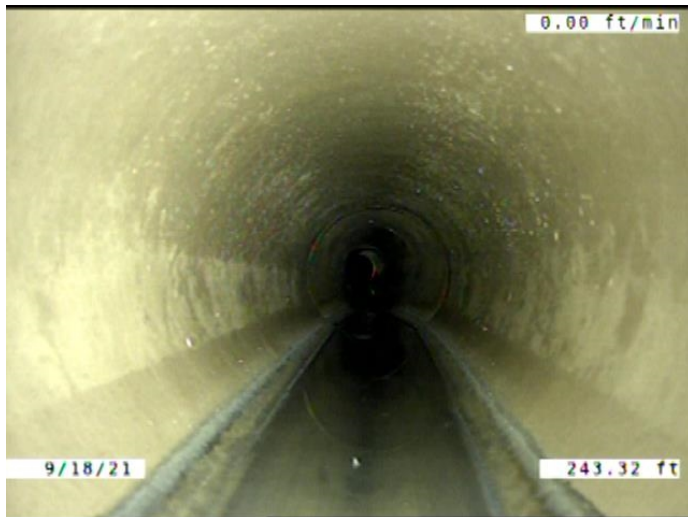
Code: **FM**
 Description: **Fracture Multiple**

Distance (ft): **243.3**
 Structural Grade: **4**
 O&M Grade: **0**
 Clock Start/From: **12**
 Clock To: **12**
 1st Value:
 2nd Value:
 Value Percent:
 Continuous Index: **F05**
 Within 8" of Joint: **YES**
 Remarks:

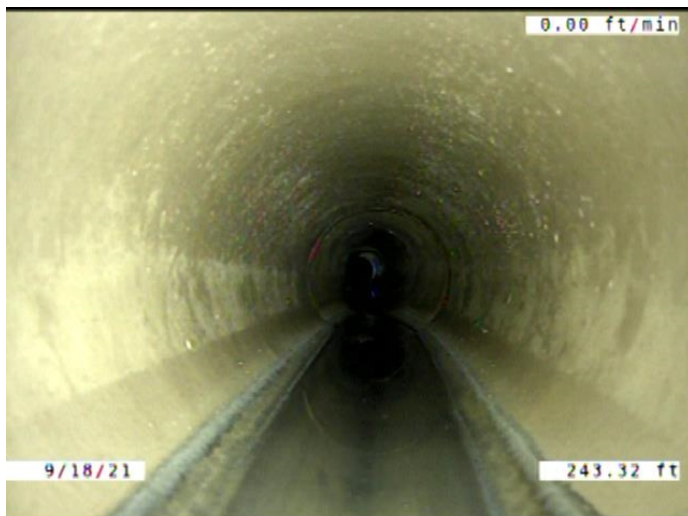
Code: **MWLS**
 Description: **Miscellaneous Water Level Sag**

Distance (ft): **243.3**
 Structural Grade: **2**
 O&M Grade: **0**
 Clock Start/From:
 Clock To:
 1st Value:
 2nd Value:
 Value Percent: **5.000**
 Continuous Index: **S06**
 Within 8" of Joint: **NO**
 Remarks:

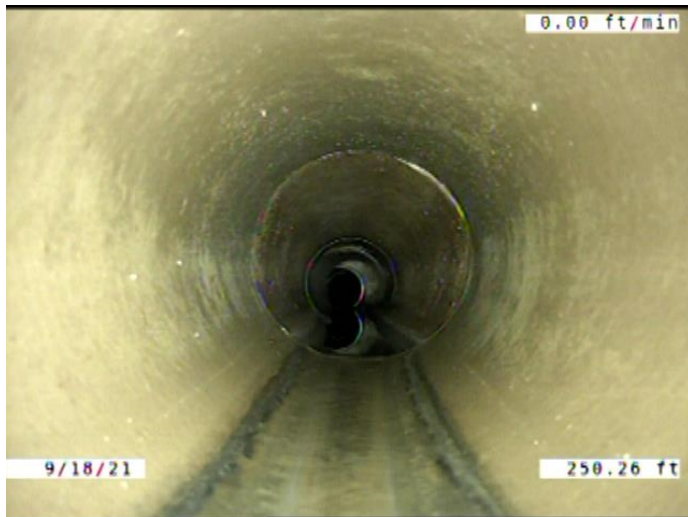
Code: **MWLS**
 Description: **Miscellaneous Water Level Sag**

Distance (ft): **250.3**
 Structural Grade: **2**
 O&M Grade: **0**
 Clock Start/From:
 Clock To:
 1st Value:
 2nd Value:
 Value Percent: **5.000**
 Continuous Index: **F06**
 Within 8" of Joint: **NO**
 Remarks:

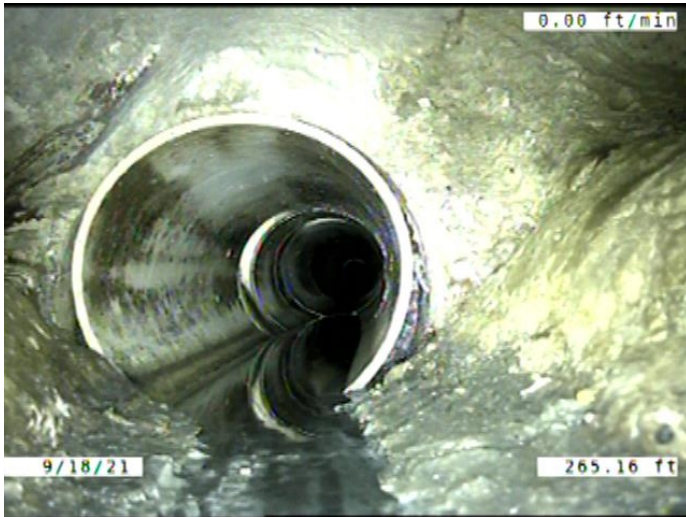
Code: **DSF**
 Description: **Deposits Settled Fine**

Distance (ft): **265.2**
 Structural Grade: **0**
 O&M Grade: **2**
 Clock Start/From: **5**
 Clock To: **7**
 1st Value:
 2nd Value:
 Value Percent: **5.000**
 Continuous Index: **F04**
 Within 8" of Joint: **YES**
 Remarks:
