Profile/Photo Observation Report

Date:	09/18/2021	Weather:		Coding:	PACP 7.0
Pipe Length (ft):	266.7	Owner:	City of Hobart	Pre Clean:	Light Cleaning
P.O.#:	YES502259	Surveyor:	S. Bucklin	PSR:	P-503-061-062
Customer:	City of Hobart	Clean Date:	08/25/2021	Shape:	C

Street:	North Wisconsin Street	Flow Control:	Not Controlled
City:	Hobart, IN	Year Renewed:	
Location:	Easement/Right of Way	Tape/Media #:	
Purpose:	Routine Assessment	Dia/Height:	10"
Use:	Sanitary Sewage Pipe	Material:	VCP
Drain Area:		Lining:	None
Category:	NA		
Comment:			
Location Details:	JUST OFF THE SW CORNER OF THE C	Direction of Survey:	Upstream
US MH:	M-503-062	DS MH:	M-503-061
		Total Length Surveyed (ft):	266.7

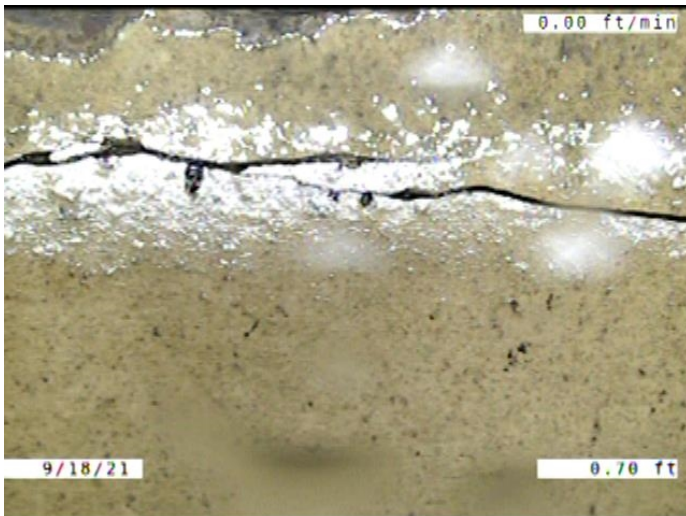
Code: **FM**
 Description: **Fracture Multiple**

Distance (ft): **.7**
 Structural Grade: **4**
 O&M Grade: **0**
 Clock Start/From: **12**
 Clock To: **12**
 1st Value:
 2nd Value:
 Value Percent:
 Continuous Index:
 Within 8" of Joint: **YES**
 Remarks:

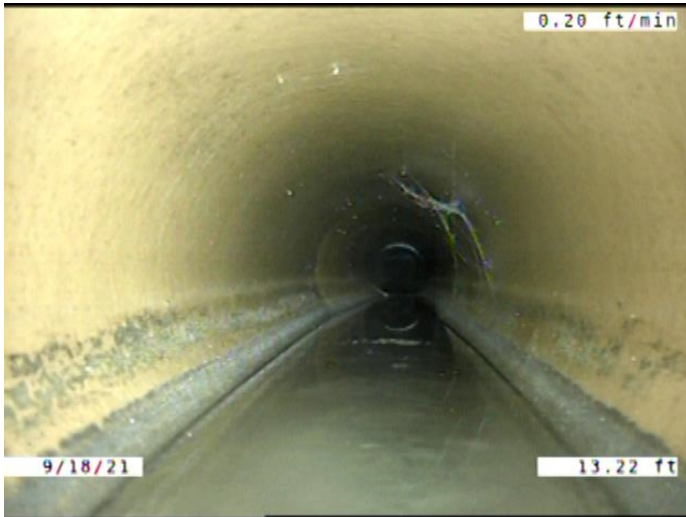
Code: **LR**
 Description: **Line Right**

Distance (ft): **13.2**
 Structural Grade: **0**
 O&M Grade: **1**
 Clock Start/From:
 Clock To:
 1st Value:
 2nd Value:
 Value Percent: **5.000**
 Continuous Index:
 Within 8" of Joint: **NO**
 Remarks:

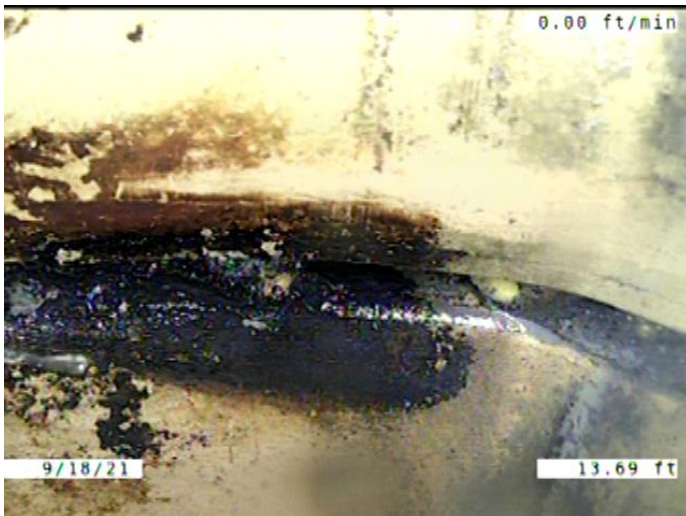
Code: **ISJ**
 Description: **Infiltration Stain Joint**

Distance (ft): **13.7**
 Structural Grade: **0**
 O&M Grade: **1**
 Clock Start/From: **1**
 Clock To: **5**
 1st Value:
 2nd Value:
 Value Percent:
 Continuous Index:
 Within 8" of Joint: **YES**
 Remarks:

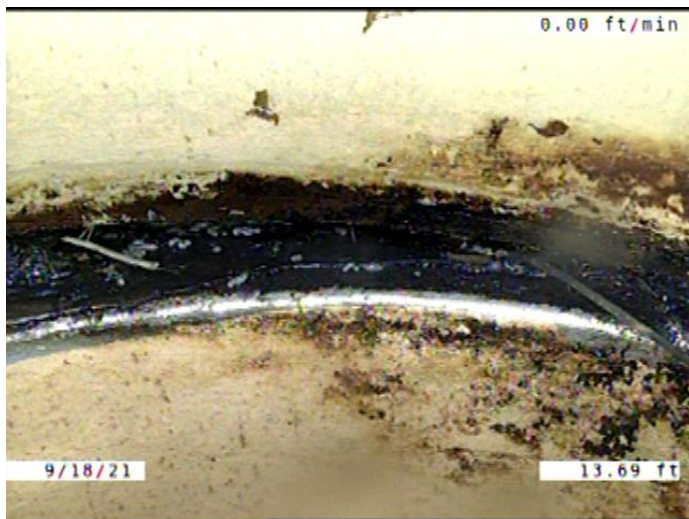
Code: **RFJ**
Description: **Roots Fine Joint**

Distance (ft): **13.7**
Structural Grade: **0**
O&M Grade: **1**
Clock Start/From: **2**
Clock To: **3**
1st Value:
2nd Value:
Value Percent:
Continuous Index:
Within 8" of Joint: **YES**
Remarks:

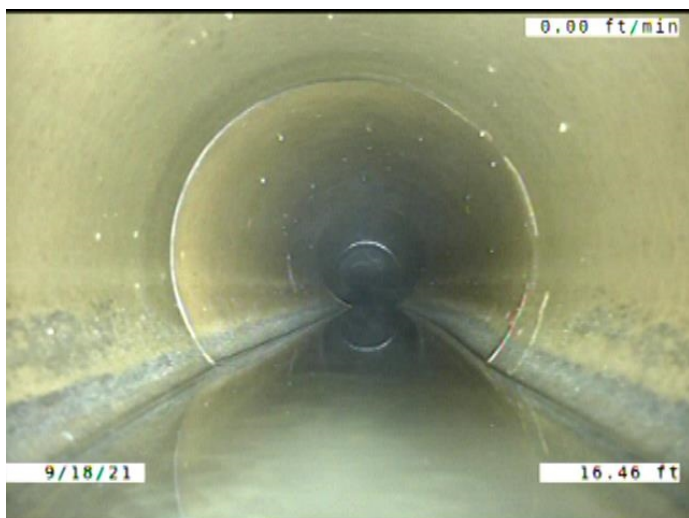
Code: **MWLS**
Description: **Miscellaneous Water Level Sag**

Distance (ft): **16.4**
Structural Grade: **2**
O&M Grade: **0**
Clock Start/From:
Clock To:
1st Value:
2nd Value:
Value Percent: **5.000**
Continuous Index: **S01**
Within 8" of Joint: **NO**
Remarks:

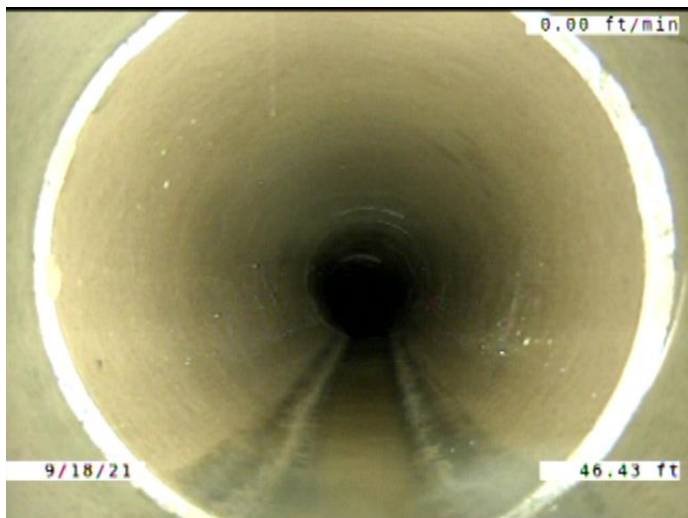
Code: **MWLS**
 Description: **Miscellaneous Water Level Sag**

Distance (ft): **46.4**
 Structural Grade: **2**
 O&M Grade: **0**
 Clock Start/From:
 Clock To:
 1st Value:
 2nd Value:
 Value Percent: **5.000**
 Continuous Index: **F01**
 Within 8" of Joint: **NO**
 Remarks:

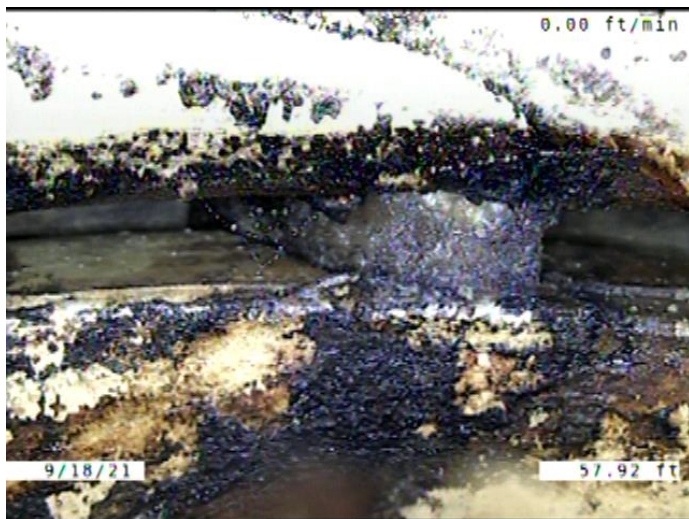
Code: **DAE**
 Description: **Deposits Attached Encrustation**

Distance (ft): **57.9**
 Structural Grade: **0**
 O&M Grade: **2**
 Clock Start/From: **7**
 Clock To: **5**
 1st Value:
 2nd Value:
 Value Percent: **5.000**
 Continuous Index:
 Within 8" of Joint: **YES**
 Remarks:

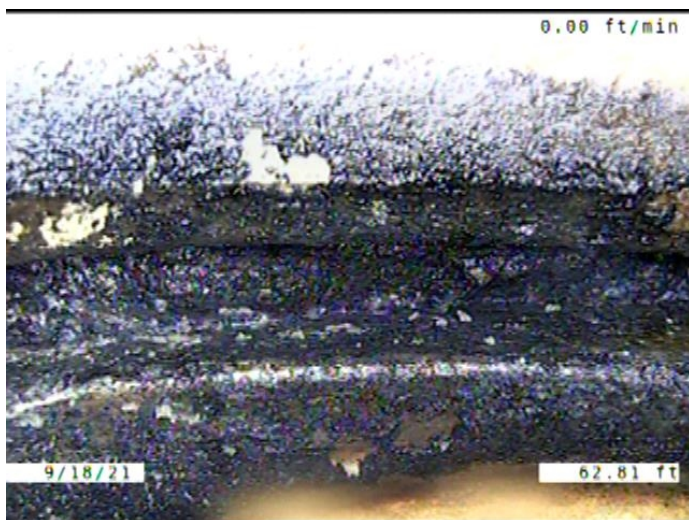
Code: **DAE**
 Description: **Deposits Attached Encrustation**

Distance (ft): **62.8**
 Structural Grade: **0**
 O&M Grade: **2**
 Clock Start/From: **8**
 Clock To: **4**
 1st Value:
 2nd Value:
 Value Percent: **5.000**
 Continuous Index:
 Within 8" of Joint: **YES**
 Remarks:

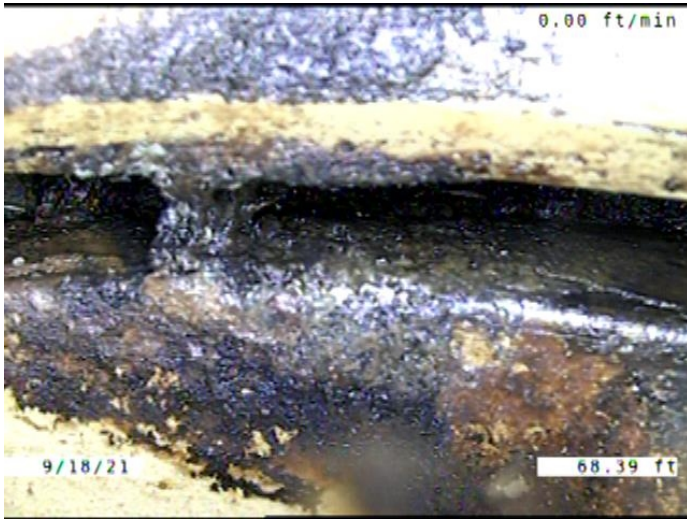
Code: **DAE**
Description: **Deposits Attached Encrustation**

Distance (ft): **68.4**
Structural Grade: **0**
O&M Grade: **2**
Clock Start/From: **8**
Clock To: **4**
1st Value:
2nd Value:
Value Percent: **5.000**
Continuous Index:
Within 8" of Joint: **YES**
Remarks:

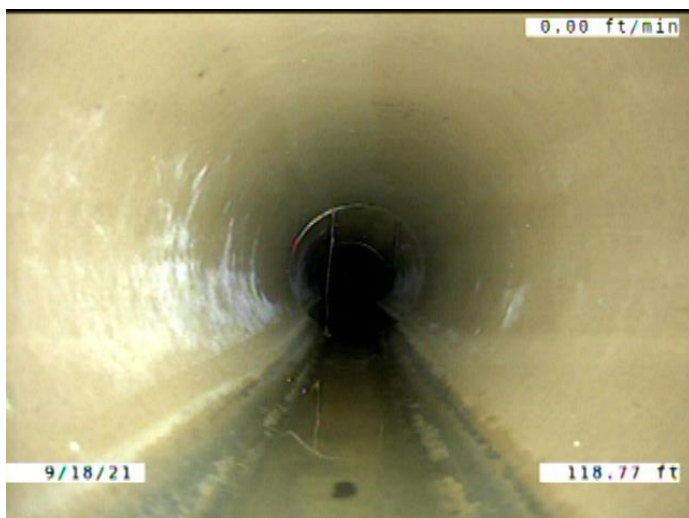
Code: **MWLS**
Description: **Miscellaneous Water Level Sag**

Distance (ft): **118.8**
Structural Grade: **2**
O&M Grade: **0**
Clock Start/From:
Clock To:
1st Value:
2nd Value:
Value Percent: **5.000**
Continuous Index: **F02**
Within 8" of Joint: **NO**
Remarks:

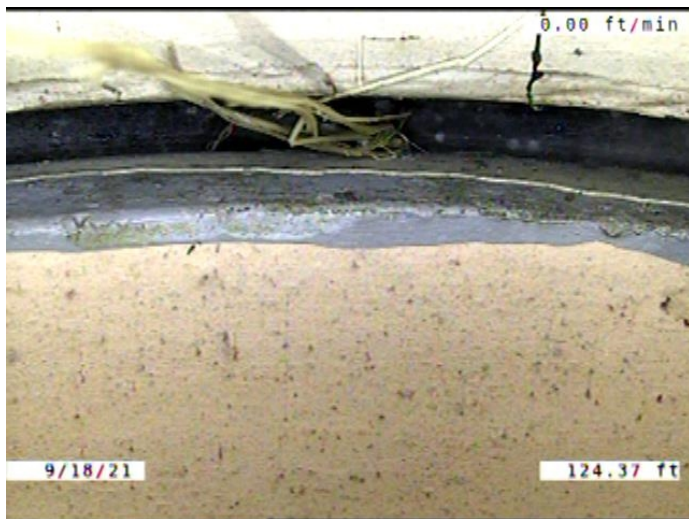
Code: **RFJ**
 Description: **Roots Fine Joint**

Distance (ft): **124.4**
 Structural Grade: **0**
 O&M Grade: **1**
 Clock Start/From: **11**
 Clock To: **2**
 1st Value:
 2nd Value:
 Value Percent:
 Continuous Index:
 Within 8" of Joint: **YES**
 Remarks:

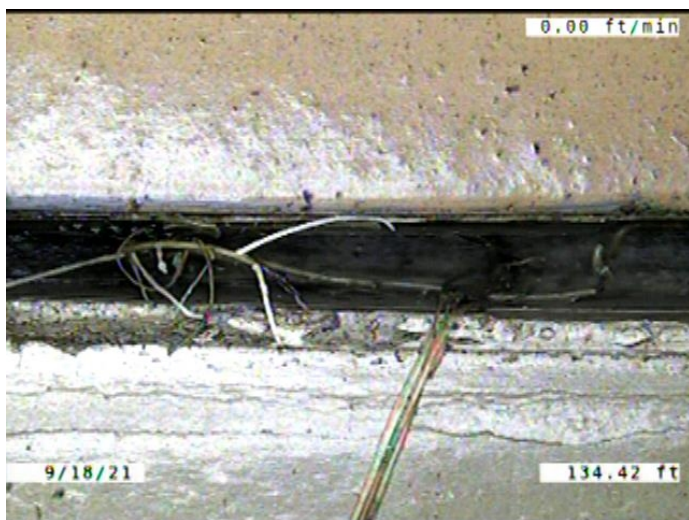
Code: **RFJ**
 Description: **Roots Fine Joint**

Distance (ft): **134.4**
 Structural Grade: **0**
 O&M Grade: **1**
 Clock Start/From: **3**
 Clock To: **5**
 1st Value:
 2nd Value:
 Value Percent:
 Continuous Index:
 Within 8" of Joint: **YES**
 Remarks:

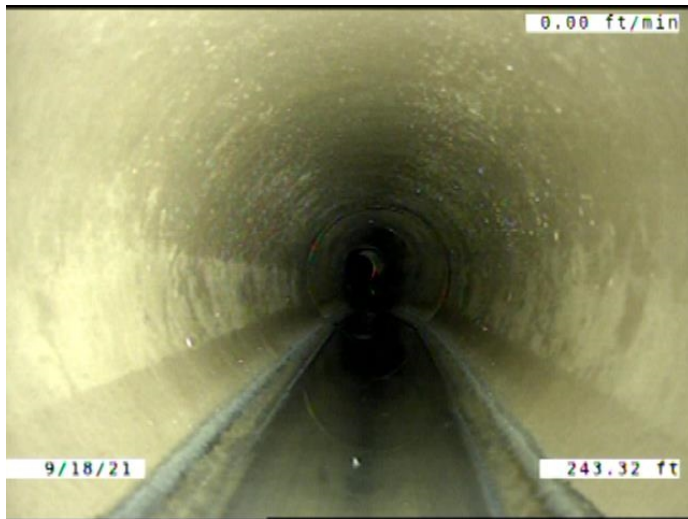
Code: **FM**
Description: **Fracture Multiple**

Distance (ft): **243.3**
Structural Grade: **4**
O&M Grade: **0**
Clock Start/From: **12**
Clock To: **12**
1st Value:
2nd Value:
Value Percent:
Continuous Index: **F05**
Within 8" of Joint: **YES**
Remarks:

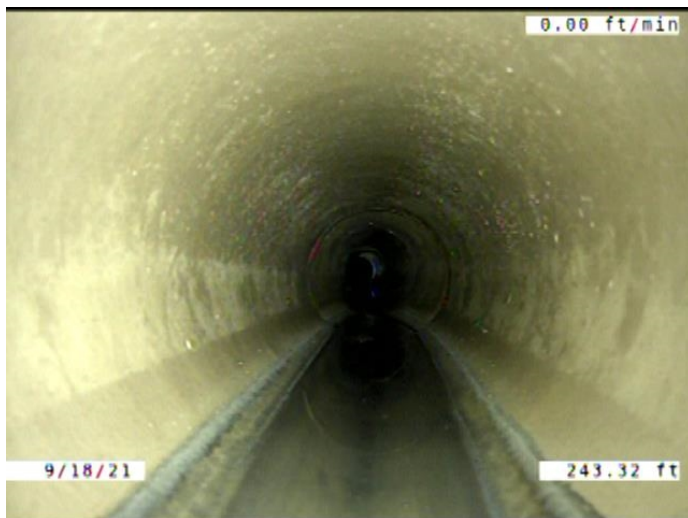
Code: **MWLS**
Description: **Miscellaneous Water Level Sag**

Distance (ft): **243.3**
Structural Grade: **2**
O&M Grade: **0**
Clock Start/From:
Clock To:
1st Value:
2nd Value:
Value Percent: **5.000**
Continuous Index: **S06**
Within 8" of Joint: **NO**
Remarks:

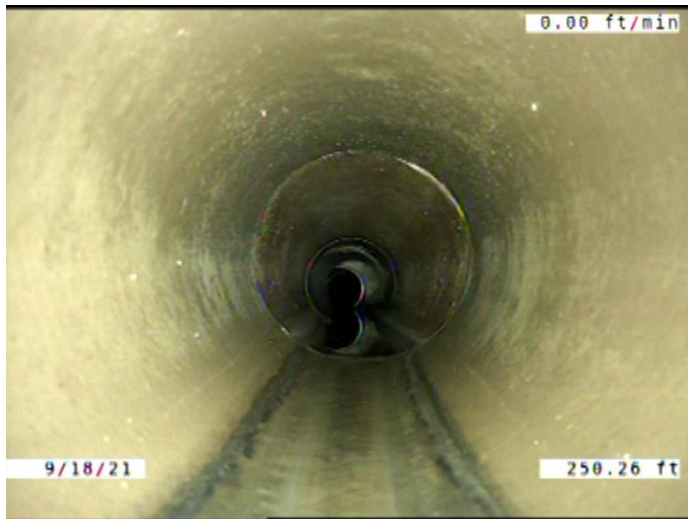
Code: **MWLS**
 Description: **Miscellaneous Water Level Sag**

Distance (ft): **250.3**
 Structural Grade: **2**
 O&M Grade: **0**
 Clock Start/From:
 Clock To:
 1st Value:
 2nd Value:
 Value Percent: **5.000**
 Continuous Index: **F06**
 Within 8" of Joint: **NO**
 Remarks:
