Profile/Photo Observation Report

Street:	W 38TH AVE	Flow Control:	Not Controlled
City:	Hobart, IN	Year Renewed:	
Location:	Other	Tape/Media #:	
Purpose:	Not Known	Dia/Height:	10"
Use:	Sanitary	Material:	VCP
Drain Area:	NA	Lining:	
Category:	NA		
Comment:

Location Details:		Direction of Survey:	Downstream
US MH:	M-503-063	DS MH:	M-503-062
		Total Length Surveyed (ft):	174.0

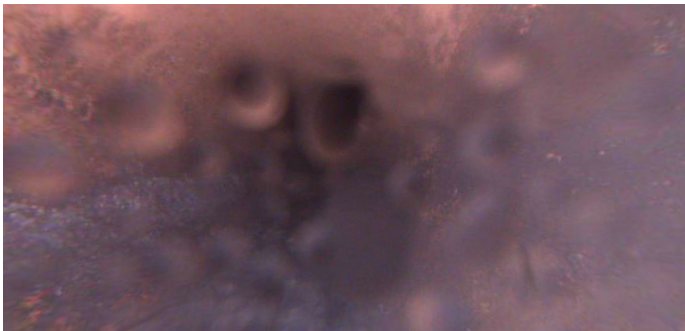
Code: **AMH**
Description: **Manhole**

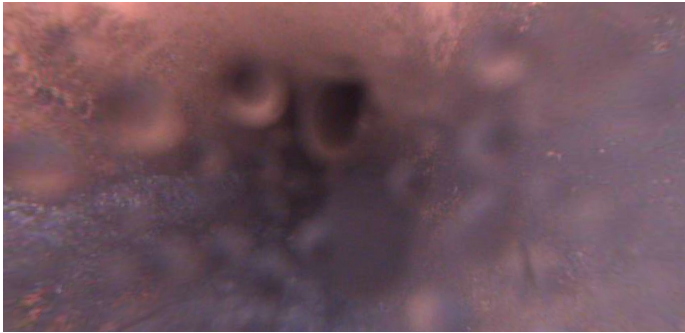
Code:	MWL
Description:	Water Level

Distance (ft):	.0
Structural Grade:	0
O&M Grade:	0
Clock Start/From:	
Clock To:	
1st Value:	
2nd Value:	
Value Percent:	5.000
Continuous Index:	
Within 8" of Joint:	NO
Remarks:

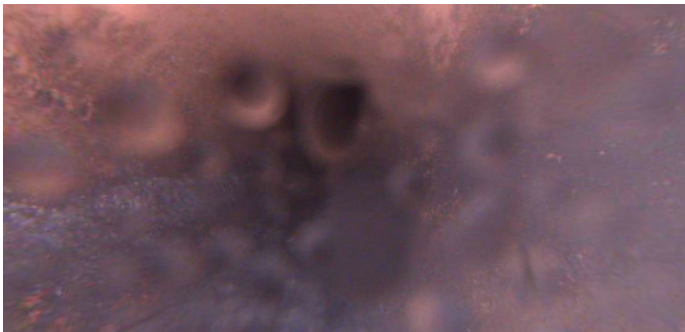
Code:	DAZ
Description:	Deposits Attached Other

Distance (ft):	.0
Structural Grade:	0
O&M Grade:	2
Clock Start/From:	8
Clock To:	4
1st Value:	
2nd Value:	
Value Percent:	5.000
Continuous Index:	S01
Within 8" of Joint:	NO
Remarks:

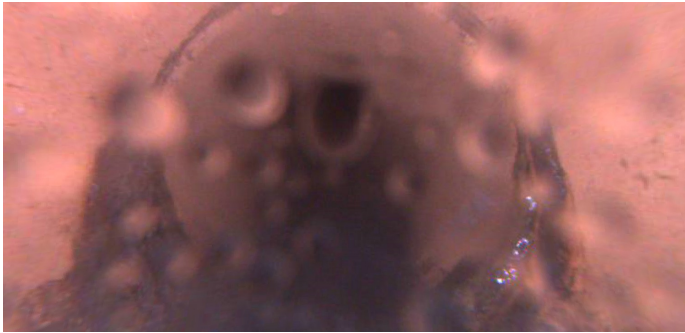
Code: **IW**
Description: **Infil Weeper**

Distance (ft): **4.1**
Structural Grade: **0**
O&M Grade: **2**
Clock Start/From: **8**
Clock To: **4**
1st Value:
2nd Value:
Value Percent:
Continuous Index:
Within 8" of Joint: **YES**
Remarks:

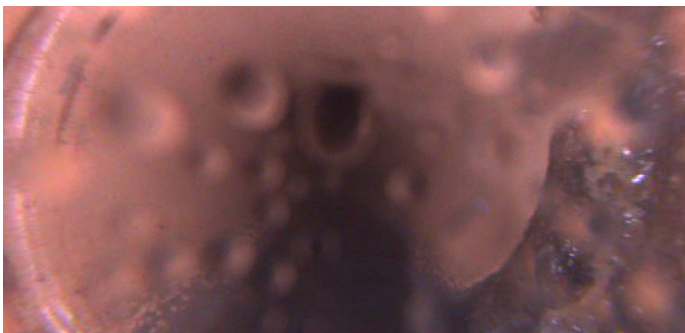
Code: **IW**
Description: **Infil Weeper**

Distance (ft): **14.0**
Structural Grade: **0**
O&M Grade: **2**
Clock Start/From: **1**
Clock To: **4**
1st Value:
2nd Value:
Value Percent:
Continuous Index:
Within 8" of Joint: **YES**
Remarks:

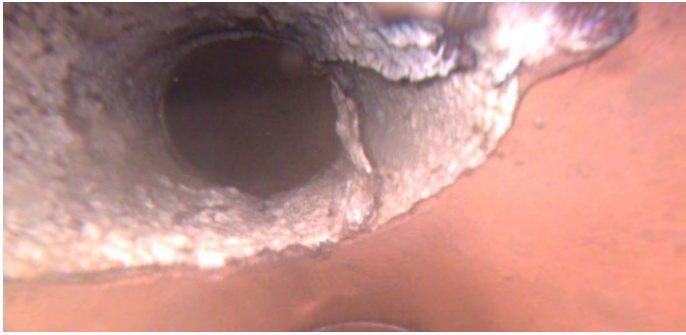
Code: **TFD**
Description: **Tap Factory Defective**

Distance (ft): **39.5**
Structural Grade: **0**
O&M Grade: **2**
Clock Start/From: **12**
Clock To:
1st Value: **4.000**
2nd Value:
Value Percent:
Continuous Index:
Within 8" of Joint:
Remarks: **DAE**

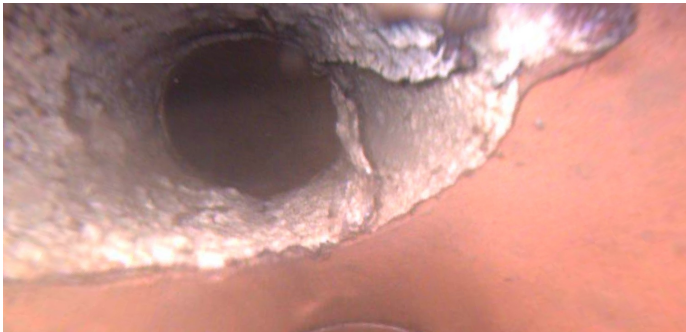
Code: **DAE**
Description: **Deposits Attached Encrustation**

Distance (ft): **39.5**
Structural Grade: **0**
O&M Grade: **2**
Clock Start/From: **11**
Clock To: **12**
1st Value:
2nd Value:
Value Percent: **5.000**
Continuous Index:
Within 8" of Joint: **NO**
Remarks:

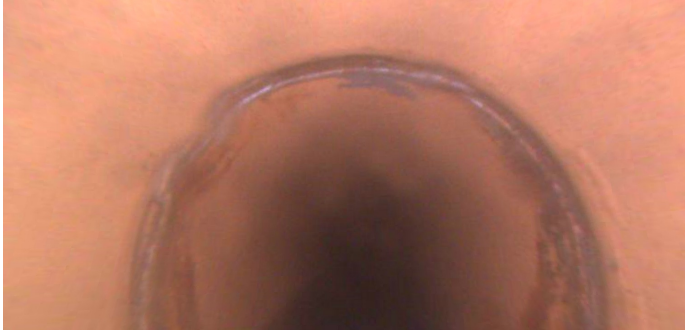
Code: **IW**
Description: **Infil Weeper**

Distance (ft): **75.7**
Structural Grade: **0**
O&M Grade: **2**
Clock Start/From: **8**
Clock To: **4**
1st Value:
2nd Value:
Value Percent:
Continuous Index: **S02**
Within 8" of Joint: **YES**
Remarks:

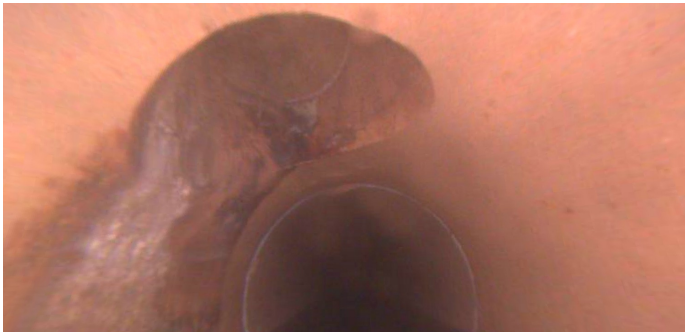
Code: **TF**
Description: **Tap Factory**

Distance (ft): **96.1**
Structural Grade: **0**
O&M Grade: **0**
Clock Start/From: **1**
Clock To:
1st Value: **4.000**
2nd Value:
Value Percent:
Continuous Index:
Within 8" of Joint:
Remarks:

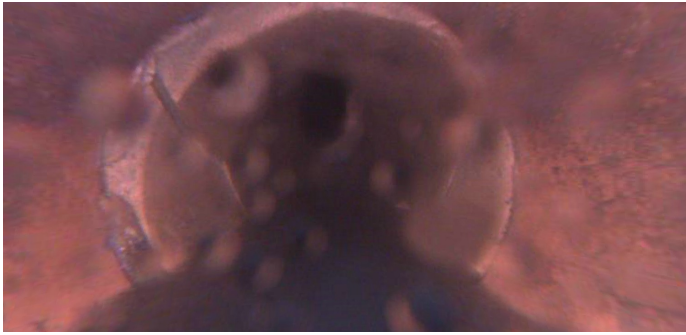
Code: **FS**
Description: **Fracture Spiral**

Distance (ft): **170.7**
Structural Grade: **3**
O&M Grade: **0**
Clock Start/From: **2**
Clock To: **10**
1st Value:
2nd Value:
Value Percent:
Continuous Index:
Within 8" of Joint: **YES**
Remarks:

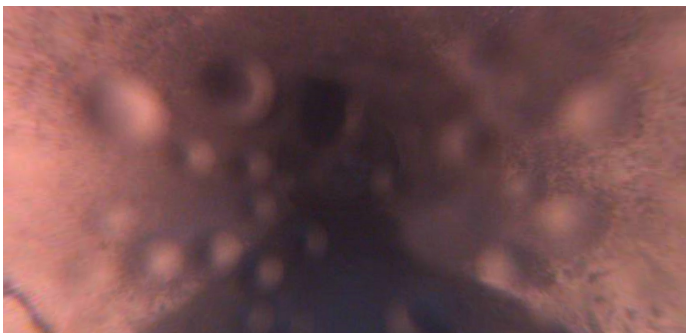
Code: **IW**
Description: **Infil Weeper**

Distance (ft): **171.5**
Structural Grade: **0**
O&M Grade: **2**
Clock Start/From: **8**
Clock To: **4**
1st Value:
2nd Value:
Value Percent:
Continuous Index: **F02**
Within 8" of Joint: **YES**
Remarks:

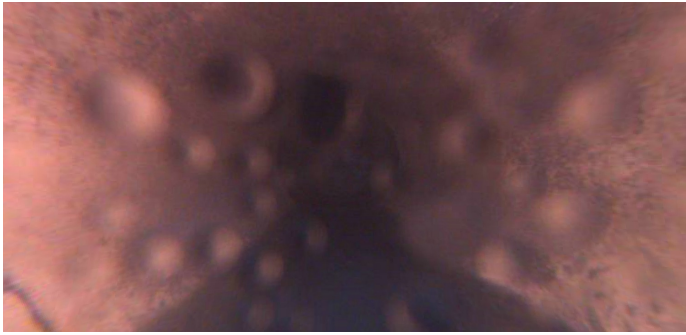
Code: **DAZ**
Description: **Deposits Attached Other**

Distance (ft): **171.5**
Structural Grade: **0**
O&M Grade: **2**
Clock Start/From: **8**
Clock To: **4**
1st Value:
2nd Value:
Value Percent: **5.000**
Continuous Index: **F01**
Within 8" of Joint: **NO**
Remarks:
