Profile/Photo Observation Report

Date:	04/14/2018	Weather:		Coding:	PACP 6.0
Pipe Length (ft):	180.6	Owner:	NA	Pre Clean:	Not Known
P.O.#:		Surveyor:	Jen Costello	PSR:	P-503-062-063
Customer:		Clean Date:	01/01/1900	Shape:	C

Street:	W 40th ave	Flow Control:	Not Controlled
City:	Hobart, IN	Year Renewed:	
Location:	Other	Tape/Media #:	
Purpose:	Not Known	Dia/Height:	10"
Use:	Sanitary	Material:	VCP
Drain Area:	NA	Lining:	
Category:	NA		
Comment:

Location Details:		Direction of Survey:	Downstream
US MH:	M-503-063	DS MH:	M-503-062
		Total Length Surveyed (ft):	174.0

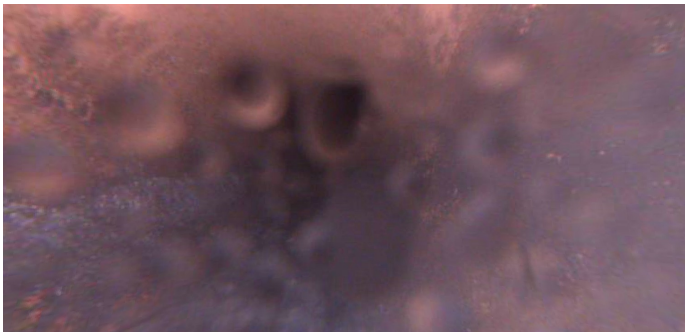
Code:	DAZ
Description:	Deposits Attached Other

Distance (ft):	.0
Structural Grade:	0
O&M Grade:	2
Clock Start/From:	8
Clock To:	4
1st Value:	
2nd Value:	
Value Percent:	5.000
Continuous Index:	S01
Within 8" of Joint:	NO
Remarks:

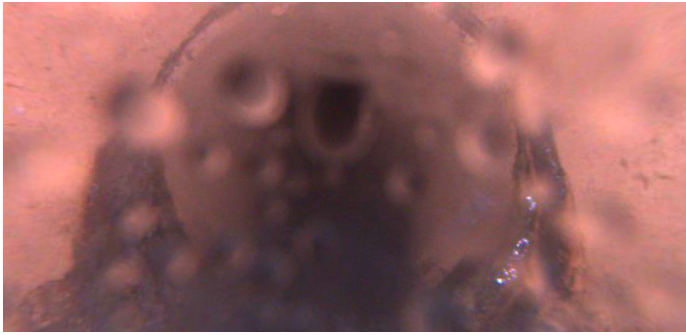
Code: **IW**
Description: **Infil Weeper**

Distance (ft): **4.1**
Structural Grade: **0**
O&M Grade: **2**
Clock Start/From: **8**
Clock To: **4**
1st Value:
2nd Value:
Value Percent:
Continuous Index:
Within 8" of Joint: **YES**
Remarks:

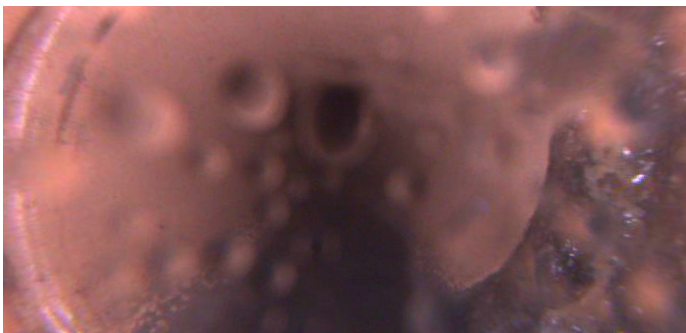
Code: **IW**
Description: **Infil Weeper**

Distance (ft): **14.0**
Structural Grade: **0**
O&M Grade: **2**
Clock Start/From: **1**
Clock To: **4**
1st Value:
2nd Value:
Value Percent:
Continuous Index:
Within 8" of Joint: **YES**
Remarks:

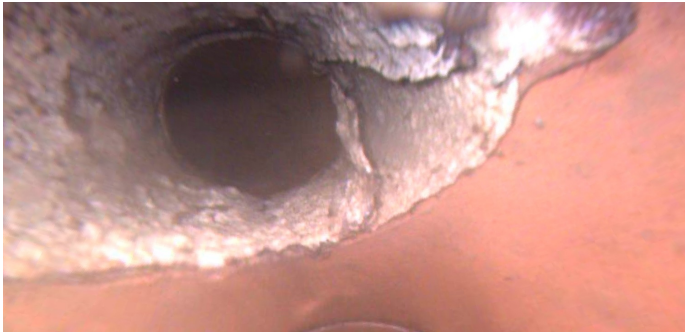
Code: **TFD**
Description: **Tap Factory Defective**

Distance (ft): **39.5**
Structural Grade: **0**
O&M Grade: **2**
Clock Start/From: **12**
Clock To:
1st Value: **4.000**
2nd Value:
Value Percent:
Continuous Index:
Within 8" of Joint:
Remarks: **DAE**

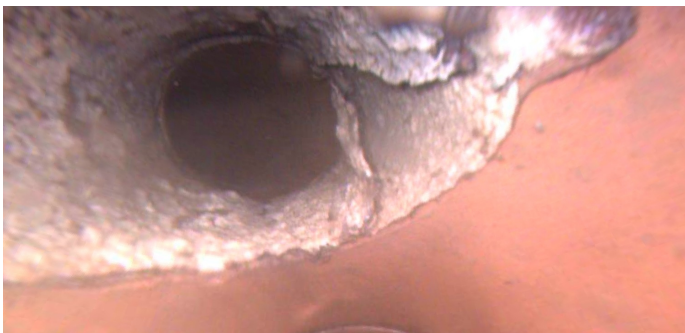
Code: **DAE**
Description: **Deposits Attached Encrustation**

Distance (ft): **39.5**
Structural Grade: **0**
O&M Grade: **2**
Clock Start/From: **11**
Clock To: **12**
1st Value:
2nd Value:
Value Percent: **5.000**
Continuous Index:
Within 8" of Joint: **NO**
Remarks:

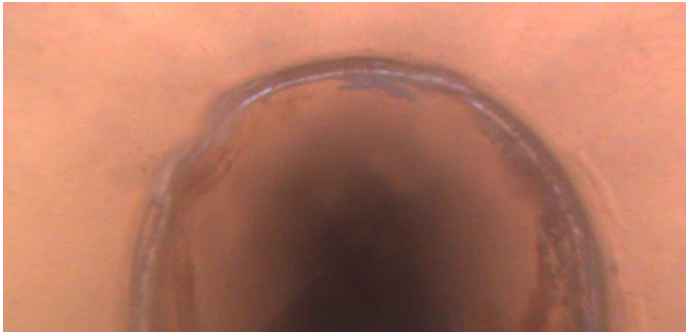
Code: **IW**
Description: **Infil Weeper**

Distance (ft): **75.7**
Structural Grade: **0**
O&M Grade: **2**
Clock Start/From: **8**
Clock To: **4**
1st Value:
2nd Value:
Value Percent:
Continuous Index: **S02**
Within 8" of Joint: **YES**
Remarks:

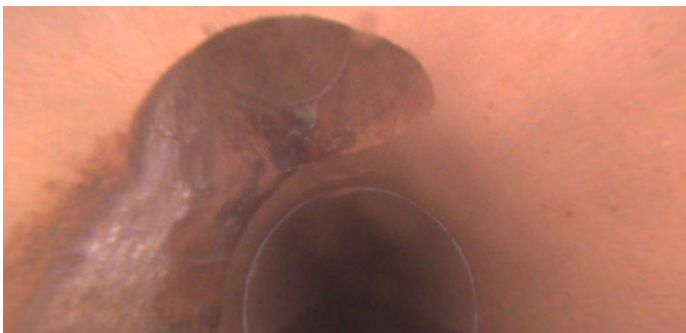
Code: **TF**
Description: **Tap Factory**

Distance (ft): **96.1**
Structural Grade: **0**
O&M Grade: **0**
Clock Start/From: **1**
Clock To:
1st Value: **4.000**
2nd Value:
Value Percent:
Continuous Index:
Within 8" of Joint:
Remarks:

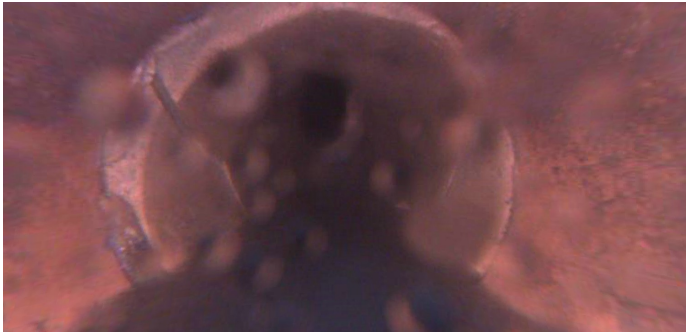
Code: **FS**
Description: **Fracture Spiral**

Distance (ft): **170.7**
Structural Grade: **3**
O&M Grade: **0**
Clock Start/From: **2**
Clock To: **10**
1st Value:
2nd Value:
Value Percent:
Continuous Index:
Within 8" of Joint: **YES**
Remarks:

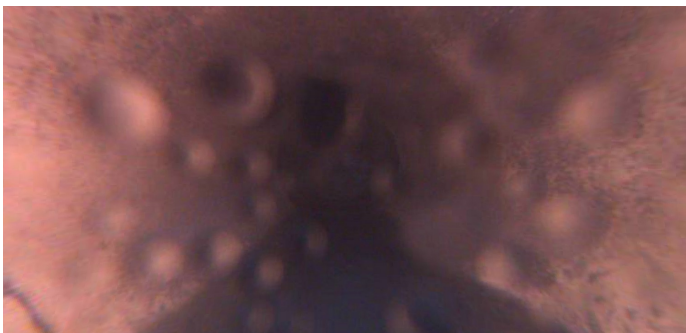
Code: **IW**
Description: **Infil Weeper**

Distance (ft): **171.5**
Structural Grade: **0**
O&M Grade: **2**
Clock Start/From: **8**
Clock To: **4**
1st Value:
2nd Value:
Value Percent:
Continuous Index: **F02**
Within 8" of Joint: **YES**
Remarks:

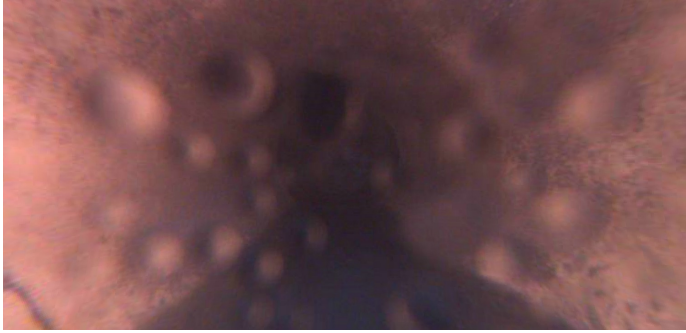
Code: **DAZ**
Description: **Deposits Attached Other**

Distance (ft): **171.5**
Structural Grade: **0**
O&M Grade: **2**
Clock Start/From: **8**
Clock To: **4**
1st Value:
2nd Value:
Value Percent: **5.000**
Continuous Index: **F01**
Within 8" of Joint: **NO**
Remarks:
