## Profile/Photo Observation Report

Street:	<b>N WISCONSIN ST &amp; W 38TH AVE</b>	Flow Control:	<b>Not Controlled</b>
City:	<b>Hobart, IN</b>	Year Renewed:	
Location:	<b>Other</b>	Tape/Media #:	
Purpose:	<b>Not Known</b>	Dia/Height:	<b>12"</b>
Use:	<b>Sanitary</b>	Material:	<b>VCP</b>
Drain Area:	<b>NA</b>	Lining:	
Category:	<b>NA</b>		
Comment:

Location Details:		Direction of Survey:	<b>Downstream</b>
US MH:	<b>M-503-063</b>	DS MH:	<b>M-503-064</b>
		Total Length Surveyed (ft):	<b>7.5</b>

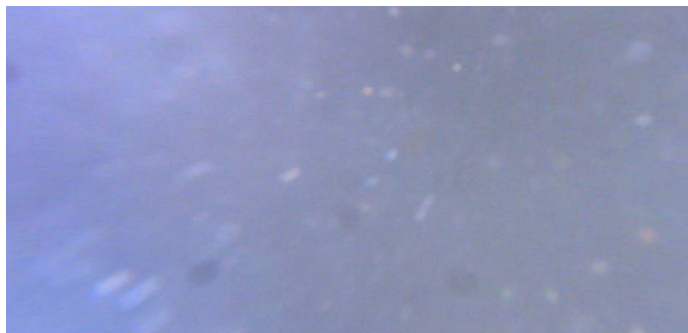
Code: **AMH**  
Description: **Manhole**

Distance (ft): **.0**  
Structural Grade: **0**  
O&M Grade: **0**  
Clock Start/From:  
Clock To:  
1st Value:  
2nd Value:  
Value Percent:  
Continuous Index:  
Within 8" of Joint: **NO**  
Remarks: **M-503-063**

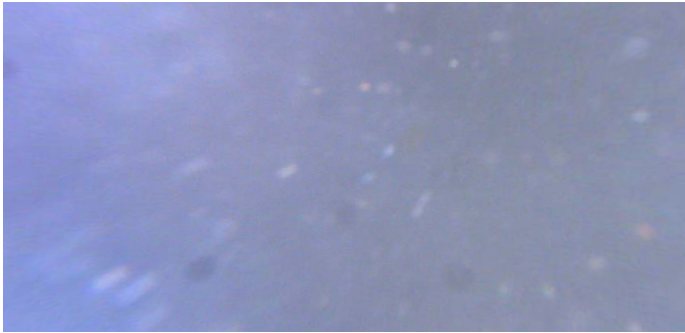
Code:	<b>MWL</b>
Description:	<b>Water Level</b>

Distance (ft):	<b>.0</b>
Structural Grade:	<b>0</b>
O&M Grade:	<b>0</b>
Clock Start/From:	
Clock To:	
1st Value:	
2nd Value:	
Value Percent:	<b>100.000</b>
Continuous Index:	
Within 8" of Joint:	<b>NO</b>
Remarks:

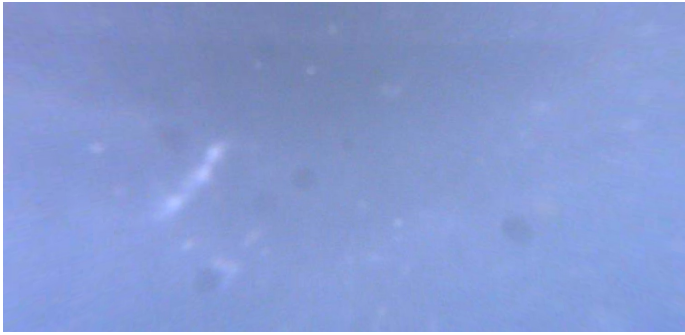
Code: **MCU**  
Description: **Camera Underwater**

Distance (ft): **7.5**  
Structural Grade: **0**  
O&M Grade: **4**  
Clock Start/From:  
Clock To:  
1st Value:  
2nd Value:  
Value Percent:  
Continuous Index:  
Within 8" of Joint: **NO**  
Remarks:

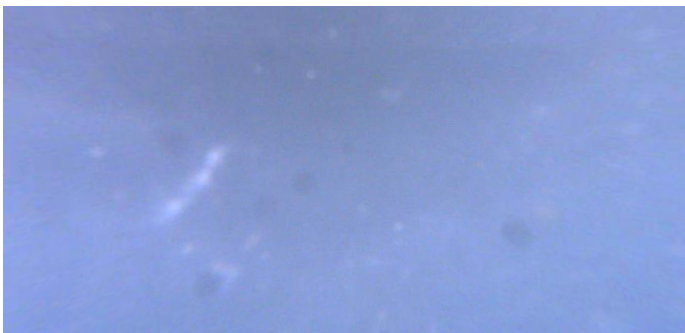
Code: **MSA**  
Description: **Abandoned Survey**

Distance (ft): **7.5**  
Structural Grade: **0**  
O&M Grade: **0**  
Clock Start/From:  
Clock To:  
1st Value:  
2nd Value:  
Value Percent:  
Continuous Index:  
Within 8" of Joint: **NO**  
Remarks: **MCU**
