Profile/Photo Observation Report

Street:	W 40th ave	Flow Control:	Not Controlled
City:	Hobart, IN	Year Renewed:	
Location:	Other	Tape/Media #:	
Purpose:	Not Known	Dia/Height:	12"
Use:	Sanitary	Material:	VCP
Drain Area:	NA	Lining:	
Category:	NA		
Comment:

Location Details:		Direction of Survey:	Downstream
US MH:	M-503-063	DS MH:	M-503-064
		Total Length Surveyed (ft):	7.5

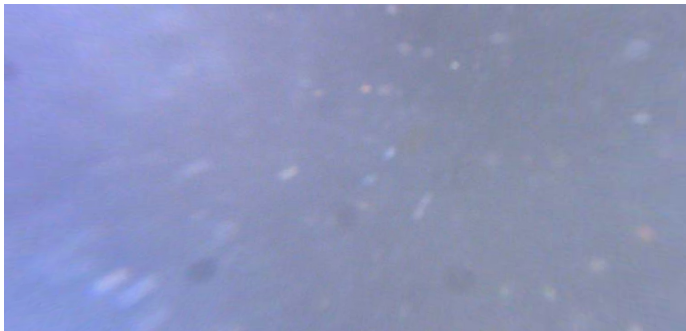
Code: **AMH**
Description: **Manhole**

Distance (ft): **.0**
Structural Grade: **0**
O&M Grade: **0**
Clock Start/From:
Clock To:
1st Value:
2nd Value:
Value Percent:
Continuous Index:
Within 8" of Joint: **NO**
Remarks: **M-503-063**

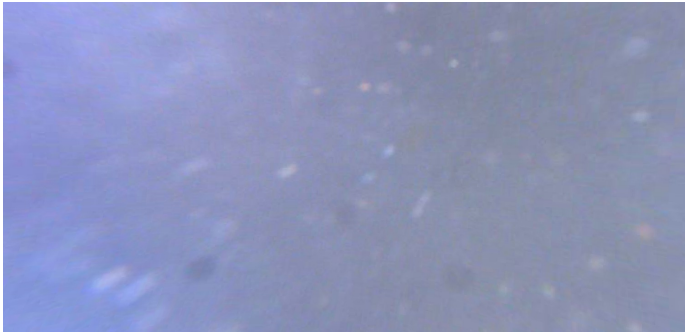
Code:	MWL
Description:	Water Level

Distance (ft):	.0
Structural Grade:	0
O&M Grade:	0
Clock Start/From:	
Clock To:	
1st Value:	
2nd Value:	
Value Percent:	100.000
Continuous Index:	
Within 8" of Joint:	NO
Remarks:

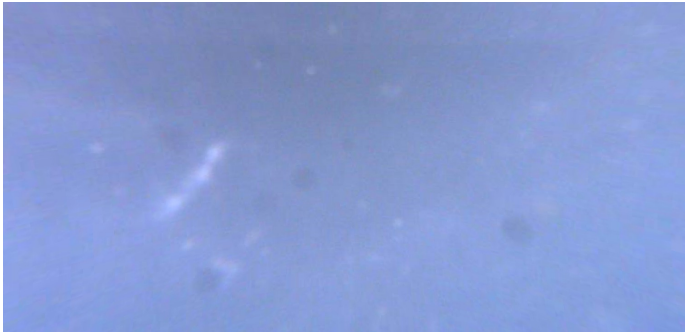
Code: **MCU**
Description: **Camera Underwater**

Distance (ft): **7.5**
Structural Grade: **0**
O&M Grade: **4**
Clock Start/From:
Clock To:
1st Value:
2nd Value:
Value Percent:
Continuous Index:
Within 8" of Joint: **NO**
Remarks:

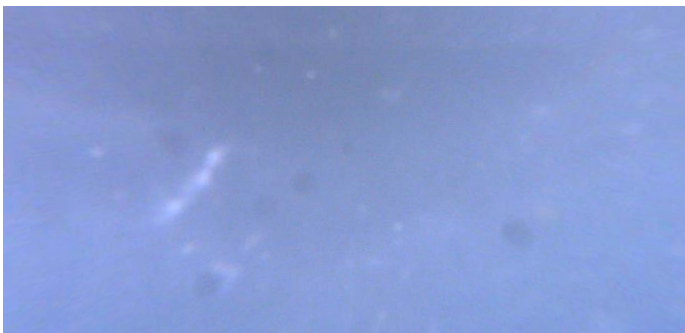
Code: **MSA**
Description: **Abandoned Survey**

Distance (ft): **7.5**
Structural Grade: **0**
O&M Grade: **0**
Clock Start/From:
Clock To:
1st Value:
2nd Value:
Value Percent:
Continuous Index:
Within 8" of Joint: **NO**
Remarks: **MCU**
