Profile/Photo Observation Report

Street:	N WISCONSIN ST & W 38TH AVE	Flow Control:	Not Controlled
City:	Hobart, IN	Year Renewed:	
Location:	Other	Tape/Media #:	
Purpose:	Not Known	Dia/Height:	12"
Use:	Sanitary	Material:	VCP
Drain Area:	NA	Lining:	
Category:	NA		
Comment:

Location Details:		Direction of Survey:	Downstream
US MH:	M-503-063	DS MH:	M-503-064
		Total Length Surveyed (ft):	141.0

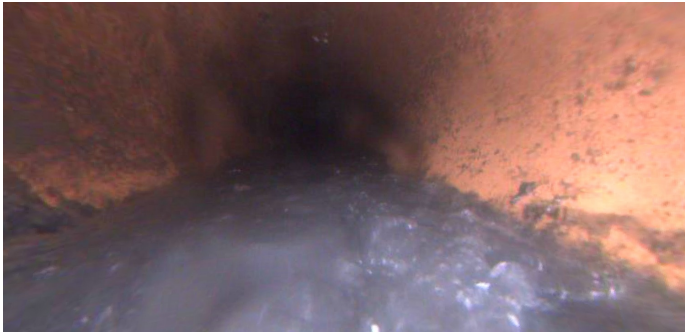
Code:	MWL
Description:	Water Level

Distance (ft):	.0
Structural Grade:	0
O&M Grade:	0
Clock Start/From:	
Clock To:	
1st Value:	
2nd Value:	
Value Percent:	20.000
Continuous Index:	
Within 8" of Joint:	NO
Remarks:

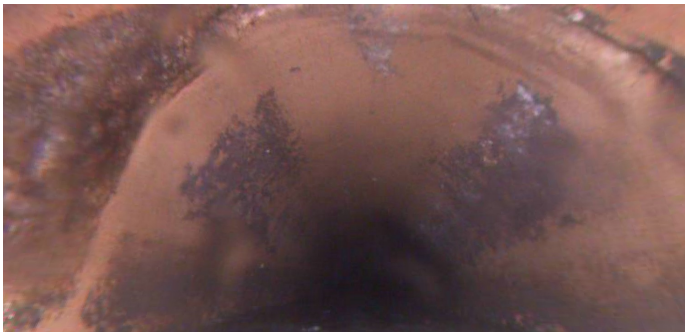
Code:	IW
Description:	Infil Weeper

Distance (ft):	20.5
Structural Grade:	0
O&M Grade:	2
Clock Start/From:	8
Clock To:	12
1st Value:	
2nd Value:	
Value Percent:	
Continuous Index:	
Within 8" of Joint:	YES
Remarks:

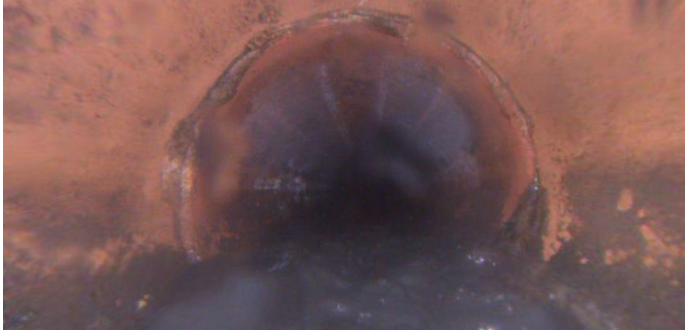
Code: **IW**
Description: **Infil Weeper**

Distance (ft): **28.3**
Structural Grade: **0**
O&M Grade: **2**
Clock Start/From: **8**
Clock To: **4**
1st Value:
2nd Value:
Value Percent:
Continuous Index:
Within 8" of Joint: **YES**
Remarks:

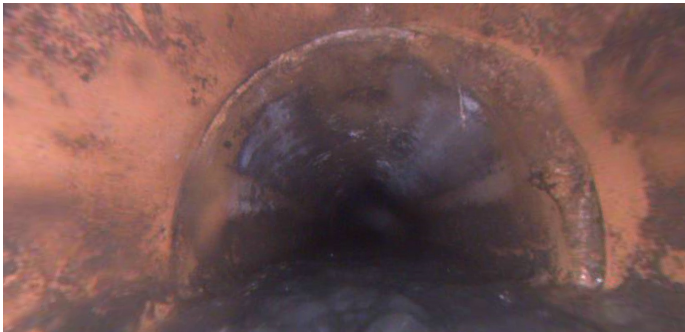
Code: **DAE**
Description: **Deposits Attached Encrustation**

Distance (ft): **40.7**
Structural Grade: **0**
O&M Grade: **2**
Clock Start/From: **12**
Clock To: **4**
1st Value:
2nd Value:
Value Percent: **5.000**
Continuous Index:
Within 8" of Joint: **YES**
Remarks:

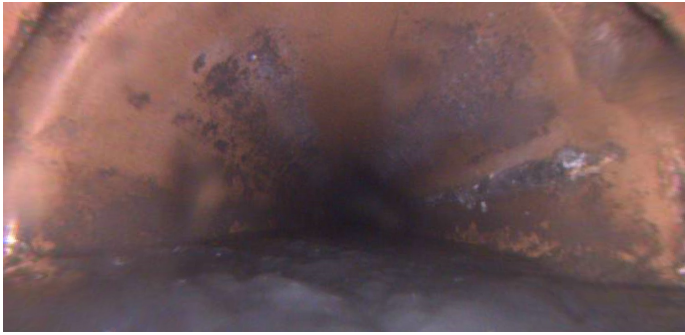
Code: **DAGS**
Description: **Deposits Attached Grease**

Distance (ft): **45.2**
Structural Grade: **0**
O&M Grade: **2**
Clock Start/From: **8**
Clock To: **4**
1st Value:
2nd Value:
Value Percent: **5.000**
Continuous Index: **S01**
Within 8" of Joint: **NO**
Remarks:

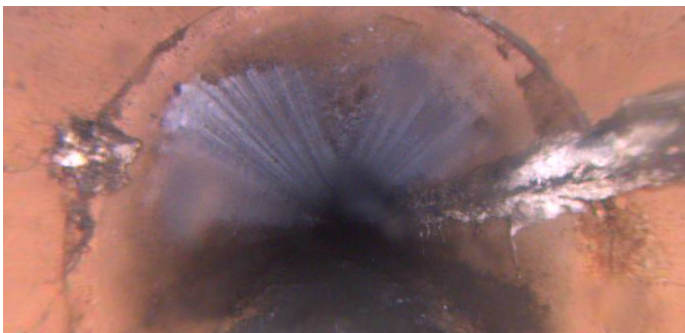
Code: **RFJ**
Description: **Roots Fine Joint**

Distance (ft): **61.7**
Structural Grade: **0**
O&M Grade: **1**
Clock Start/From: **9**
Clock To:
1st Value:
2nd Value:
Value Percent:
Continuous Index:
Within 8" of Joint: **YES**
Remarks:

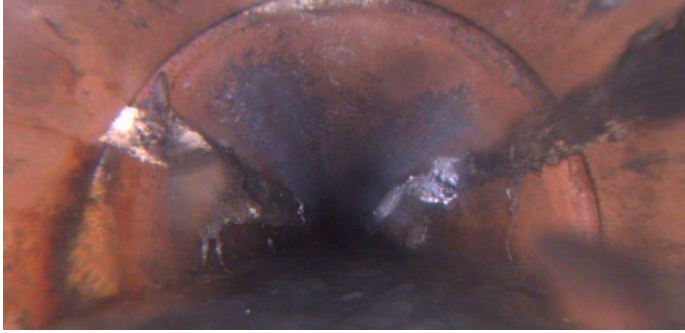
Code: **IW**
Description: **Infil Weeper**

Distance (ft): **90.4**
Structural Grade: **0**
O&M Grade: **2**
Clock Start/From: **8**
Clock To: **10**
1st Value:
2nd Value:
Value Percent:
Continuous Index:
Within 8" of Joint: **YES**
Remarks:

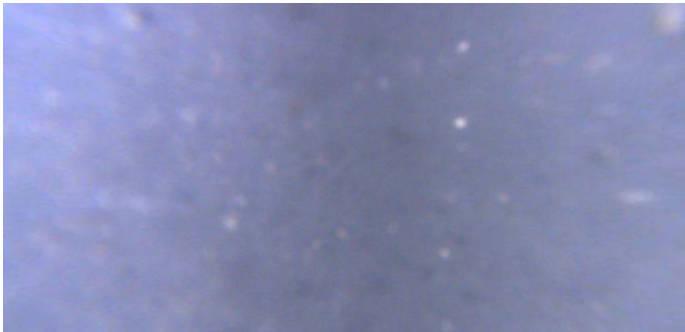
Code: **DAGS**
Description: **Deposits Attached Grease**

Distance (ft): **123.9**
Structural Grade: **0**
O&M Grade: **2**
Clock Start/From: **8**
Clock To: **4**
1st Value:
2nd Value:
Value Percent: **5.000**
Continuous Index: **F01**
Within 8" of Joint: **NO**
Remarks:

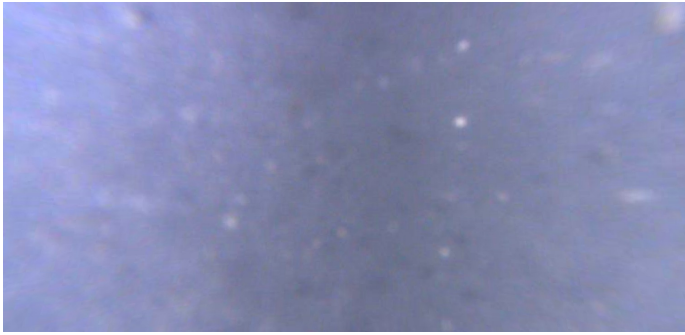
Code: **MWL**
Description: **Water Level**

Distance (ft): **123.9**
Structural Grade: **0**
O&M Grade: **0**
Clock Start/From:
Clock To:
1st Value:
2nd Value:
Value Percent: **100.000**
Continuous Index:
Within 8" of Joint: **NO**
Remarks:

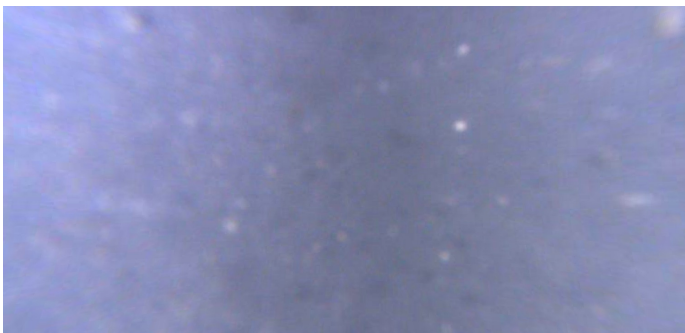
Code: **MCU**
Description: **Camera Underwater**

Distance (ft): **123.9**
Structural Grade: **0**
O&M Grade: **4**
Clock Start/From:
Clock To:
1st Value:
2nd Value:
Value Percent:
Continuous Index: **S02**
Within 8" of Joint: **NO**
Remarks:

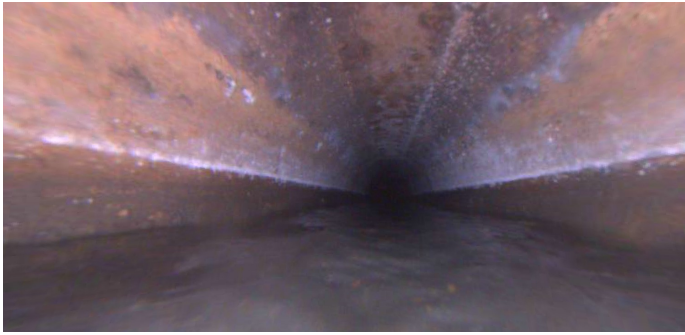
Code: **MCU**
Description: **Camera Underwater**

Distance (ft): **132.8**
Structural Grade: **0**
O&M Grade: **4**
Clock Start/From:
Clock To:
1st Value:
2nd Value:
Value Percent:
Continuous Index: **F02**
Within 8" of Joint: **NO**
Remarks:
