## Profile/Photo Observation Report

Date:	<b>04/14/2018</b>	Weather:		Coding:	<b>PACP 6.0</b>
Pipe Length (ft):	<b>156.5</b>	Owner:	<b>NA</b>	Pre Clean:	<b>Not Known</b>
P.O.#:		Surveyor:	<b>Jen Costello</b>	PSR:	<b>P-503-064-065</b>
Customer:		Clean Date:	<b>01/01/1900</b>	Shape:	<b>C</b>

Street:	<b>N WISCONSIN ST</b>	Flow Control:	<b>Not Controlled</b>
City:	<b>Hobart, IN</b>	Year Renewed:	
Location:	<b>Other</b>	Tape/Media #:	
Purpose:	<b>Not Known</b>	Dia/Height:	<b>12"</b>
Use:	<b>Sanitary</b>	Material:	<b>VCP</b>
Drain Area:	<b>NA</b>	Lining:	
Category:	<b>NA</b>		
Comment:

Location Details:		Direction of Survey:	<b>Downstream</b>
US MH:	<b>M-503-064</b>	DS MH:	<b>M-503-065</b>
		Total Length Surveyed (ft):	<b>155.0</b>

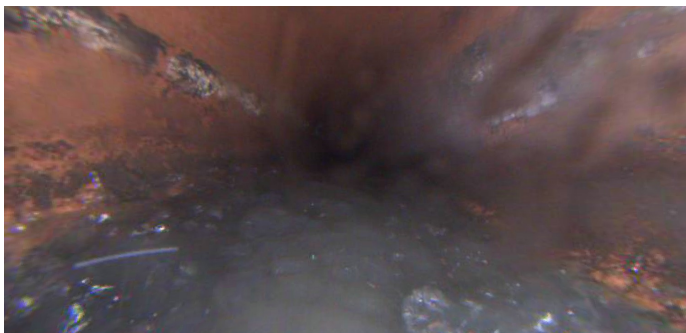
Code: **AMH**  
Description: **Manhole**

Distance (ft): **.0**  
Structural Grade: **0**  
O&M Grade: **0**  
Clock Start/From:  
Clock To:  
1st Value:  
2nd Value:  
Value Percent:  
Continuous Index:  
Within 8" of Joint: **NO**  
Remarks: **M-503-064**

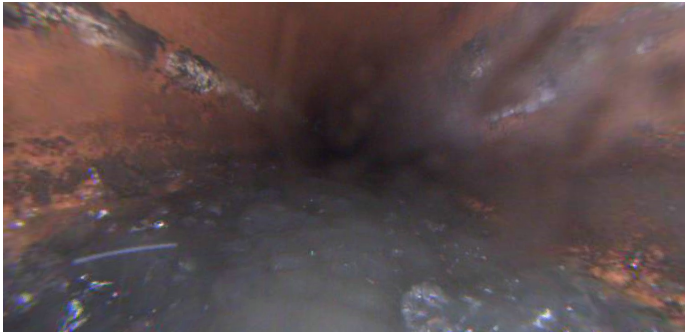
Code:	<b>MWL</b>
Description:	<b>Water Level</b>

Distance (ft):	<b>.0</b>
Structural Grade:	<b>0</b>
O&M Grade:	<b>0</b>
Clock Start/From:	
Clock To:	
1st Value:	
2nd Value:	
Value Percent:	<b>30.000</b>
Continuous Index:	
Within 8" of Joint:	<b>NO</b>
Remarks:

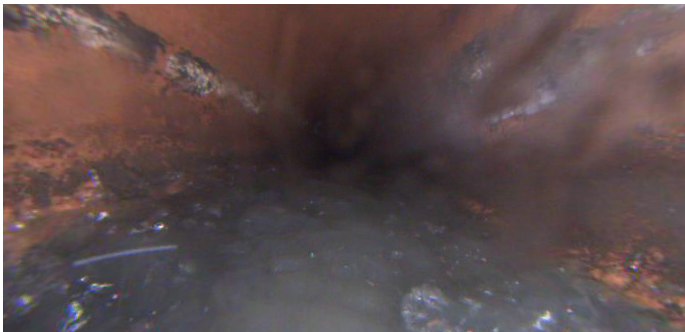
Code:	<b>DAGS</b>
Description:	<b>Deposits Attached Grease</b>

Distance (ft):	<b>.0</b>
Structural Grade:	<b>0</b>
O&M Grade:	<b>2</b>
Clock Start/From:	<b>8</b>
Clock To:	<b>4</b>
1st Value:	
2nd Value:	
Value Percent:	<b>5.000</b>
Continuous Index:	<b>S01</b>
Within 8" of Joint:	<b>NO</b>
Remarks:

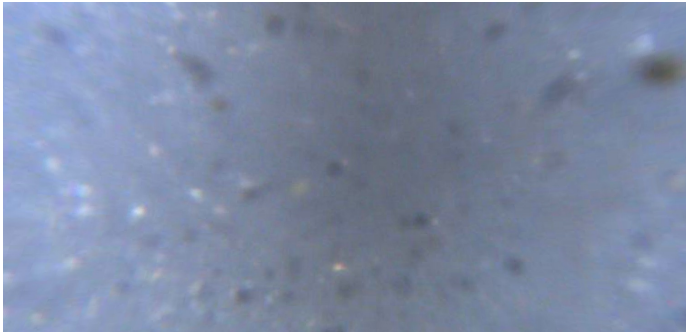
Code: **DAGS**  
Description: **Deposits Attached Grease**

Distance (ft): **88.2**  
Structural Grade: **0**  
O&M Grade: **2**  
Clock Start/From: **8**  
Clock To: **4**  
1st Value:  
2nd Value:  
Value Percent: **5.000**  
Continuous Index: **F01**  
Within 8" of Joint: **NO**  
Remarks:

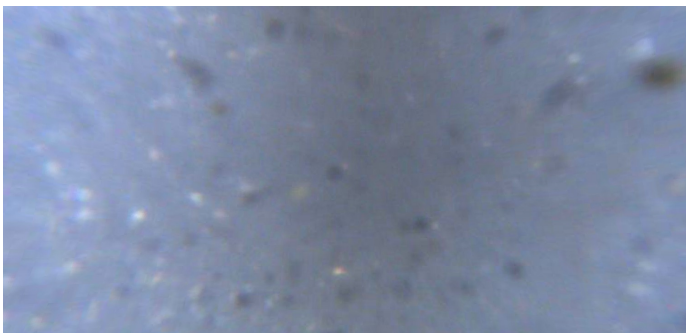
Code: **MWL**  
Description: **Water Level**

Distance (ft): **88.2**  
Structural Grade: **0**  
O&M Grade: **0**  
Clock Start/From:  
Clock To:  
1st Value:  
2nd Value:  
Value Percent: **100.000**  
Continuous Index:  
Within 8" of Joint: **NO**  
Remarks:

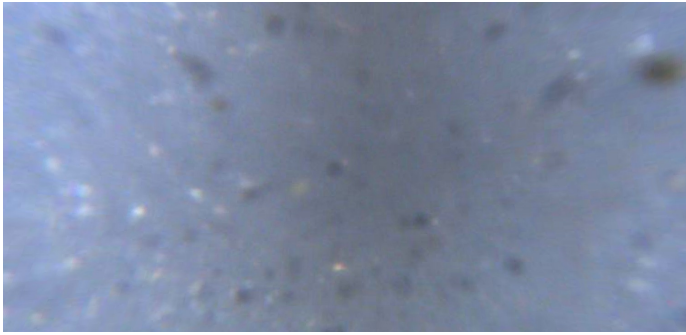
Code: **MCU**  
Description: **Camera Underwater**

Distance (ft): **88.2**  
Structural Grade: **0**  
O&M Grade: **4**  
Clock Start/From:  
Clock To:  
1st Value:  
2nd Value:  
Value Percent:  
Continuous Index: **S02**  
Within 8" of Joint: **NO**  
Remarks:

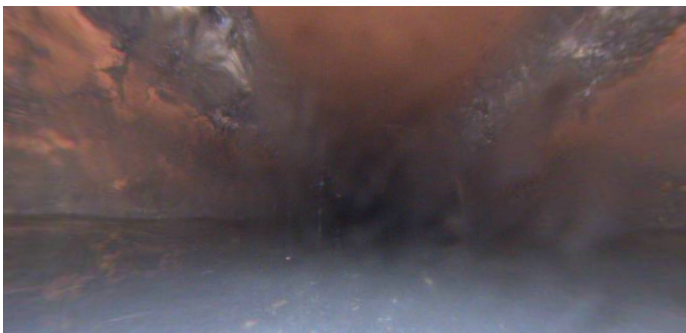
Code: **MCU**  
Description: **Camera Underwater**

Distance (ft): **94.3**  
Structural Grade: **0**  
O&M Grade: **4**  
Clock Start/From:  
Clock To:  
1st Value:  
2nd Value:  
Value Percent:  
Continuous Index: **F02**  
Within 8" of Joint: **NO**  
Remarks:

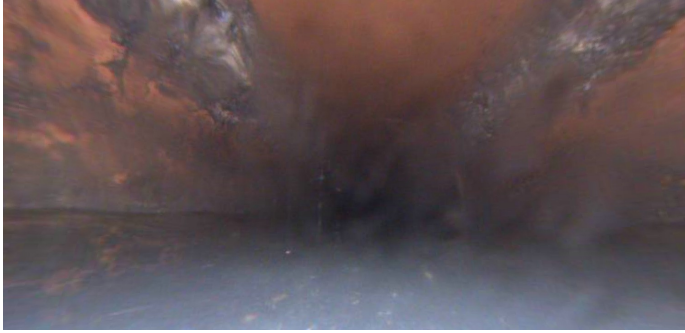
Code: **MWL**  
Description: **Water Level**

Distance (ft): **94.3**  
Structural Grade: **0**  
O&M Grade: **0**  
Clock Start/From:  
Clock To:  
1st Value:  
2nd Value:  
Value Percent: **40.000**  
Continuous Index:  
Within 8" of Joint: **NO**  
Remarks:

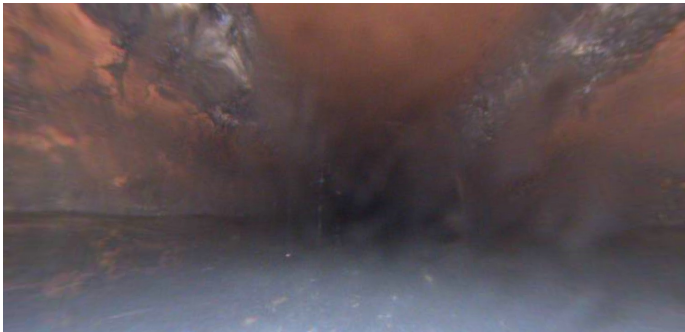
Code: **DAGS**  
Description: **Deposits Attached Grease**

Distance (ft): **94.3**  
Structural Grade: **0**  
O&M Grade: **2**  
Clock Start/From: **8**  
Clock To: **4**  
1st Value:  
2nd Value:  
Value Percent: **10.000**  
Continuous Index: **S03**  
Within 8" of Joint: **NO**  
Remarks:

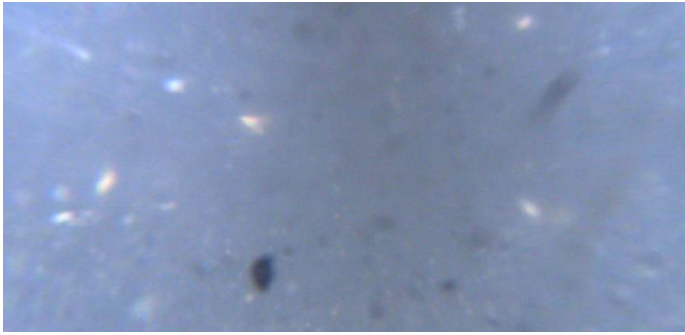
Code: **DAGS**  
Description: **Deposits Attached Grease**

Distance (ft): **100.0**  
Structural Grade: **0**  
O&M Grade: **2**  
Clock Start/From: **8**  
Clock To: **4**  
1st Value:  
2nd Value:  
Value Percent: **10.000**  
Continuous Index: **F03**  
Within 8" of Joint: **NO**  
Remarks:

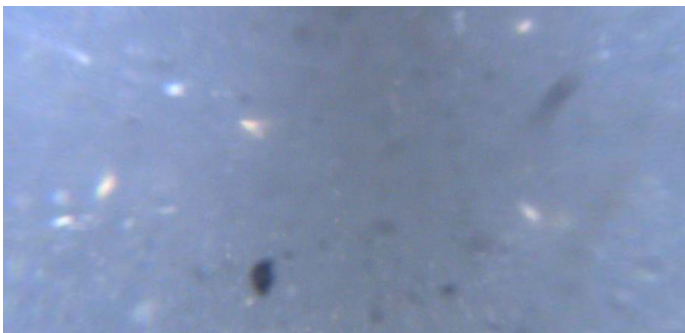
Code: **MWL**  
Description: **Water Level**

Distance (ft): **100.0**  
Structural Grade: **0**  
O&M Grade: **0**  
Clock Start/From:  
Clock To:  
1st Value:  
2nd Value:  
Value Percent: **100.000**  
Continuous Index:  
Within 8" of Joint: **NO**  
Remarks:

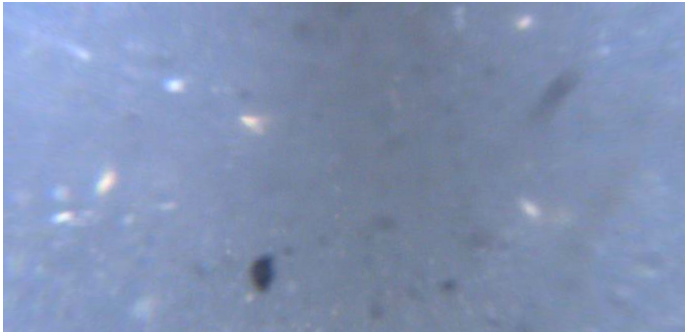
Code: **MCU**  
Description: **Camera Underwater**

Distance (ft): **100.0**  
Structural Grade: **0**  
O&M Grade: **4**  
Clock Start/From:  
Clock To:  
1st Value:  
2nd Value:  
Value Percent:  
Continuous Index: **S04**  
Within 8" of Joint: **NO**  
Remarks:

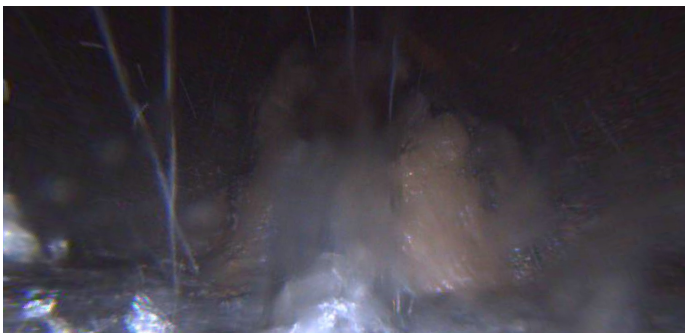
Code: **MCU**  
Description: **Camera Underwater**

Distance (ft): **155.0**  
Structural Grade: **0**  
O&M Grade: **4**  
Clock Start/From:  
Clock To:  
1st Value:  
2nd Value:  
Value Percent:  
Continuous Index: **F04**  
Within 8" of Joint: **NO**  
Remarks:

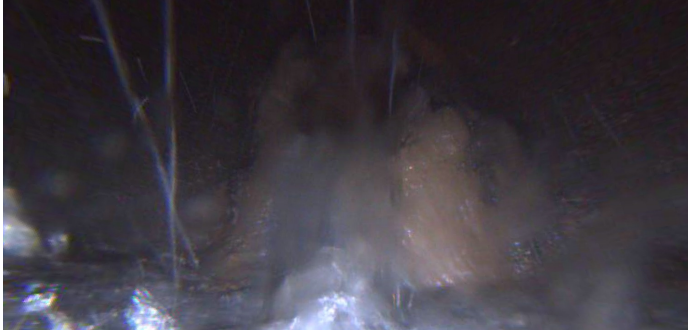
Code:	AMH
Description:	Manhole
Distance (ft):	155.0
Structural Grade:	0
O&M Grade:	0
Clock Start/From:	
Clock To:	
1st Value:	
2nd Value:	
Value Percent:	
Continuous Index:	
Within 8" of Joint:	NO
Remarks:	M-503-065
