## Profile/Photo Observation Report

Date:	<b>04/14/2018</b>	Weather:		Coding:	<b>PACP 6.0</b>
Pipe Length (ft):	<b>156.5</b>	Owner:	<b>NA</b>	Pre Clean:	<b>Not Known</b>
P.O.#:		Surveyor:	<b>Jen Costello</b>	PSR:	<b>P-503-064-065</b>
Customer:		Clean Date:	<b>01/01/1900</b>	Shape:	<b>C</b>

Street:	<b>W 40th ave</b>	Flow Control:	<b>Not Controlled</b>
City:	<b>Hobart, IN</b>	Year Renewed:	
Location:	<b>Other</b>	Tape/Media #:	
Purpose:	<b>Not Known</b>	Dia/Height:	<b>12"</b>
Use:	<b>Sanitary</b>	Material:	<b>VCP</b>
Drain Area:	<b>NA</b>	Lining:	
Category:	<b>NA</b>		
Comment:

Location Details:		Direction of Survey:	<b>Downstream</b>
US MH:	<b>M-503-064</b>	DS MH:	<b>M-503-065</b>
		Total Length Surveyed (ft):	<b>155.0</b>

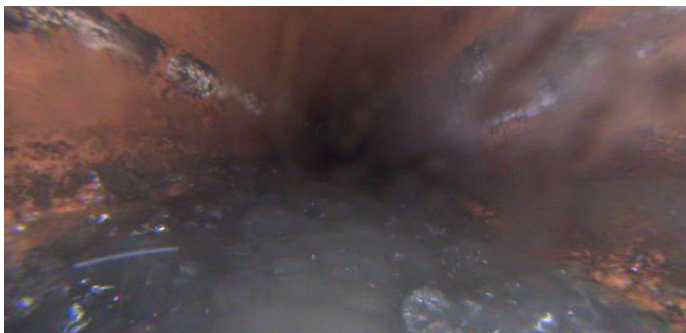
Code: **AMH**  
Description: **Manhole**

Distance (ft): **.0**  
Structural Grade: **0**  
O&M Grade: **0**  
Clock Start/From:  
Clock To:  
1st Value:  
2nd Value:  
Value Percent:  
Continuous Index:  
Within 8" of Joint: **NO**  
Remarks: **M-503-064**

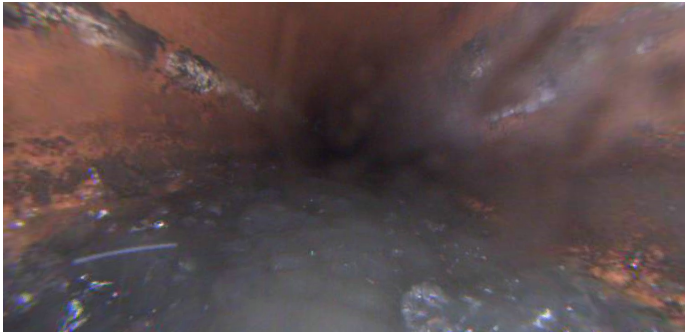
Code:	<b>MWL</b>
Description:	<b>Water Level</b>

Distance (ft):	<b>.0</b>
Structural Grade:	<b>0</b>
O&M Grade:	<b>0</b>
Clock Start/From:	
Clock To:	
1st Value:	
2nd Value:	
Value Percent:	<b>30.000</b>
Continuous Index:	
Within 8" of Joint:	<b>NO</b>
Remarks:

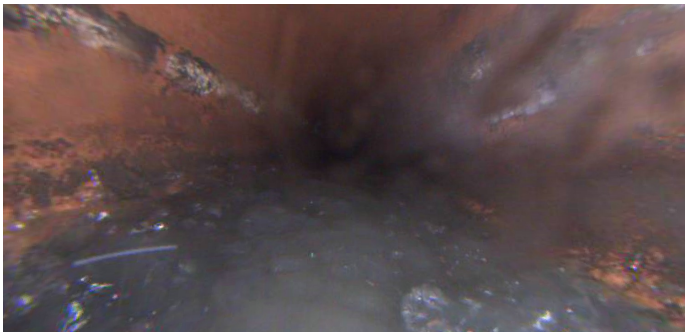
Code:	<b>DAGS</b>
Description:	<b>Deposits Attached Grease</b>

Distance (ft):	<b>.0</b>
Structural Grade:	<b>0</b>
O&M Grade:	<b>2</b>
Clock Start/From:	<b>8</b>
Clock To:	<b>4</b>
1st Value:	
2nd Value:	
Value Percent:	<b>5.000</b>
Continuous Index:	<b>S01</b>
Within 8" of Joint:	<b>NO</b>
Remarks:

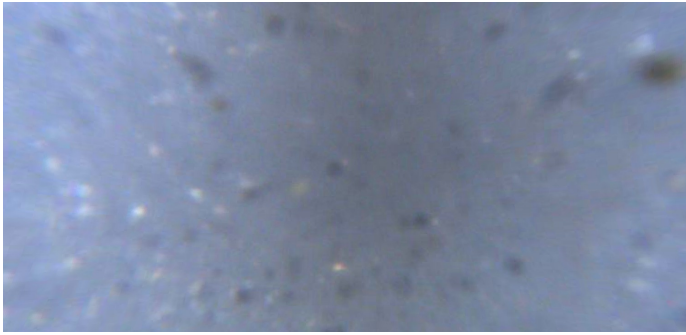
Code: **DAGS**  
Description: **Deposits Attached Grease**

Distance (ft): **88.2**  
Structural Grade: **0**  
O&M Grade: **2**  
Clock Start/From: **8**  
Clock To: **4**  
1st Value:  
2nd Value:  
Value Percent: **5.000**  
Continuous Index: **F01**  
Within 8" of Joint: **NO**  
Remarks:

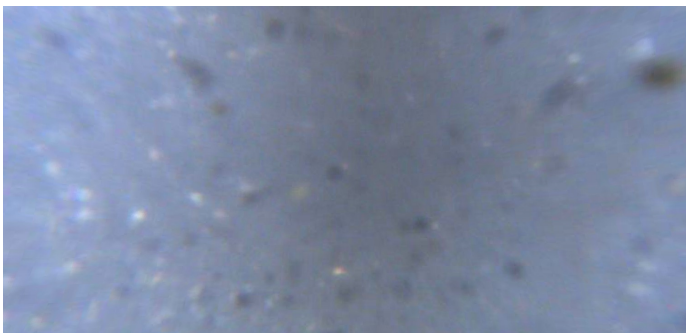
Code: **MWL**  
Description: **Water Level**

Distance (ft): **88.2**  
Structural Grade: **0**  
O&M Grade: **0**  
Clock Start/From:  
Clock To:  
1st Value:  
2nd Value:  
Value Percent: **100.000**  
Continuous Index:  
Within 8" of Joint: **NO**  
Remarks:

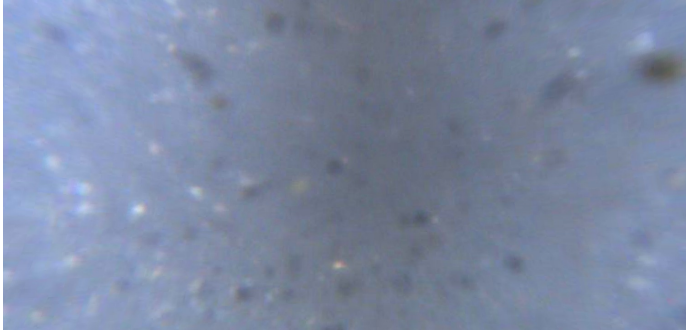
Code: **MCU**  
Description: **Camera Underwater**

Distance (ft): **88.2**  
Structural Grade: **0**  
O&M Grade: **4**  
Clock Start/From:  
Clock To:  
1st Value:  
2nd Value:  
Value Percent:  
Continuous Index: **S02**  
Within 8" of Joint: **NO**  
Remarks:

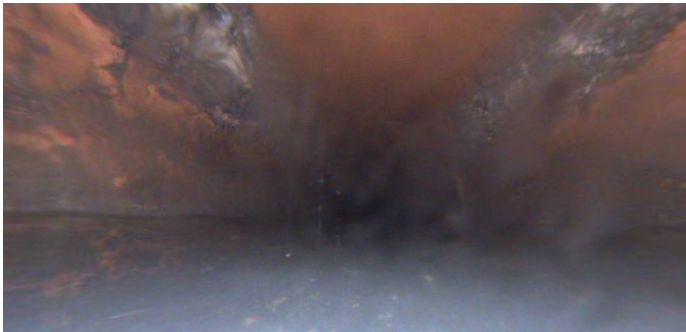
Code: **MCU**  
Description: **Camera Underwater**

Distance (ft): **94.3**  
Structural Grade: **0**  
O&M Grade: **4**  
Clock Start/From:  
Clock To:  
1st Value:  
2nd Value:  
Value Percent:  
Continuous Index: **F02**  
Within 8" of Joint: **NO**  
Remarks:

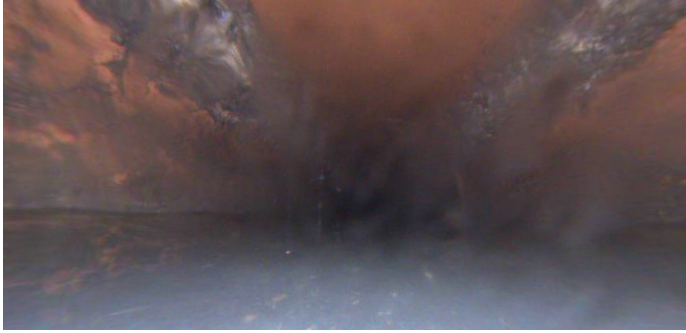
Code: **MWL**  
Description: **Water Level**

Distance (ft): **94.3**  
Structural Grade: **0**  
O&M Grade: **0**  
Clock Start/From:  
Clock To:  
1st Value:  
2nd Value:  
Value Percent: **40.000**  
Continuous Index:  
Within 8" of Joint: **NO**  
Remarks:

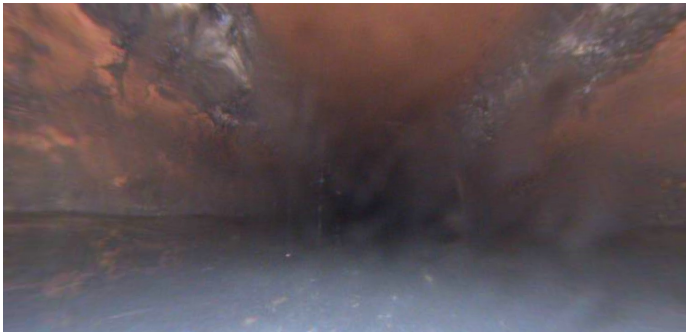
Code: **DAGS**  
Description: **Deposits Attached Grease**

Distance (ft): **94.3**  
Structural Grade: **0**  
O&M Grade: **2**  
Clock Start/From: **8**  
Clock To: **4**  
1st Value:  
2nd Value:  
Value Percent: **10.000**  
Continuous Index: **S03**  
Within 8" of Joint: **NO**  
Remarks:

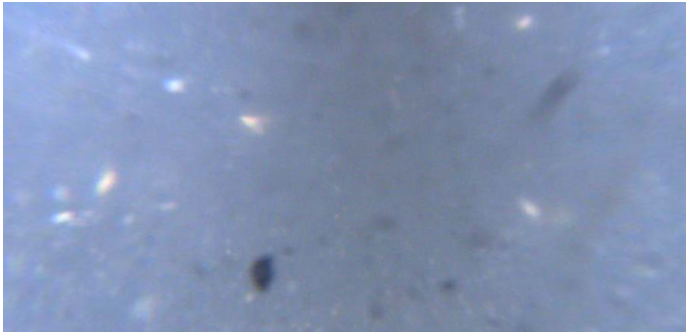
Code: **DAGS**  
Description: **Deposits Attached Grease**

Distance (ft): **100.0**  
Structural Grade: **0**  
O&M Grade: **2**  
Clock Start/From: **8**  
Clock To: **4**  
1st Value:  
2nd Value:  
Value Percent: **10.000**  
Continuous Index: **F03**  
Within 8" of Joint: **NO**  
Remarks:

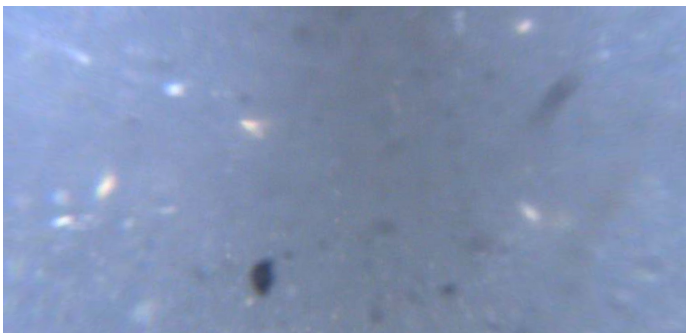
Code: **MWL**  
Description: **Water Level**

Distance (ft): **100.0**  
Structural Grade: **0**  
O&M Grade: **0**  
Clock Start/From:  
Clock To:  
1st Value:  
2nd Value:  
Value Percent: **100.000**  
Continuous Index:  
Within 8" of Joint: **NO**  
Remarks:

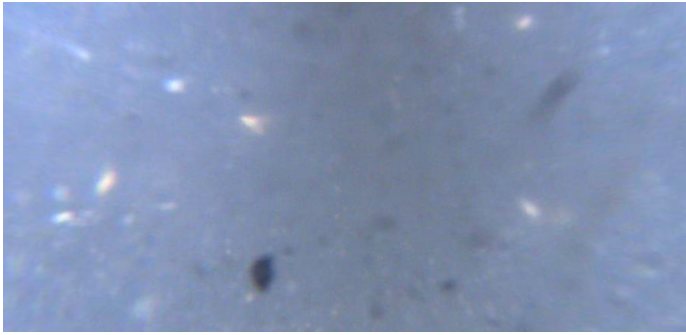
Code: **MCU**  
Description: **Camera Underwater**

Distance (ft): **100.0**  
Structural Grade: **0**  
O&M Grade: **4**  
Clock Start/From:  
Clock To:  
1st Value:  
2nd Value:  
Value Percent:  
Continuous Index: **S04**  
Within 8" of Joint: **NO**  
Remarks:

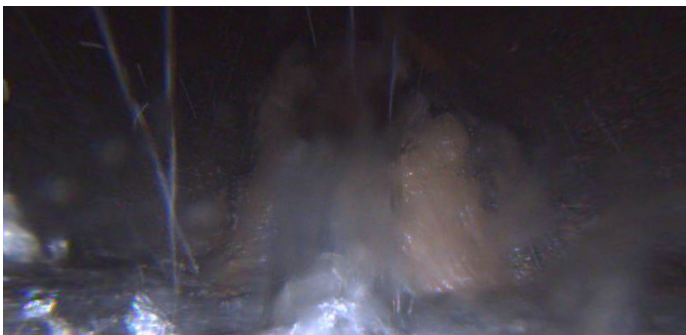
Code: **MCU**  
Description: **Camera Underwater**

Distance (ft): **155.0**  
Structural Grade: **0**  
O&M Grade: **4**  
Clock Start/From:  
Clock To:  
1st Value:  
2nd Value:  
Value Percent:  
Continuous Index: **F04**  
Within 8" of Joint: **NO**  
Remarks:

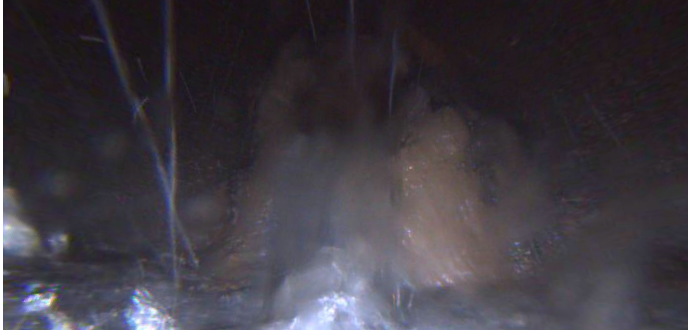
Code:	AMH
Description:	Manhole
Distance (ft):	155.0
Structural Grade:	0
O&M Grade:	0
Clock Start/From:	
Clock To:	
1st Value:	
2nd Value:	
Value Percent:	
Continuous Index:	
Within 8" of Joint:	NO
Remarks:	M-503-065
