## Profile/Photo Observation Report

Date:	<b>04/28/2018</b>	Weather:		Coding:	<b>PACP 6.0</b>
Pipe Length (ft):		Owner:	<b>City of Hobart</b>	Pre Clean:	<b>Not Known</b>
P.O.#:	<b>131</b>	Surveyor:	<b>M. Pielacha</b>	PSR:	<b>P-503-065-LS002</b>
Customer:	<b>City of Hobart</b>	Clean Date:		Shape:	<b>C</b>

Street:	<b>North Wisconsin Street</b>	Flow Control:	<b>Not Controlled</b>
City:	<b>Hobart, IN</b>	Year Renewed:	
Location:	<b>Light Highway</b>	Tape/Media #:	<b>DEP-131</b>
Purpose:	<b>Routine Assessment</b>	Dia/Height:	<b>12"</b>
Use:	<b>Sanitary</b>	Material:	<b>VCP</b>
Drain Area:		Lining:	
Category:	<b>NA</b>		
Comment:	<b>YES501824 Submittal 2</b>		
Location Details:		Direction of Survey:	<b>Downstream</b>
US MH:	<b>M-503-065</b>	DS MH:	<b>LS-002</b>
		Total Length Surveyed (ft):	<b>78.4</b>

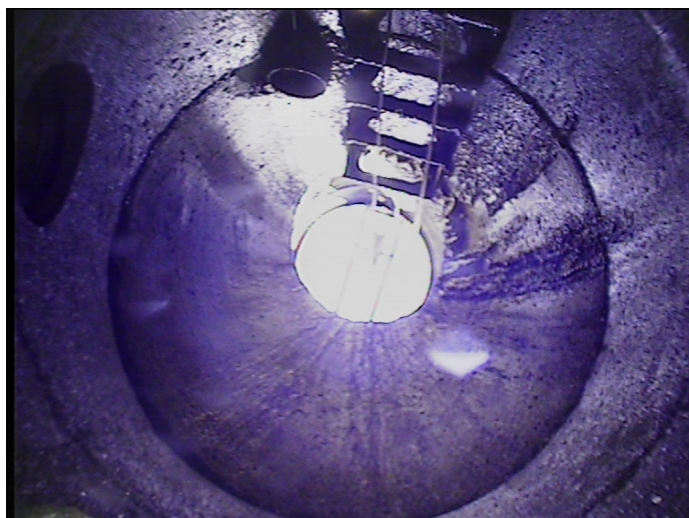
Code: **AMH**  
Description: **Manhole**

Distance (ft): **.0**  
Structural Grade: **0**  
O&M Grade: **0**  
Clock Start/From:  
Clock To:  
1st Value:  
2nd Value:  
Value Percent:  
Continuous Index:  
Within 8" of Joint: **NO**  
Remarks: **M-503-065**

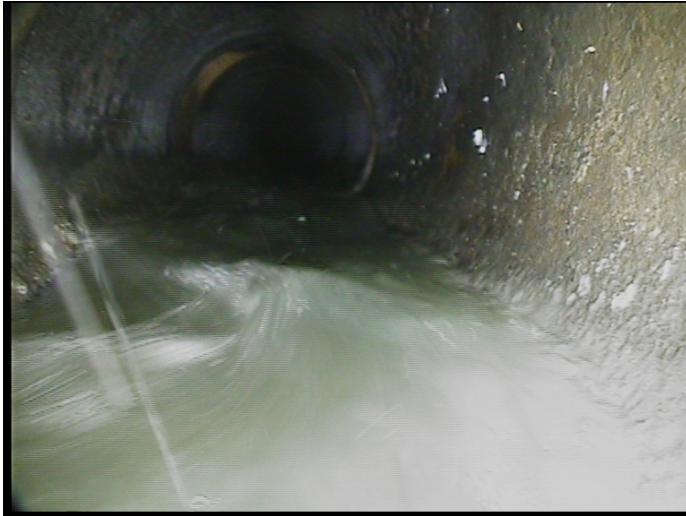
Code: **MWL**  
Description: **Water Level**

Distance (ft): **.0**  
Structural Grade: **0**  
O&M Grade: **0**  
Clock Start/From:  
Clock To:  
1st Value:  
2nd Value:  
Value Percent: **15.000**  
Continuous Index:  
Within 8" of Joint: **NO**  
Remarks:

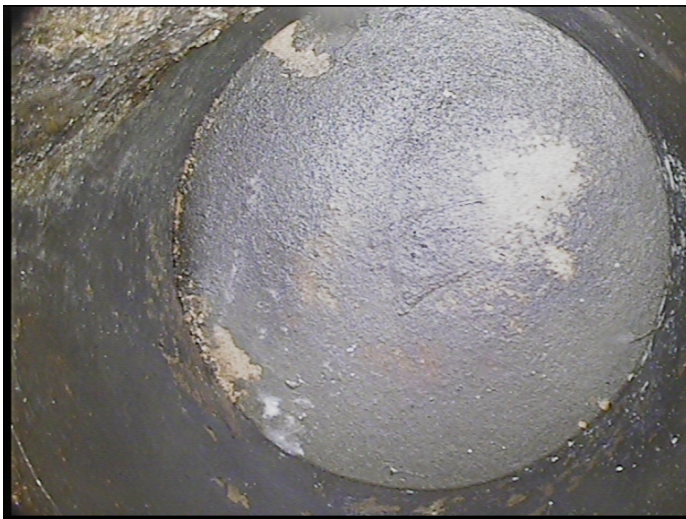
Code: **TFC**  
Description: **Tap Factory Capped**

Distance (ft): **4.0**  
Structural Grade: **0**  
O&M Grade: **0**  
Clock Start/From: **11**  
Clock To:  
1st Value: **4.000**  
2nd Value:  
Value Percent:  
Continuous Index:  
Within 8" of Joint: **NO**  
Remarks:

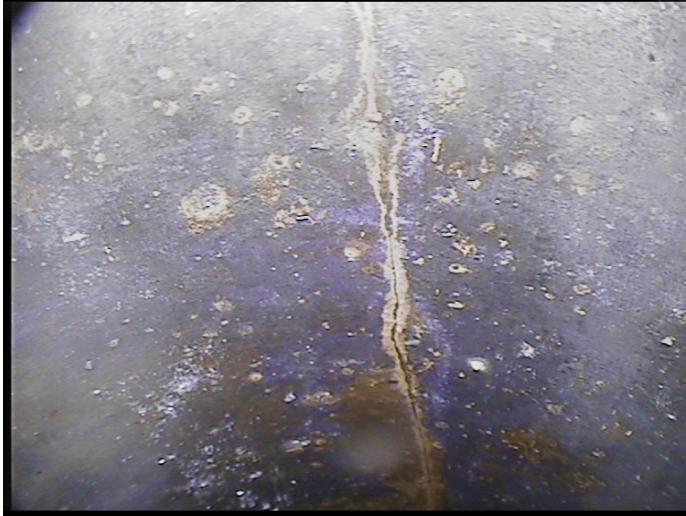
Code:	<b>CL</b>
Description:	<b>Crack Longitudinal</b>
Distance (ft):	<b>46.8</b>
Structural Grade:	<b>2</b>
O&M Grade:	<b>0</b>
Clock Start/From:	<b>12</b>
Clock To:	
1st Value:	
2nd Value:	
Value Percent:	
Continuous Index:	
Within 8" of Joint:	<b>NO</b>
Remarks:

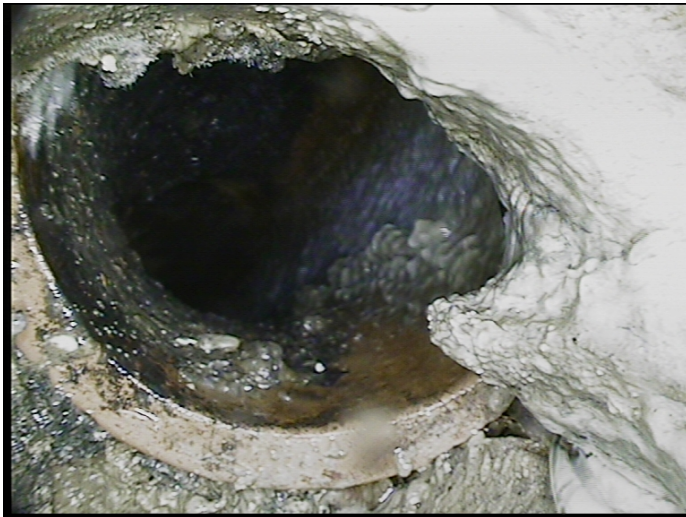
Code:	<b>TFA</b>
Description:	<b>Tap Factory Active</b>
Distance (ft):	<b>60.4</b>
Structural Grade:	<b>0</b>
O&M Grade:	<b>0</b>
Clock Start/From:	<b>2</b>
Clock To:	
1st Value:	<b>4.000</b>
2nd Value:	
Value Percent:	
Continuous Index:	
Within 8" of Joint:	<b>NO</b>
Remarks:

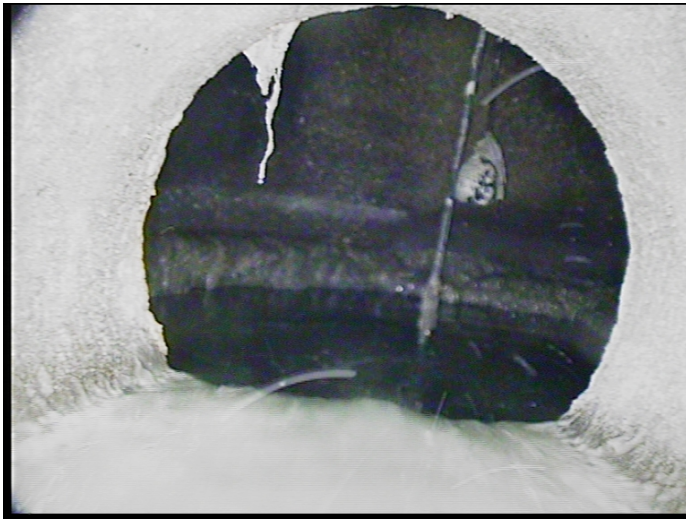
Code:	<b>AWW</b>
Description:	<b>Wet Well</b>
Distance (ft):	<b>78.4</b>
Structural Grade:	<b>0</b>
O&M Grade:	<b>0</b>
Clock Start/From:	
Clock To:	
1st Value:	
2nd Value:	
Value Percent:	
Continuous Index:	
Within 8" of Joint:	<b>NO</b>
Remarks:	<b>LS-002</b>
