Profile/Photo Observation Report

Date:	09/18/2021	Weather:		Coding:	PACP 7.0
Pipe Length (ft):	200.7	Owner:	City of Hobart	Pre Clean:	Heavy Cleaning
P.O.#:	YES502259	Surveyor:	S. Bucklin	PSR:	P-503-066-065
Customer:	City of Hobart	Clean Date:	08/25/2021	Shape:	C

Street:	North Wisconsin Street	Flow Control:	Not Controlled
City:	Hobart, IN	Year Renewed:	
Location:	Easement/Right of Way	Tape/Media #:	
Purpose:	Routine Assessment	Dia/Height:	10"
Use:	Sanitary Sewage Pipe	Material:	VCP
Drain Area:		Lining:	None
Category:	NA		
Comment:			
Location Details:	WEST OF THE ROAD. IN THE GRASS	Direction of Survey:	Downstream
US MH:	M-503-065	DS MH:	M-503-066
		Total Length Surveyed (ft):	200.7

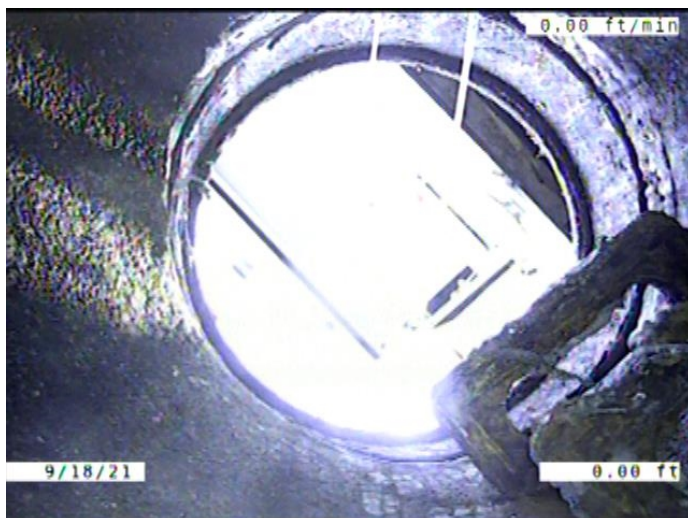
Code: **AMH**
Description: **Manhole**

Distance (ft): **.0**
Structural Grade: **0**
O&M Grade: **0**
Clock Start/From:
Clock To:
1st Value:
2nd Value:
Value Percent:
Continuous Index:
Within 8" of Joint: **NO**
Remarks: **M-503-065**

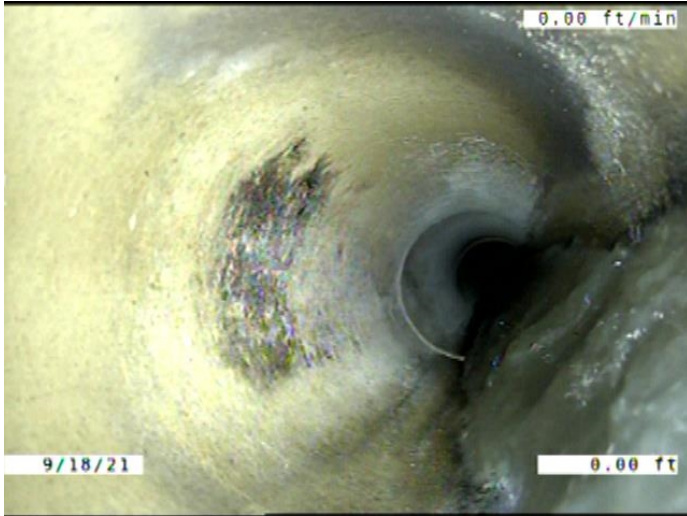
Code: **MWL**
Description: **Miscellaneous Water Level**

Distance (ft): **.0**
Structural Grade: **0**
O&M Grade: **0**
Clock Start/From:
Clock To:
1st Value:
2nd Value:
Value Percent: **15.000**
Continuous Index:
Within 8" of Joint: **NO**
Remarks:

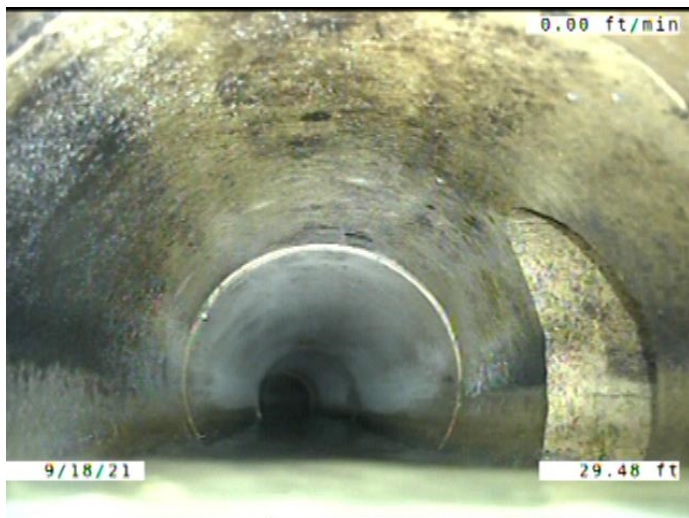
Code: **LL**
 Description: **Line Left**

Distance (ft): **29.5**
 Structural Grade: **0**
 O&M Grade: **1**
 Clock Start/From:
 Clock To:
 1st Value:
 2nd Value:
 Value Percent: **5.000**
 Continuous Index:
 Within 8" of Joint: **NO**
 Remarks:

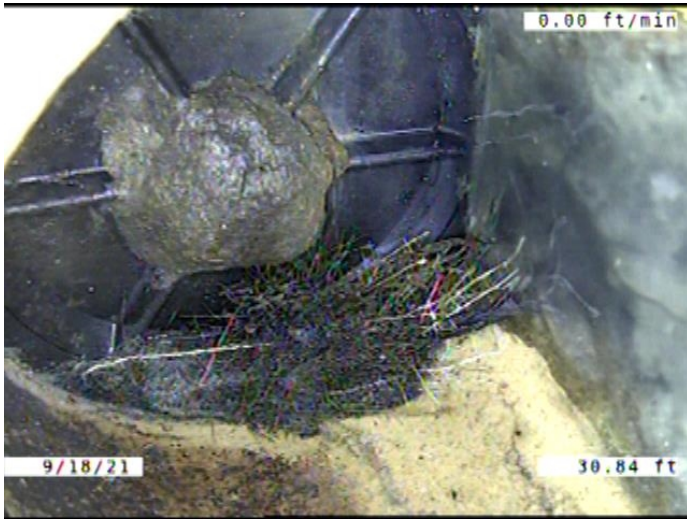
Code: **TF**
Description: **Tap Factory**

Distance (ft): **30.8**
Structural Grade: **0**
O&M Grade: **0**
Clock Start/From: **3**
Clock To:
1st Value: **6.000**
2nd Value:
Value Percent:
Continuous Index:
Within 8" of Joint: **YES**
Remarks: **PLUGGED. ROOTS GROWING AROUND THE PLUG**

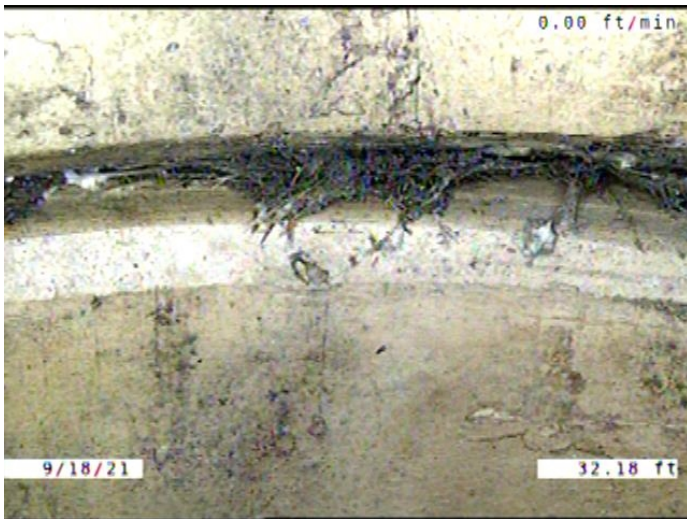
Code: **RFJ**
Description: **Roots Fine Joint**

Distance (ft): **32.2**
Structural Grade: **0**
O&M Grade: **1**
Clock Start/From: **8**
Clock To: **10**
1st Value:
2nd Value:
Value Percent:
Continuous Index:
Within 8" of Joint: **YES**
Remarks:

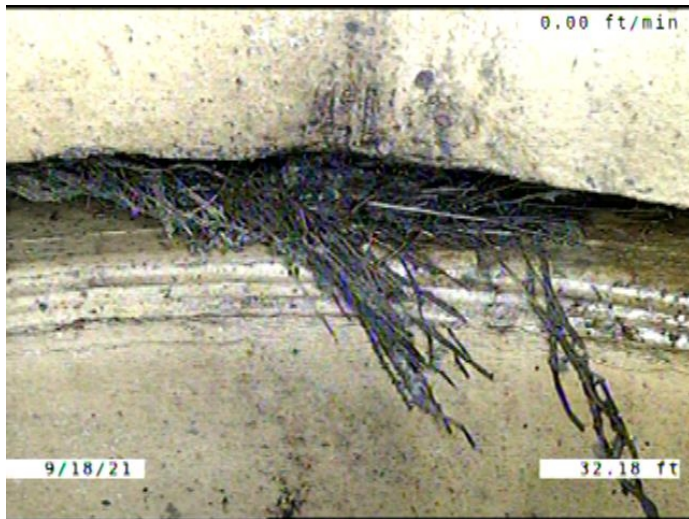
Code: **RFJ**
Description: **Roots Fine Joint**

Distance (ft): **32.2**
Structural Grade: **0**
O&M Grade: **1**
Clock Start/From: **1**
Clock To: **3**
1st Value:
2nd Value:
Value Percent:
Continuous Index:
Within 8" of Joint: **YES**
Remarks:

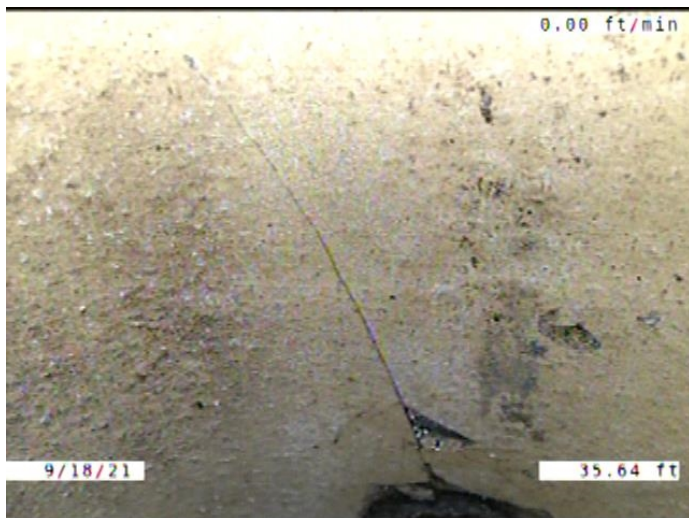
Code: **CM**
Description: **Crack Multiple**

Distance (ft): **35.6**
Structural Grade: **3**
O&M Grade: **0**
Clock Start/From: **10**
Clock To: **1**
1st Value:
2nd Value:
Value Percent:
Continuous Index:
Within 8" of Joint: **YES**
Remarks:

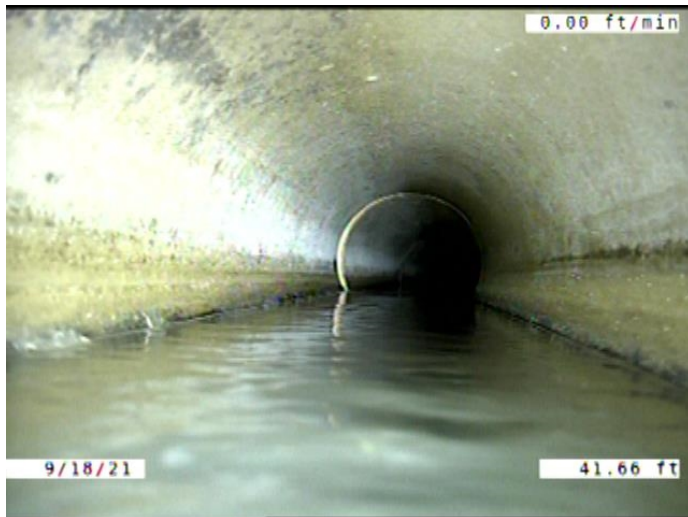
Code: **LR**
 Description: **Line Right**

Distance (ft): **41.7**
 Structural Grade: **0**
 O&M Grade: **1**
 Clock Start/From:
 Clock To:
 1st Value:
 2nd Value:
 Value Percent: **5.000**
 Continuous Index:
 Within 8" of Joint: **NO**
 Remarks:

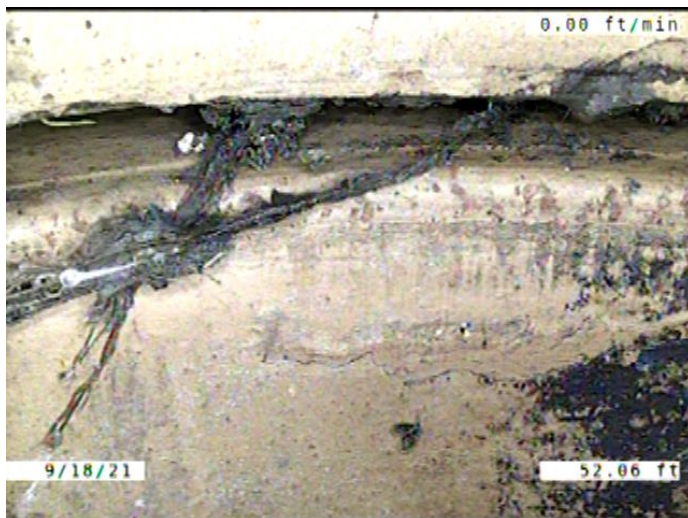
Code: **RFJ**
 Description: **Roots Fine Joint**

Distance (ft): **52.1**
 Structural Grade: **0**
 O&M Grade: **1**
 Clock Start/From: **10**
 Clock To:
 1st Value:
 2nd Value:
 Value Percent:
 Continuous Index:
 Within 8" of Joint: **YES**
 Remarks:

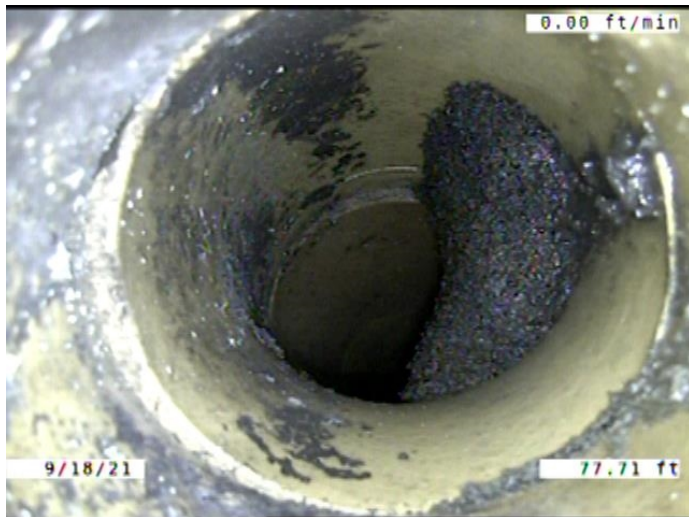
Code: **TF**
 Description: **Tap Factory**

Distance (ft): **77.7**
 Structural Grade: **0**
 O&M Grade: **0**
 Clock Start/From: **2**
 Clock To:
 1st Value: **6.000**
 2nd Value:
 Value Percent:
 Continuous Index:
 Within 8" of Joint: **YES**
 Remarks:

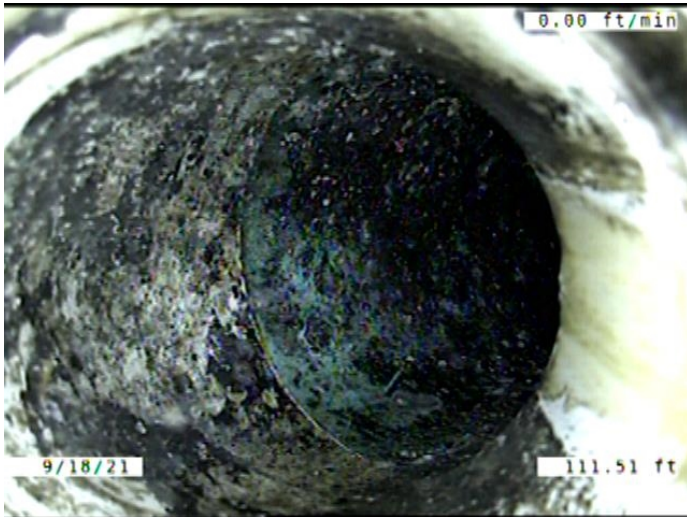
Code: **TB**
 Description: **Tap Break-in/Hammer**

Distance (ft): **111.5**
 Structural Grade: **0**
 O&M Grade: **0**
 Clock Start/From: **1**
 Clock To:
 1st Value: **6.000**
 2nd Value:
 Value Percent:
 Continuous Index:
 Within 8" of Joint: **NO**
 Remarks: **CONSTANTLY RUNNING WATER**

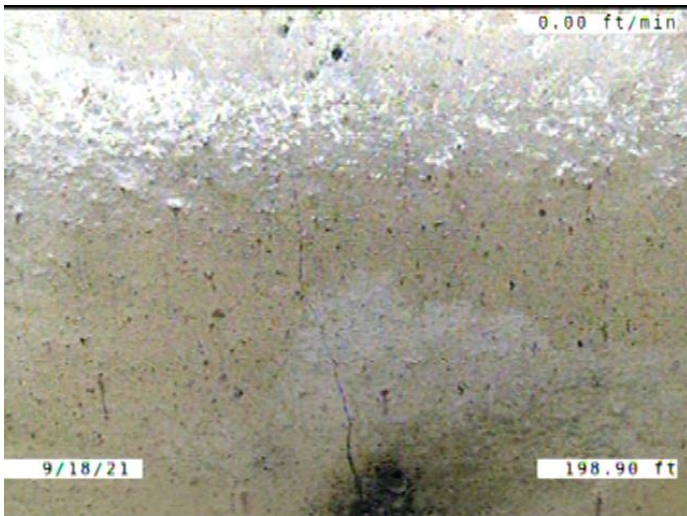
Code: **CM**
 Description: **Crack Multiple**

Distance (ft): **198.9**
 Structural Grade: **3**
 O&M Grade: **0**
 Clock Start/From: **12**
 Clock To: **3**
 1st Value:
 2nd Value:
 Value Percent:
 Continuous Index:
 Within 8" of Joint: **YES**
 Remarks:

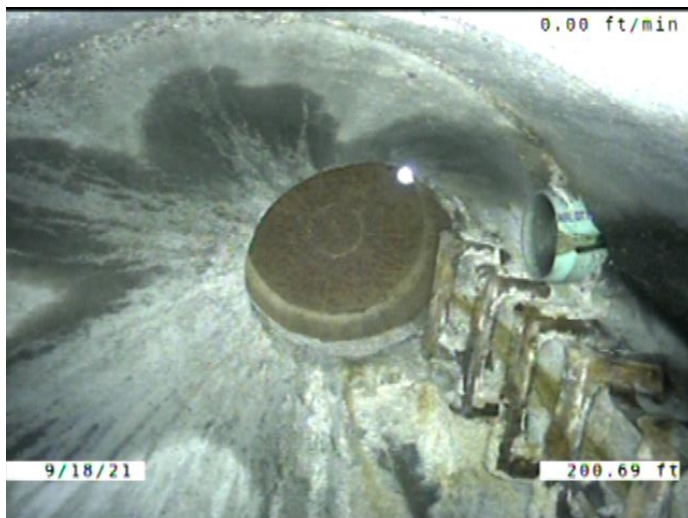
Code: **AMH**
 Description: **Manhole**

Distance (ft): **200.7**
 Structural Grade: **0**
 O&M Grade: **0**
 Clock Start/From:
 Clock To:
 1st Value:
 2nd Value:
 Value Percent:
 Continuous Index:
 Within 8" of Joint: **NO**
 Remarks: **M-503-066**
