Profile/Photo Observation Report

Date:	09/18/2021	Weather:		Coding:	PACP 7.0
Pipe Length (ft):	200.7	Owner:	City of Hobart	Pre Clean:	Heavy Cleaning
P.O.#:	YES502259	Surveyor:	S. Bucklin	PSR:	P-503-066-065
Customer:	City of Hobart	Clean Date:	08/25/2021	Shape:	C

Street:	North Wisconsin Street	Flow Control:	Not Controlled
City:	Hobart, IN	Year Renewed:	
Location:	Easement/Right of Way	Tape/Media #:	
Purpose:	Routine Assessment	Dia/Height:	10"
Use:	Sanitary Sewage Pipe	Material:	VCP
Drain Area:		Lining:	None
Category:	NA		
Comment:			
Location Details:	WEST OF THE ROAD. IN THE GRASS	Direction of Survey:	Downstream
US MH:	M-503-065	DS MH:	M-503-066
		Total Length Surveyed (ft):	200.7

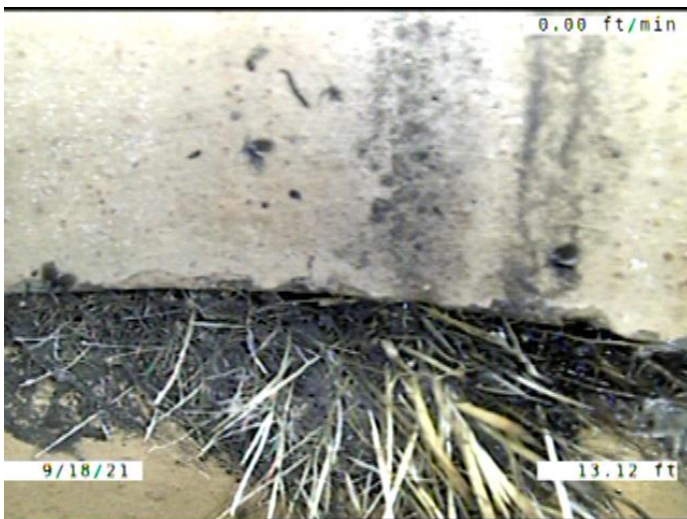
Code: **RFJ**
Description: **Roots Fine Joint**

Distance (ft): **13.1**
Structural Grade: **0**
O&M Grade: **1**
Clock Start/From: **9**
Clock To: **3**
1st Value:
2nd Value:
Value Percent:
Continuous Index:
Within 8" of Joint: **YES**
Remarks:

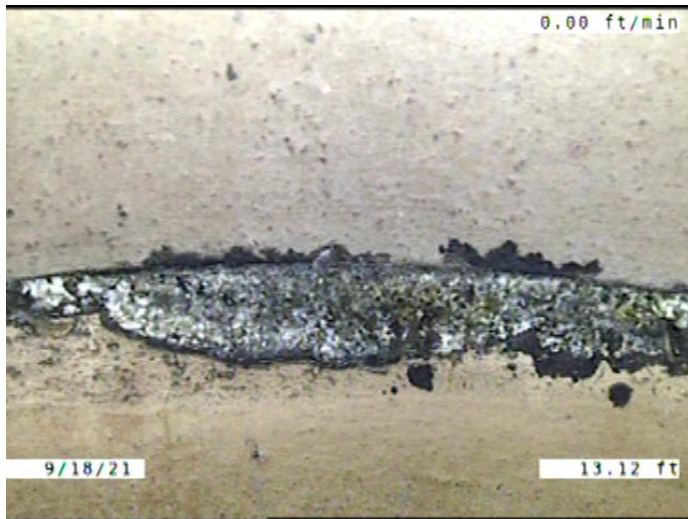
Code: **DAE**
Description: **Deposits Attached Encrustation**

Distance (ft): **13.1**
Structural Grade: **0**
O&M Grade: **2**
Clock Start/From: **11**
Clock To: **1**
1st Value:
2nd Value:
Value Percent: **5.000**
Continuous Index:
Within 8" of Joint: **YES**
Remarks:

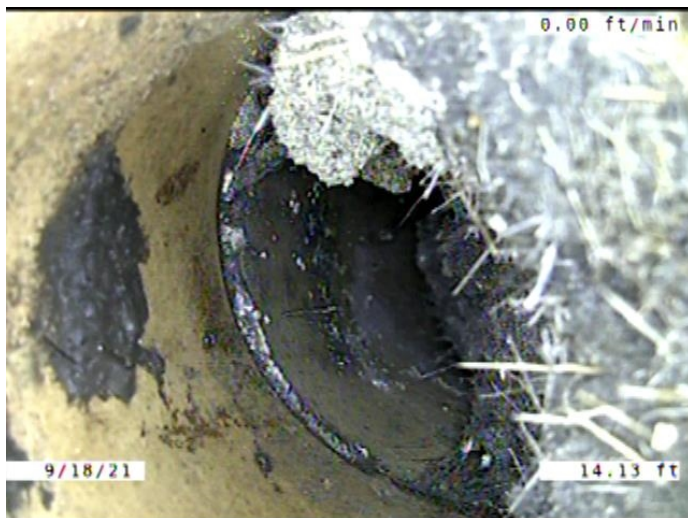
Code: **TF**
Description: **Tap Factory**

Distance (ft): **14.1**
Structural Grade: **0**
O&M Grade: **0**
Clock Start/From: **2**
Clock To:
1st Value: **6.000**
2nd Value:
Value Percent:
Continuous Index:
Within 8" of Joint: **YES**
Remarks: **LOOKS TO BE 80% PLUGGED WITH ROOTS AND DIRT**

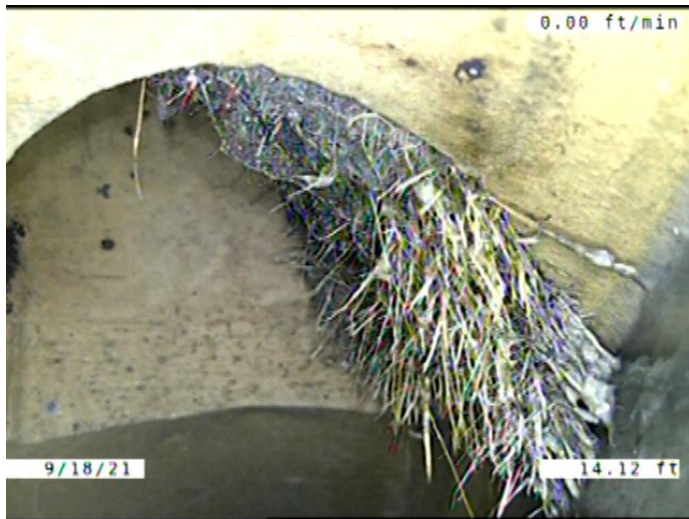
Code: **RML**
 Description: **Roots Medium Lateral**

Distance (ft): **14.1**
 Structural Grade: **0**
 O&M Grade: **3**
 Clock Start/From: **2**
 Clock To: **3**
 1st Value:
 2nd Value:
 Value Percent: **5.000**
 Continuous Index:
 Within 8" of Joint: **NO**
 Remarks:

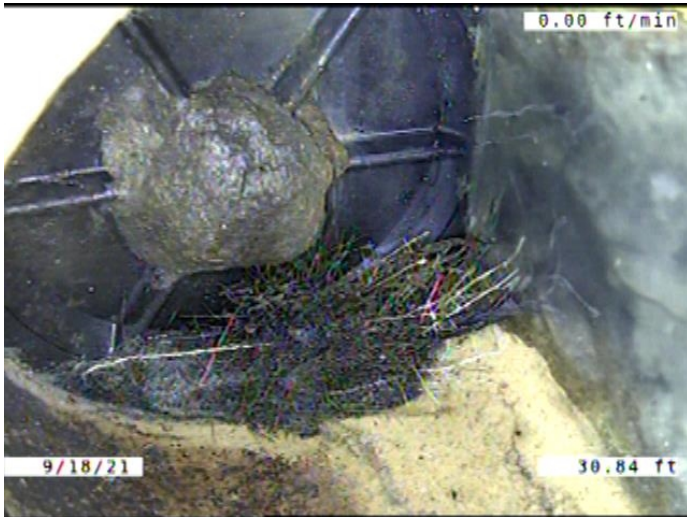
Code: **TF**
Description: **Tap Factory**

Distance (ft): **30.8**
Structural Grade: **0**
O&M Grade: **0**
Clock Start/From: **3**
Clock To:
1st Value: **6.000**
2nd Value:
Value Percent:
Continuous Index:
Within 8" of Joint: **YES**
Remarks: **PLUGGED. ROOTS GROWING AROUND THE PLUG**

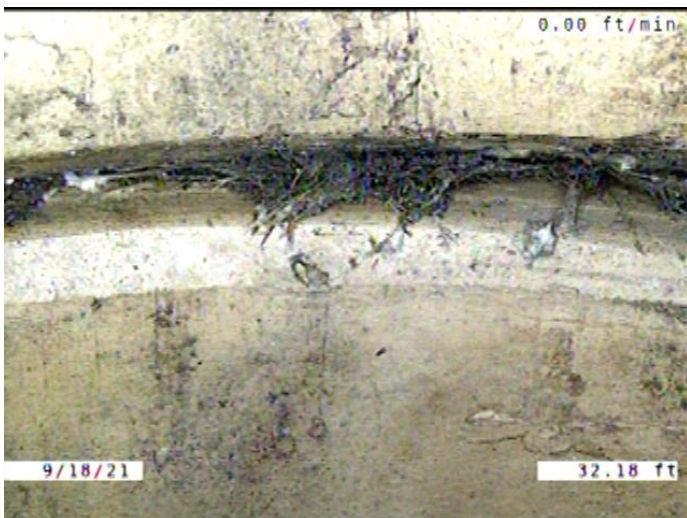
Code: **RFJ**
Description: **Roots Fine Joint**

Distance (ft): **32.2**
Structural Grade: **0**
O&M Grade: **1**
Clock Start/From: **8**
Clock To: **10**
1st Value:
2nd Value:
Value Percent:
Continuous Index:
Within 8" of Joint: **YES**
Remarks:

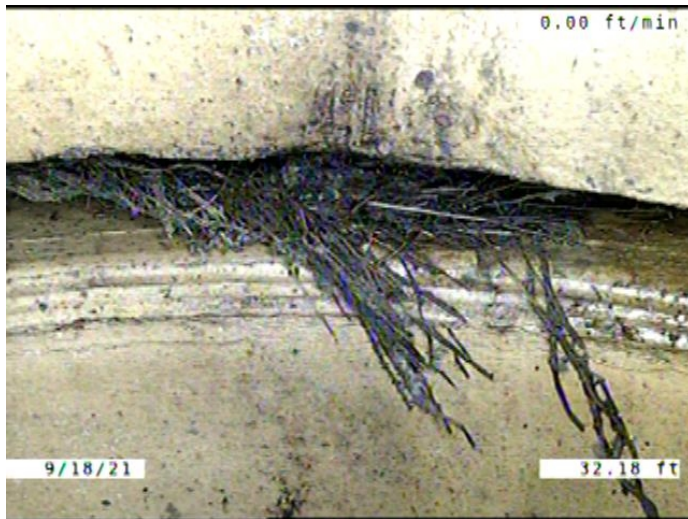
Code: **RFJ**
Description: **Roots Fine Joint**

Distance (ft): **32.2**
Structural Grade: **0**
O&M Grade: **1**
Clock Start/From: **1**
Clock To: **3**
1st Value:
2nd Value:
Value Percent:
Continuous Index:
Within 8" of Joint: **YES**
Remarks:

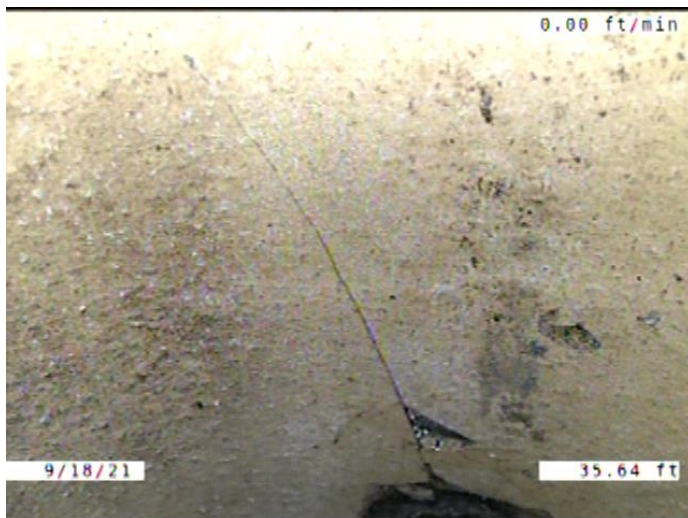
Code: **CM**
Description: **Crack Multiple**

Distance (ft): **35.6**
Structural Grade: **3**
O&M Grade: **0**
Clock Start/From: **10**
Clock To: **1**
1st Value:
2nd Value:
Value Percent:
Continuous Index:
Within 8" of Joint: **YES**
Remarks:

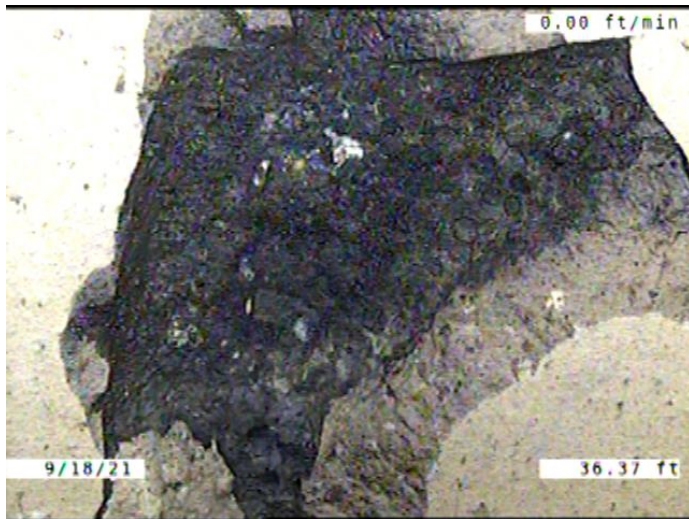
Code: **HSV**
 Description: **Hole Soil Visible**

Distance (ft): **36.4**
 Structural Grade: **5**
 O&M Grade: **0**
 Clock Start/From: **12**
 Clock To: **1**
 1st Value:
 2nd Value:
 Value Percent:
 Continuous Index:
 Within 8" of Joint: **YES**
 Remarks:

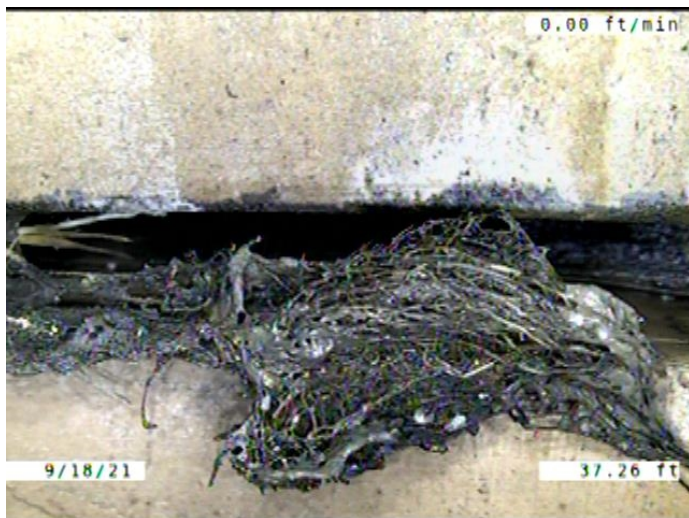
Code: **RFJ**
 Description: **Roots Fine Joint**

Distance (ft): **37.3**
 Structural Grade: **0**
 O&M Grade: **1**
 Clock Start/From: **1**
 Clock To: **3**
 1st Value:
 2nd Value:
 Value Percent:
 Continuous Index:
 Within 8" of Joint: **YES**
 Remarks:

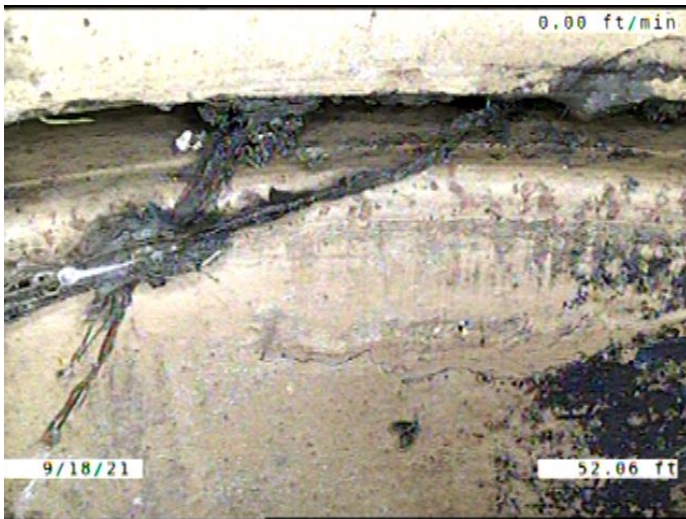
Code: **RFJ**
 Description: **Roots Fine Joint**

Distance (ft): **52.1**
 Structural Grade: **0**
 O&M Grade: **1**
 Clock Start/From: **10**
 Clock To:
 1st Value:
 2nd Value:
 Value Percent:
 Continuous Index:
 Within 8" of Joint: **YES**
 Remarks:

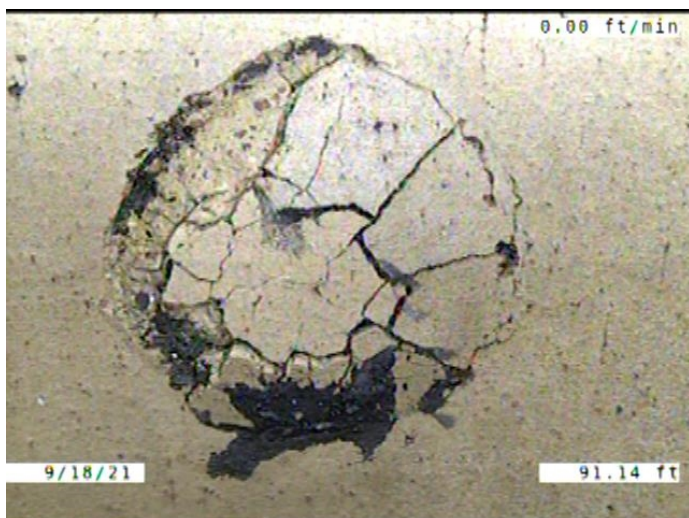
Code: **BSV**
 Description: **Broken Soil Visible**

Distance (ft): **91.1**
 Structural Grade: **5**
 O&M Grade: **0**
 Clock Start/From: **1**
 Clock To: **2**
 1st Value:
 2nd Value:
 Value Percent:
 Continuous Index:
 Within 8" of Joint: **NO**
 Remarks:

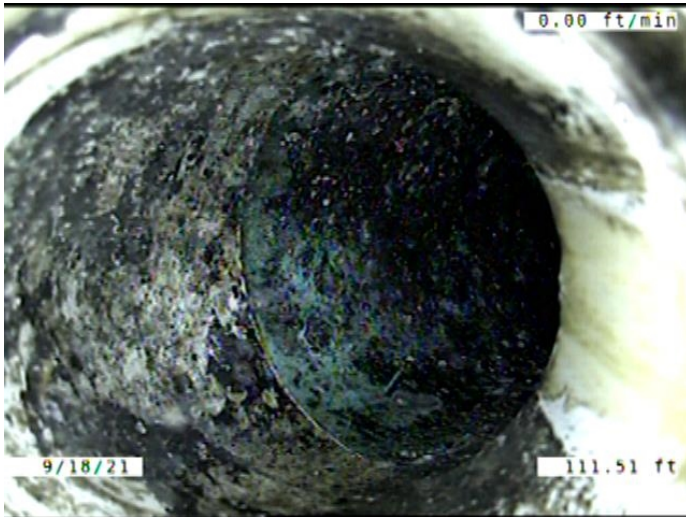
Code: **TB**
 Description: **Tap Break-in/Hammer**

Distance (ft): **111.5**
 Structural Grade: **0**
 O&M Grade: **0**
 Clock Start/From: **1**
 Clock To:
 1st Value: **6.000**
 2nd Value:
 Value Percent:
 Continuous Index:
 Within 8" of Joint: **NO**
 Remarks: **CONSTANTLY RUNNING WATER**

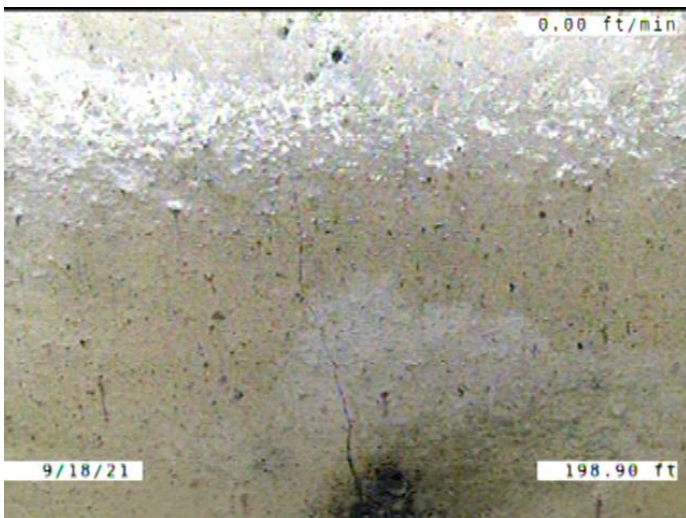
Code: **CM**
 Description: **Crack Multiple**

Distance (ft): **198.9**
 Structural Grade: **3**
 O&M Grade: **0**
 Clock Start/From: **12**
 Clock To: **3**
 1st Value:
 2nd Value:
 Value Percent:
 Continuous Index:
 Within 8" of Joint: **YES**
 Remarks:

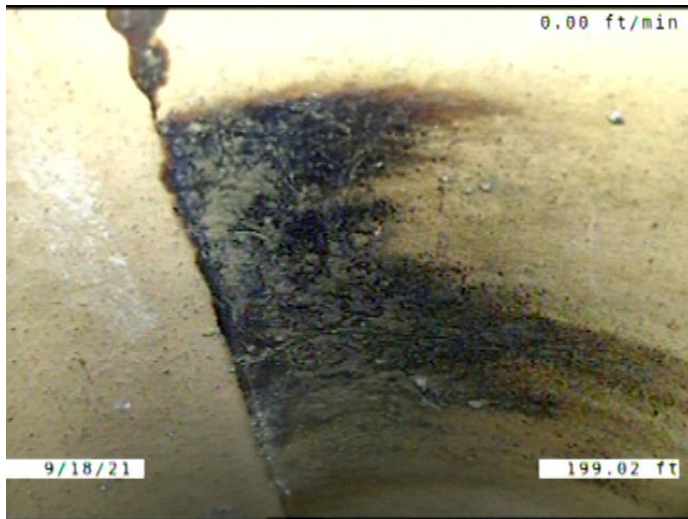
Code: **ISB**
 Description: **Infiltration Stain Barrel**

Distance (ft): **199.0**
 Structural Grade: **0**
 O&M Grade: **1**
 Clock Start/From: **12**
 Clock To: **3**
 1st Value:
 2nd Value:
 Value Percent:
 Continuous Index:
 Within 8" of Joint: **YES**
 Remarks:
