Profile/Photo Observation Report

Street:	North Wisconsin Street	Flow Control:	
City:	Hobart, IN	Year Renewed:	
Location:	Light Highway	Tape/Media #:	996
Purpose:	Routine Assessment	Dia/Height:	10"
Use:	Sanitary	Material:	VCP
Drain Area:		Lining:	
Category:	NA		
Comment:

Location Details:		Direction of Survey:	Downstream
US MH:	M-503-66	DS MH:	M-503-67
		Total Length Surveyed (ft):	307.2

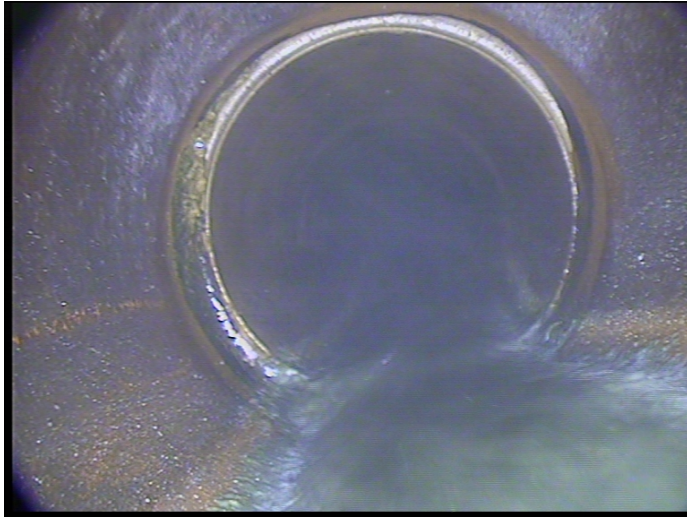
Code: **MWL**
Description: **Water Level**

Distance (ft): **.0**
Structural Grade: **0**
O&M Grade: **0**
Clock Start/From:
Clock To:
1st Value:
2nd Value:
Value Percent: **5.000**
Continuous Index:
Within 8" of Joint: **NO**
Remarks:

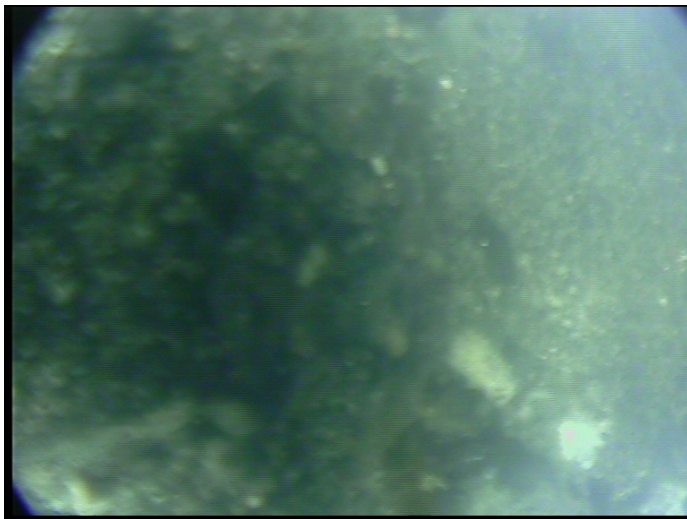
Code: **OBZ**
Description: **Obstacle Other**

Distance (ft): **147.8**
Structural Grade: **0**
O&M Grade: **2**
Clock Start/From: **6**
Clock To:
1st Value:
2nd Value:
Value Percent: **10.000**
Continuous Index:
Within 8" of Joint: **NO**
Remarks: **under water debris**

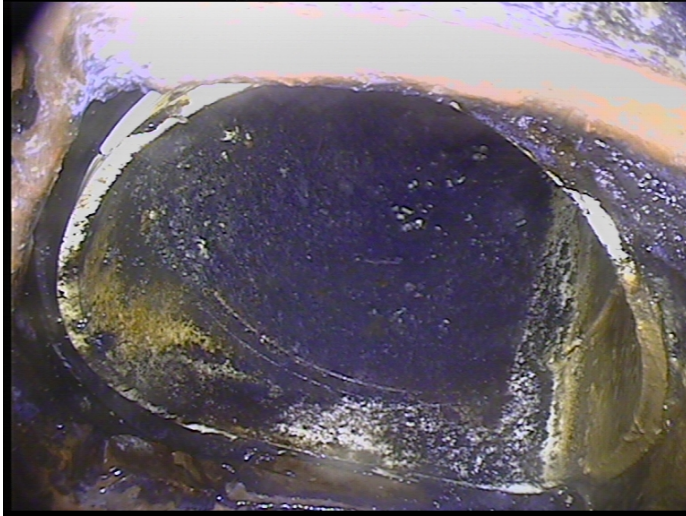
Code: **TB**
Description: **Tap Break-in**

Distance (ft): **195.1**
Structural Grade: **0**
O&M Grade: **0**
Clock Start/From: **3**
Clock To:
1st Value: **4.000**
2nd Value:
Value Percent:
Continuous Index:
Within 8" of Joint: **NO**
Remarks:

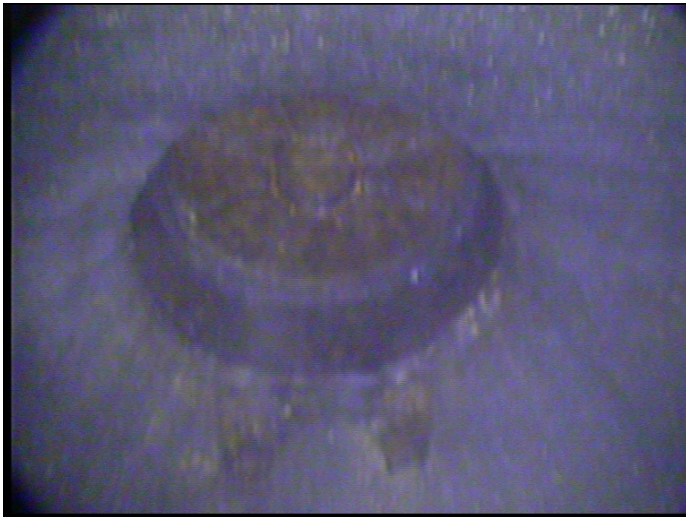
Code: **AMH**
Description: **Manhole**

Distance (ft): **307.1**
Structural Grade: **0**
O&M Grade: **0**
Clock Start/From:
Clock To:
1st Value:
2nd Value:
Value Percent:
Continuous Index:
Within 8" of Joint: **NO**
Remarks: **M-503-67**
