## Profile/Photo Observation Report

Date:	<b>09/18/2021</b>	Weather:		Coding:	<b>PACP 7.0</b>
Pipe Length (ft):	<b>93.0</b>	Owner:	<b>City of Hobart</b>	Pre Clean:	<b>Light Cleaning</b>
P.O.#:	<b>YES502259</b>	Surveyor:	<b>S. Bucklin</b>	PSR:	<b>P-603-037-066</b>
Customer:	<b>City of Hobart</b>	Clean Date:	<b>08/25/2021</b>	Shape:	<b>C</b>

Street:	<b>North Wisconsin Street</b>	Flow Control:	<b>Not Controlled</b>
City:	<b>Hobart, IN</b>	Year Renewed:	
Location:	<b>Easement/Right of Way</b>	Tape/Media #:	
Purpose:	<b>Routine Assessment</b>	Dia/Height:	<b>8"</b>
Use:	<b>Sanitary Sewage Pipe</b>	Material:	<b>VCP</b>
Drain Area:		Lining:	<b>None</b>
Category:	<b>NA</b>		
Comment:			
Location Details:	<b>JUST WEST OF THE ROAD IN THE GR</b>	Direction of Survey:	<b>Upstream</b>
US MH:	<b>M-503-066</b>	DS MH:	<b>M-603-037</b>
		Total Length Surveyed (ft):	<b>62.7</b>

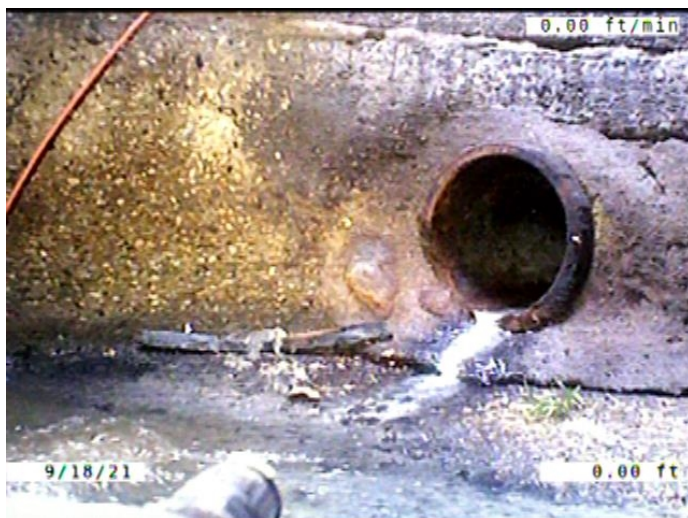
Code: **AMH**  
Description: **Manhole**

Distance (ft): **.0**  
Structural Grade: **0**  
O&M Grade: **0**  
Clock Start/From:  
Clock To:  
1st Value:  
2nd Value:  
Value Percent:  
Continuous Index:  
Within 8" of Joint: **NO**  
Remarks: **M-603-037**

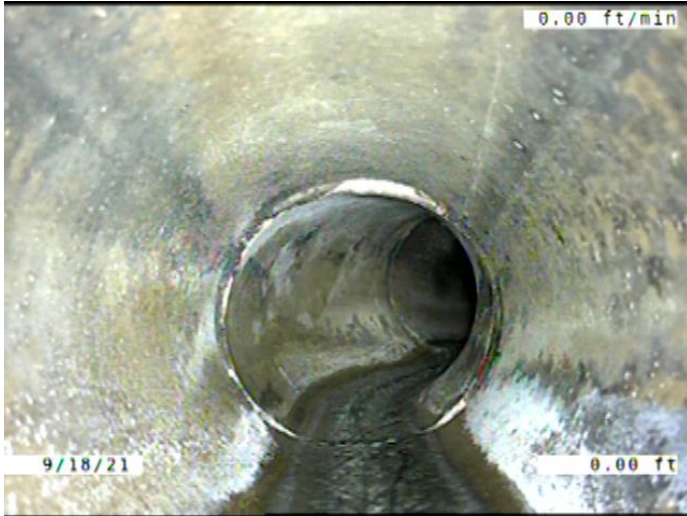
Code: **MWL**  
Description: **Miscellaneous Water Level**

Distance (ft): **.0**  
Structural Grade: **0**  
O&M Grade: **0**  
Clock Start/From:  
Clock To:  
1st Value:  
2nd Value:  
Value Percent: **5.000**  
Continuous Index:  
Within 8" of Joint: **NO**  
Remarks:

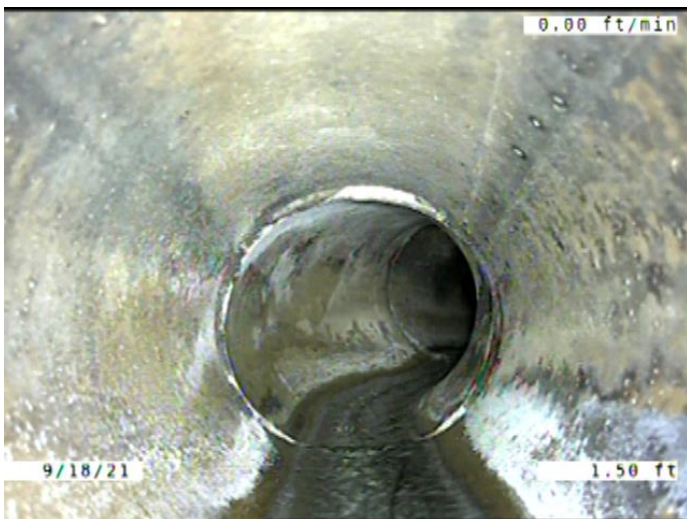
Code: **MGO**  
Description: **Miscellaneous General Observation**

Distance (ft): **1.5**  
Structural Grade: **0**  
O&M Grade: **0**  
Clock Start/From:  
Clock To:  
1st Value:  
2nd Value:  
Value Percent:  
Continuous Index:  
Within 8" of Joint: **NO**  
Remarks: **DROP INTO THE MANHOLE. HAD TO START IN THE PIPE.**

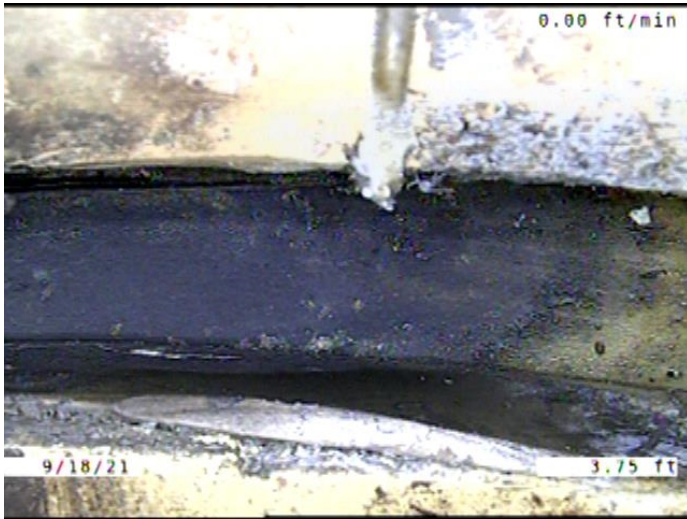
Code: **JAM**  
Description: **Joint Angular Medium**

Distance (ft): **3.7**  
Structural Grade: **3**  
O&M Grade: **0**  
Clock Start/From:  
Clock To:  
1st Value:  
2nd Value:  
Value Percent:  
Continuous Index:  
Within 8" of Joint: **NO**  
Remarks:

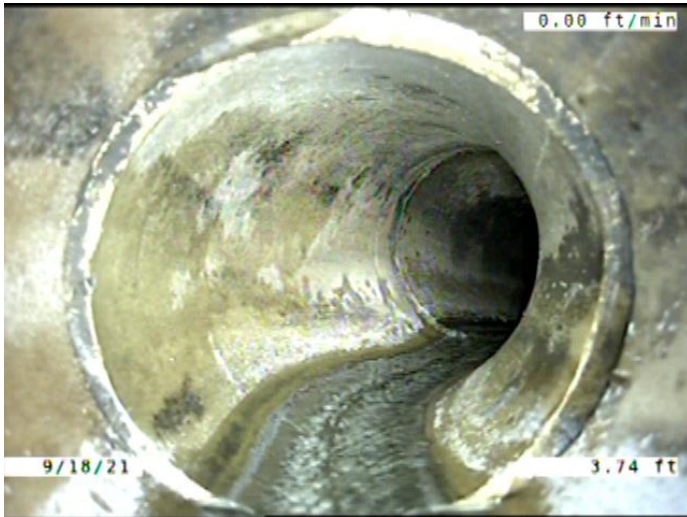
Code: **LR**  
Description: **Line Right**

Distance (ft): **3.7**  
Structural Grade: **0**  
O&M Grade: **4**  
Clock Start/From:  
Clock To:  
1st Value:  
2nd Value:  
Value Percent: **60.000**  
Continuous Index:  
Within 8" of Joint: **NO**  
Remarks:

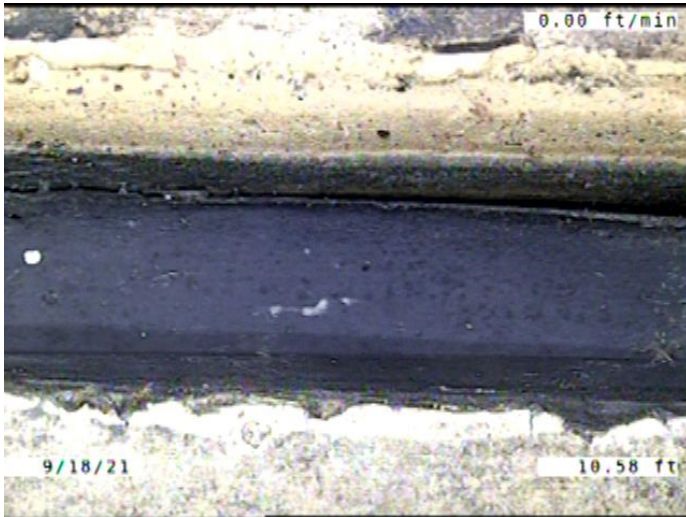
Code: **JAM**  
 Description: **Joint Angular Medium**

Distance (ft): **10.6**  
 Structural Grade: **3**  
 O&M Grade: **0**  
 Clock Start/From:  
 Clock To:  
 1st Value:  
 2nd Value:  
 Value Percent:  
 Continuous Index:  
 Within 8" of Joint: **NO**  
 Remarks:

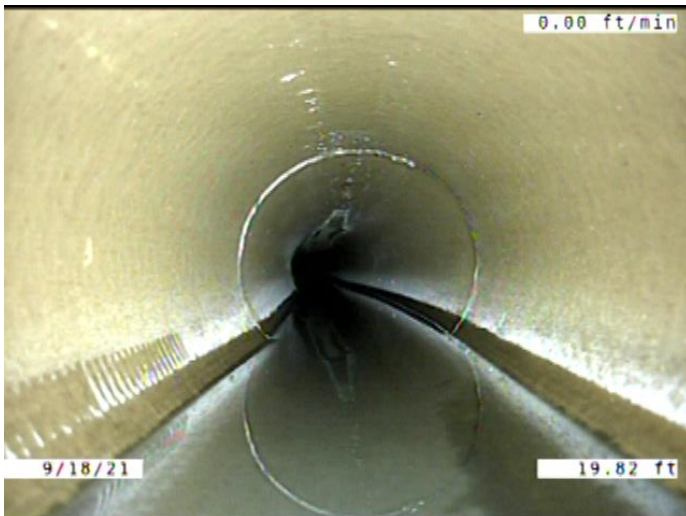
Code: **LL**  
 Description: **Line Left**

Distance (ft): **19.8**  
 Structural Grade: **0**  
 O&M Grade: **2**  
 Clock Start/From:  
 Clock To:  
 1st Value:  
 2nd Value:  
 Value Percent: **15.000**  
 Continuous Index:  
 Within 8" of Joint: **NO**  
 Remarks:

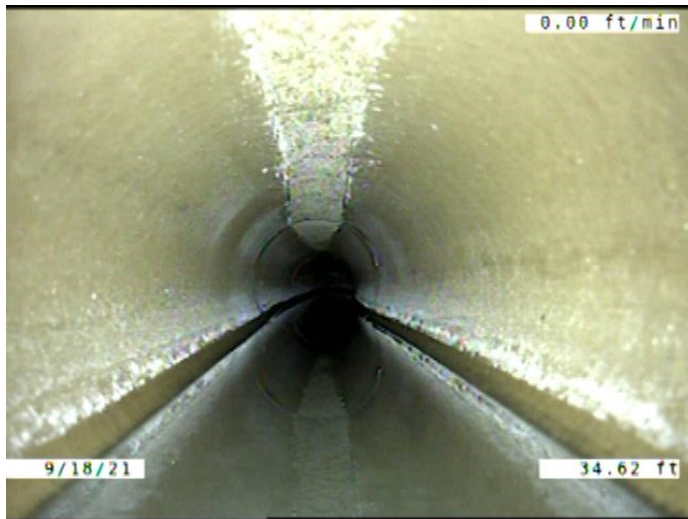
Code: **LL**  
 Description: **Line Left**

Distance (ft): **34.6**  
 Structural Grade: **0**  
 O&M Grade: **1**  
 Clock Start/From:  
 Clock To:  
 1st Value:  
 2nd Value:  
 Value Percent: **5.000**  
 Continuous Index:  
 Within 8" of Joint: **NO**  
 Remarks:

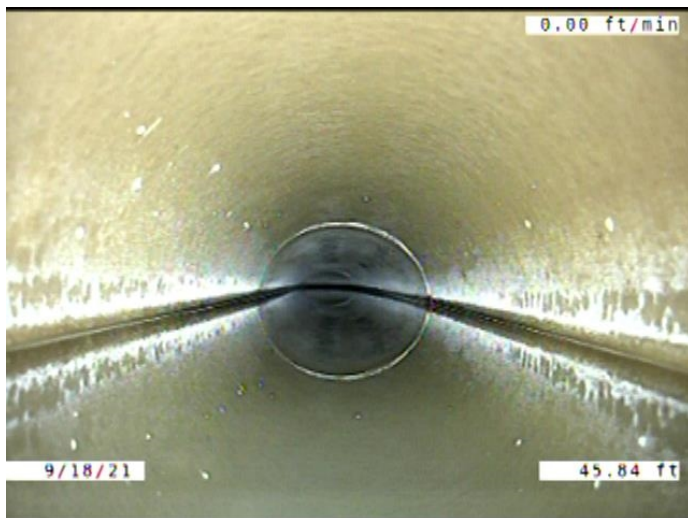
Code: **MWL**  
 Description: **Miscellaneous Water Level**

Distance (ft): **45.8**  
 Structural Grade: **0**  
 O&M Grade: **0**  
 Clock Start/From:  
 Clock To:  
 1st Value:  
 2nd Value:  
 Value Percent: **50.000**  
 Continuous Index:  
 Within 8" of Joint: **NO**  
 Remarks:

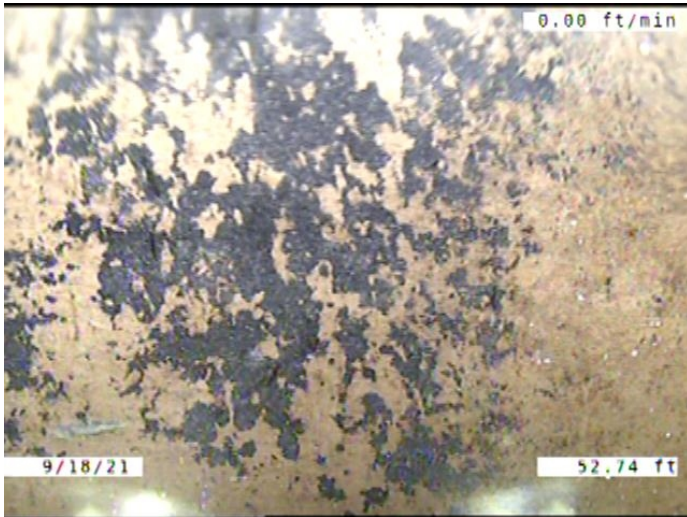
Code: **MCU**  
Description: **Miscellaneous Camera Underwater**

Distance (ft): **52.7**  
Structural Grade: **0**  
O&M Grade: **4**  
Clock Start/From:  
Clock To:  
1st Value:  
2nd Value:  
Value Percent:  
Continuous Index: **S01**  
Within 8" of Joint: **NO**  
Remarks:

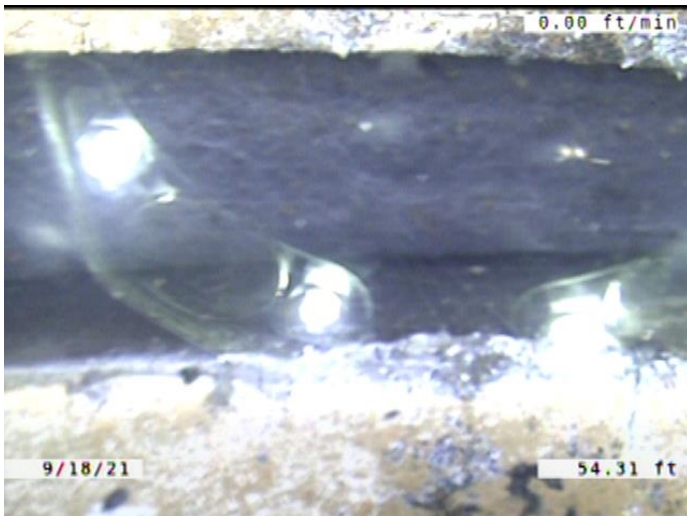
Code: **JSM**  
Description: **Joint Separated Medium**

Distance (ft): **54.3**  
Structural Grade: **3**  
O&M Grade: **0**  
Clock Start/From:  
Clock To:  
1st Value:  
2nd Value:  
Value Percent:  
Continuous Index:  
Within 8" of Joint: **NO**  
Remarks:

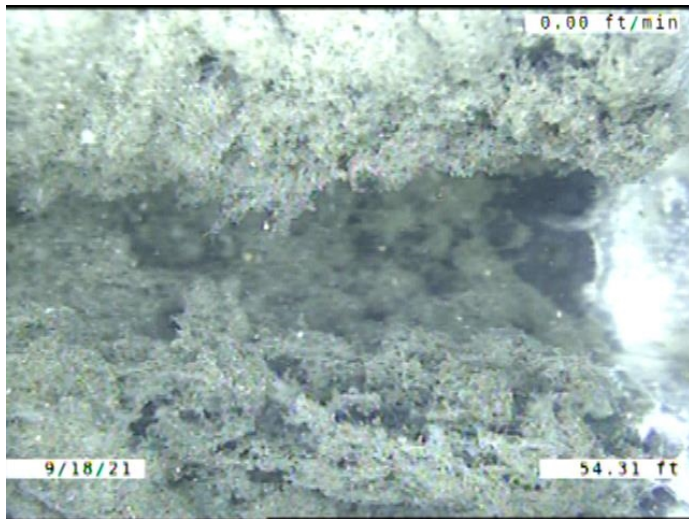
Code: **DSF**  
Description: **Deposits Settled Fine**

Distance (ft): **54.3**  
Structural Grade: **0**  
O&M Grade: **2**  
Clock Start/From: **5**  
Clock To: **7**  
1st Value:  
2nd Value:  
Value Percent: **5.000**  
Continuous Index: **S02**  
Within 8" of Joint: **YES**  
Remarks:
