Profile/Photo Observation Report

Date:	09/18/2021	Weather:		Coding:	PACP 7.0
Pipe Length (ft):	93.0	Owner:	City of Hobart	Pre Clean:	Light Cleaning
P.O.#:	YES502259	Surveyor:	S. Bucklin	PSR:	P-603-037-066
Customer:	City of Hobart	Clean Date:	08/25/2021	Shape:	C

Street:	North Wisconsin Street	Flow Control:	Not Controlled
City:	Hobart, IN	Year Renewed:	
Location:	Easement/Right of Way	Tape/Media #:	
Purpose:	Routine Assessment	Dia/Height:	8"
Use:	Sanitary Sewage Pipe	Material:	VCP
Drain Area:		Lining:	None
Category:	NA		
Comment:

Location Details:	JUST WEST OF THE ROAD IN THE GR	Direction of Survey:	Upstream
US MH:	M-503-066	DS MH:	M-603-037
		Total Length Surveyed (ft):	62.7

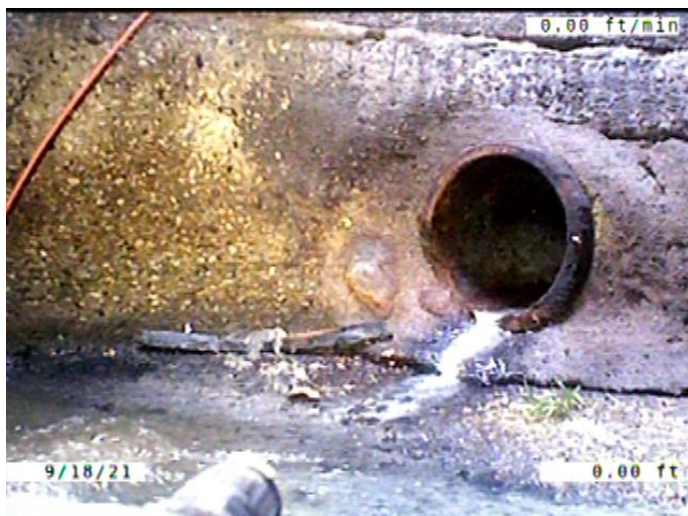
Code: **AMH**
Description: **Manhole**

Distance (ft): **.0**
Structural Grade: **0**
O&M Grade: **0**
Clock Start/From:
Clock To:
1st Value:
2nd Value:
Value Percent:
Continuous Index:
Within 8" of Joint: **NO**
Remarks: **M-603-037**

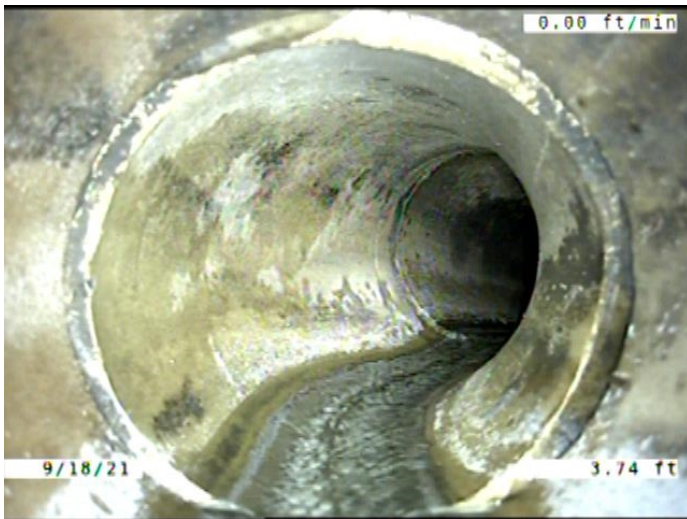
Code: **LR**
 Description: **Line Right**

Distance (ft): **3.7**
 Structural Grade: **0**
 O&M Grade: **4**
 Clock Start/From:
 Clock To:
 1st Value:
 2nd Value:
 Value Percent: **60.000**
 Continuous Index:
 Within 8" of Joint: **NO**
 Remarks:
