Profile/Photo Observation Report

Date:	04/15/2018	Weather:		Coding:	PACP 6.0
Pipe Length (ft):	135.9	Owner:	NA	Pre Clean:	Not Known
P.O.#:		Surveyor:	Selasie Honu	PSR:	P-503-068-067
Customer:		Clean Date:	01/01/1900	Shape:	C

Street:	N WISCONSIN ST	Flow Control:	Not Controlled
City:	Hobart, IN	Year Renewed:	
Location:	Other	Tape/Media #:	
Purpose:	Not Known	Dia/Height:	8"
Use:	Sanitary	Material:	VCP
Drain Area:	NA	Lining:	
Category:	NA		
Comment:

Location Details:		Direction of Survey:	Downstream
US MH:	M-503-067	DS MH:	M-503-068
		Total Length Surveyed (ft):	111.9

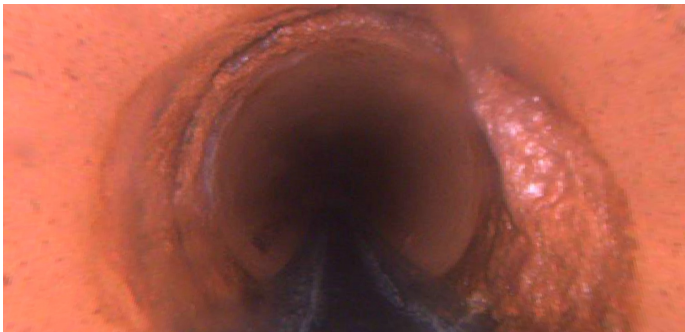
Code:	DAE
Description:	Deposits Attached Encrustation

Distance (ft):	4.2
Structural Grade:	0
O&M Grade:	3
Clock Start/From:	7
Clock To:	5
1st Value:	
2nd Value:	
Value Percent:	15.000
Continuous Index:	
Within 8" of Joint:	YES
Remarks:

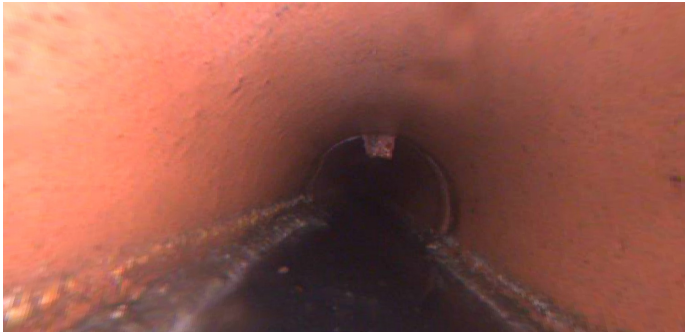
Code: **DAE**
Description: **Deposits Attached Encrustation**

Distance (ft): **13.9**
Structural Grade: **0**
O&M Grade: **2**
Clock Start/From: **12**
Clock To: **5**
1st Value:
2nd Value:
Value Percent: **5.000**
Continuous Index:
Within 8" of Joint: **YES**
Remarks:

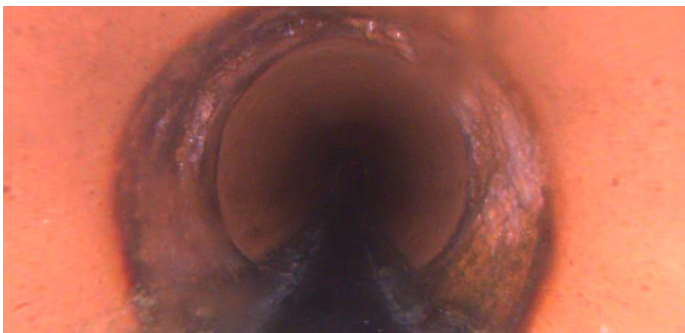
Code: **ID**
Description: **Infil Dripper**

Distance (ft): **18.5**
Structural Grade: **0**
O&M Grade: **3**
Clock Start/From: **12**
Clock To:
1st Value:
2nd Value:
Value Percent:
Continuous Index:
Within 8" of Joint: **YES**
Remarks:

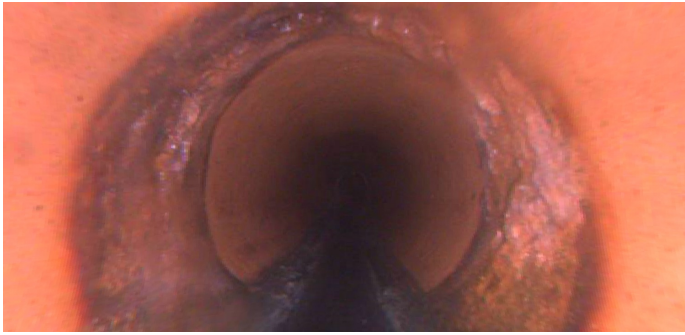
Code: **DAE**
Description: **Deposits Attached Encrustation**

Distance (ft): **18.6**
Structural Grade: **0**
O&M Grade: **2**
Clock Start/From: **7**
Clock To: **5**
1st Value:
2nd Value:
Value Percent: **10.000**
Continuous Index: **S01**
Within 8" of Joint: **YES**
Remarks:

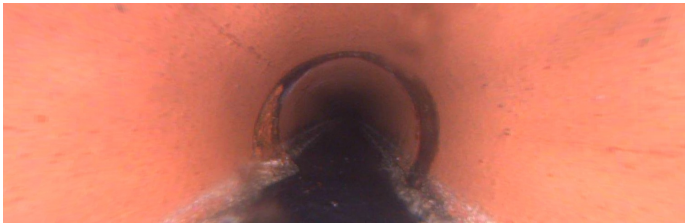
Code: **DAE**
Description: **Deposits Attached Encrustation**

Distance (ft): **52.1**
Structural Grade: **0**
O&M Grade: **2**
Clock Start/From: **7**
Clock To: **5**
1st Value:
2nd Value:
Value Percent: **10.000**
Continuous Index: **F01**
Within 8" of Joint: **YES**
Remarks:

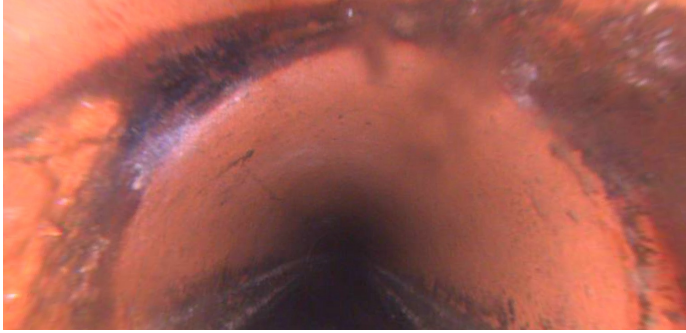
Code: **IW**
Description: **Infil Weeper**

Distance (ft): **52.7**
Structural Grade: **0**
O&M Grade: **2**
Clock Start/From: **8**
Clock To: **4**
1st Value:
2nd Value:
Value Percent:
Continuous Index:
Within 8" of Joint: **YES**
Remarks:

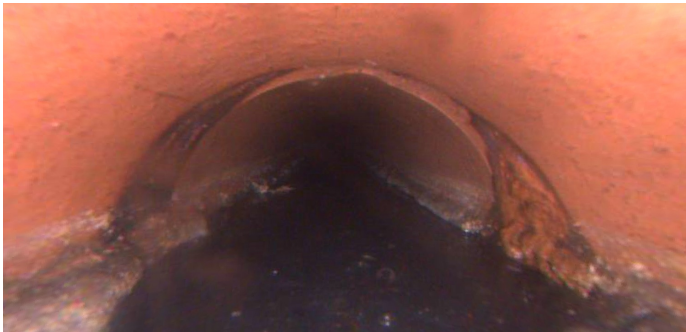
Code: **IW**
Description: **Infil Weeper**

Distance (ft): **60.6**
Structural Grade: **0**
O&M Grade: **2**
Clock Start/From: **8**
Clock To: **4**
1st Value:
2nd Value:
Value Percent:
Continuous Index:
Within 8" of Joint: **YES**
Remarks:

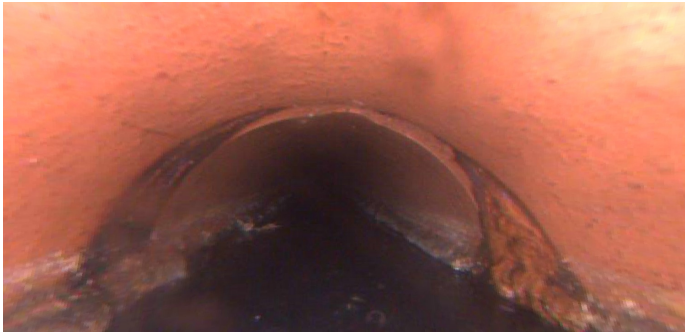
Code: **DAE**
Description: **Deposits Attached Encrustation**

Distance (ft): **60.6**
Structural Grade: **0**
O&M Grade: **2**
Clock Start/From: **9**
Clock To: **3**
1st Value:
2nd Value:
Value Percent: **5.000**
Continuous Index:
Within 8" of Joint: **YES**
Remarks:

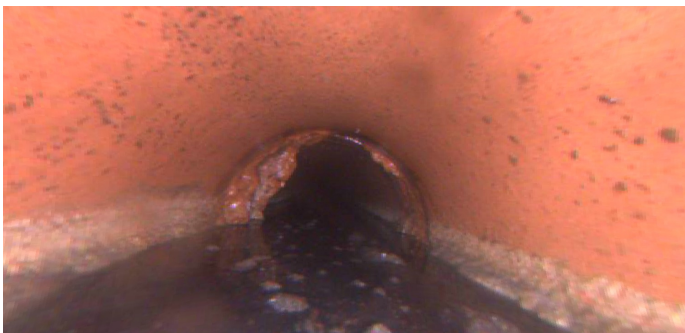
Code: **DAE**
Description: **Deposits Attached Encrustation**

Distance (ft): **70.5**
Structural Grade: **0**
O&M Grade: **2**
Clock Start/From: **9**
Clock To: **3**
1st Value:
2nd Value:
Value Percent: **10.000**
Continuous Index:
Within 8" of Joint: **YES**
Remarks:

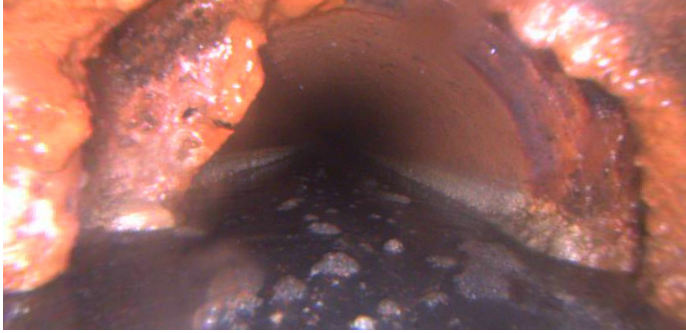
Code: ID
Description: Infil Dripper

Distance (ft): 71.2
Structural Grade: 0
O&M Grade: 3
Clock Start/From: 12
Clock To:
1st Value:
2nd Value:
Value Percent:
Continuous Index:
Within 8" of Joint: YES
Remarks:

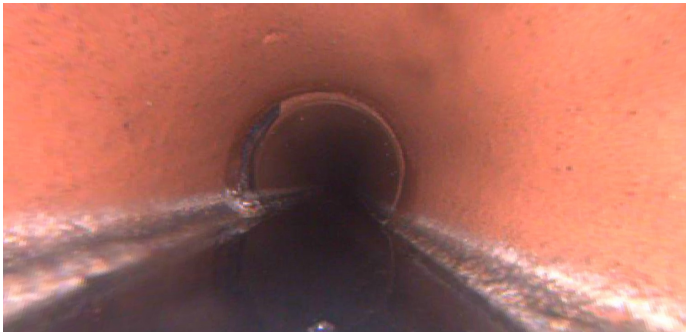
Code: IS
Description: Infil Stain

Distance (ft): 80.9
Structural Grade: 0
O&M Grade: 0
Clock Start/From: 7
Clock To: 5
1st Value:
2nd Value:
Value Percent:
Continuous Index:
Within 8" of Joint: YES
Remarks:

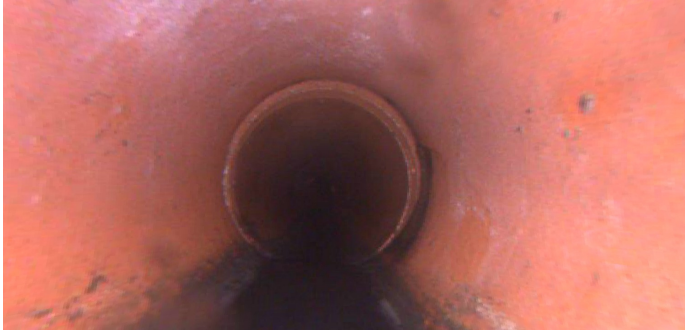
Code: **IS**
Description: **Infil Stain**

Distance (ft): **86.4**
Structural Grade: **0**
O&M Grade: **0**
Clock Start/From: **3**
Clock To: **5**
1st Value:
2nd Value:
Value Percent:
Continuous Index:
Within 8" of Joint: **YES**
Remarks:

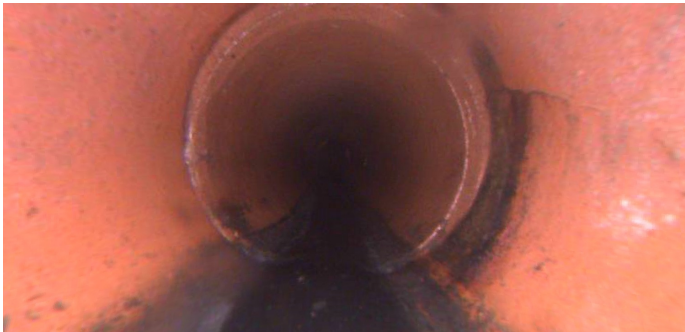
Code: **FL**
Description: **Fracture Longitudinal**

Distance (ft): **86.7**
Structural Grade: **3**
O&M Grade: **0**
Clock Start/From: **3**
Clock To:
1st Value:
2nd Value:
Value Percent:
Continuous Index:
Within 8" of Joint: **YES**
Remarks:

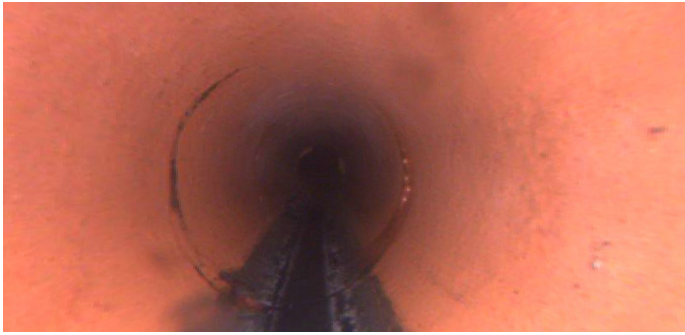
Code: **FC**
Description: **Fracture Circumferential**

Distance (ft): **88.6**
Structural Grade: **2**
O&M Grade: **0**
Clock Start/From: **1**
Clock To: **11**
1st Value:
2nd Value:
Value Percent:
Continuous Index:
Within 8" of Joint:
Remarks:

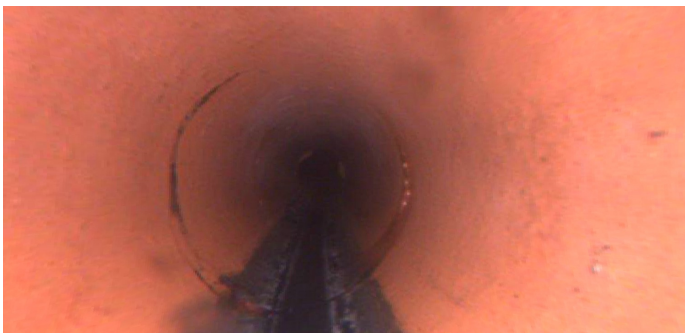
Code: **DAE**
Description: **Deposits Attached Encrustation**

Distance (ft): **88.6**
Structural Grade: **0**
O&M Grade: **2**
Clock Start/From: **1**
Clock To: **5**
1st Value:
2nd Value:
Value Percent: **5.000**
Continuous Index:
Within 8" of Joint: **NO**
Remarks:

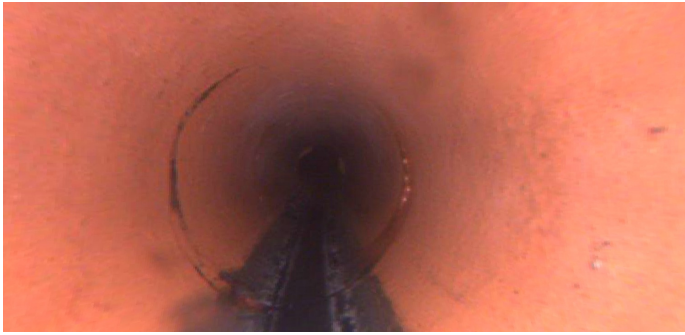
Code: **IS**
Description: **Infil Stain**

Distance (ft): **88.6**
Structural Grade: **0**
O&M Grade: **0**
Clock Start/From: **6**
Clock To: **11**
1st Value:
2nd Value:
Value Percent:
Continuous Index:
Within 8" of Joint:
Remarks:

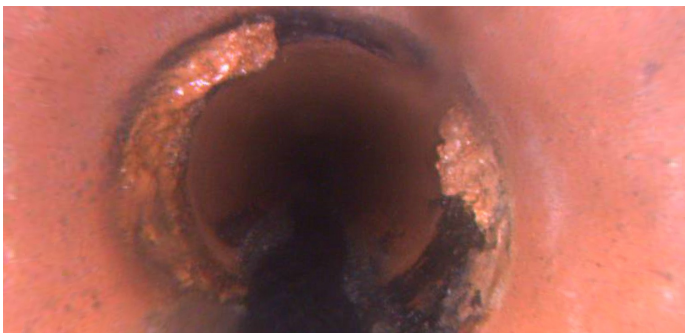
Code: **IW**
Description: **Infil Weeper**

Distance (ft): **92.1**
Structural Grade: **0**
O&M Grade: **2**
Clock Start/From: **8**
Clock To: **4**
1st Value:
2nd Value:
Value Percent:
Continuous Index:
Within 8" of Joint: **YES**
Remarks:

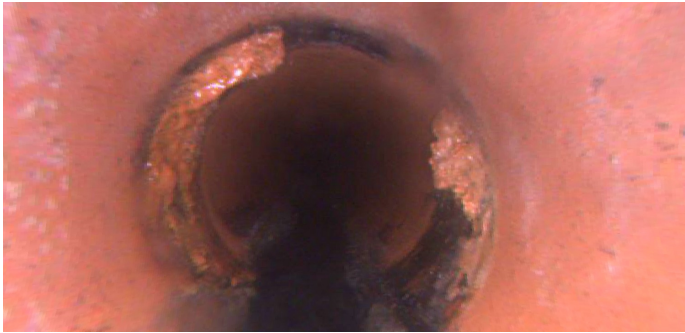
Code: **DAE**
Description: **Deposits Attached Encrustation**

Distance (ft): **92.1**
Structural Grade: **0**
O&M Grade: **3**
Clock Start/From: **7**
Clock To: **5**
1st Value:
2nd Value:
Value Percent: **20.000**
Continuous Index:
Within 8" of Joint: **YES**
Remarks:

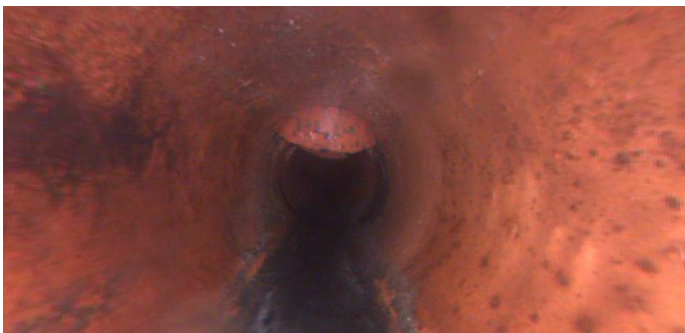
Code: **TBI**
Description: **Tap Break-in Intruding**

Distance (ft): **110.0**
Structural Grade: **0**
O&M Grade: **2**
Clock Start/From: **12**
Clock To:
1st Value: **6.000**
2nd Value: **2.000**
Value Percent:
Continuous Index:
Within 8" of Joint:
Remarks:

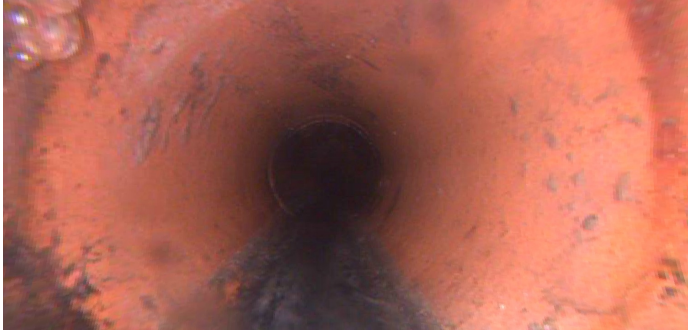
Code:	MSA
Description:	Abandoned Survey
Distance (ft):	111.9
Structural Grade:	0
O&M Grade:	0
Clock Start/From:	
Clock To:	
1st Value:	
2nd Value:	
Value Percent:	
Continuous Index:	
Within 8" of Joint:	NO
Remarks:	camera stopped due to intruding tap
