Profile/Photo Observation Report

Date:	10/24/2021	Weather:		Coding:	PACP 6.0
Pipe Length (ft):		Owner:	Hobart, IN	Pre Clean:	Not Known
P.O.#:	995_1	Surveyor:	M. Pielacha	PSR:	P-603-018-067
Customer:	Hobart, IN	Clean Date:		Shape:	C

Street:	37th Avenue	Flow Control:	
City:	Hobart, IN	Year Renewed:	
Location:	Light Highway	Tape/Media #:	995
Purpose:	Routine Assessment	Dia/Height:	8"
Use:	Sanitary	Material:	VCP
Drain Area:		Lining:	
Category:	NA		
Comment:

Location Details:		Direction of Survey:	Upstream
US MH:	M-503-67	DS MH:	M-603-18
		Total Length Surveyed (ft):	332.8

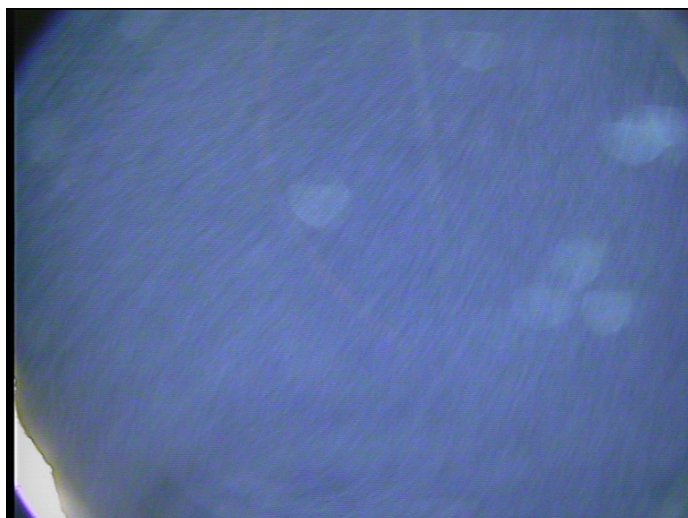
Code: **AMH**
 Description: **Manhole**

Distance (ft): **.0**
 Structural Grade: **0**
 O&M Grade: **0**
 Clock Start/From:
 Clock To:
 1st Value:
 2nd Value:
 Value Percent:
 Continuous Index:
 Within 8" of Joint: **NO**
 Remarks: **M-603-18**

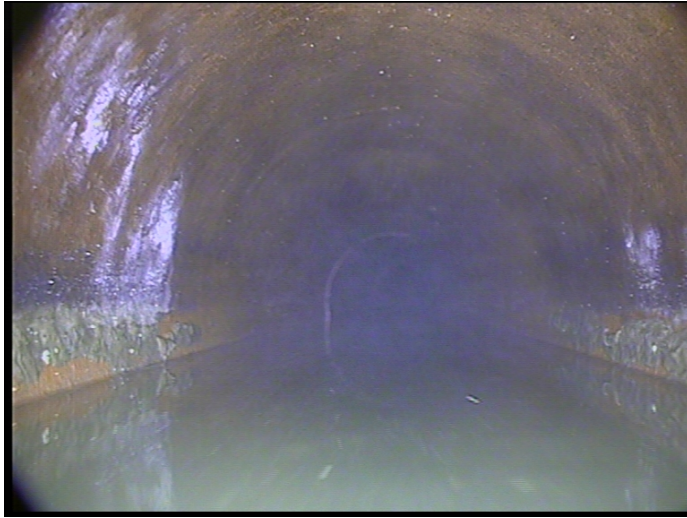
Code: **MWL**
Description: **Water Level**

Distance (ft): **.0**
Structural Grade: **0**
O&M Grade: **0**
Clock Start/From:
Clock To:
1st Value:
2nd Value:
Value Percent: **15.000**
Continuous Index:
Within 8" of Joint: **NO**
Remarks:

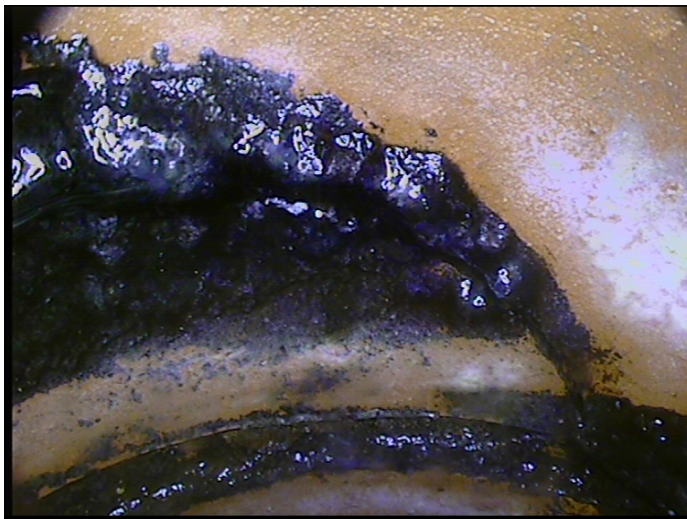
Code: **FC**
Description: **Fracture Circumferential**

Distance (ft): **17.6**
Structural Grade: **2**
O&M Grade: **0**
Clock Start/From: **9**
Clock To: **12**
1st Value:
2nd Value:
Value Percent:
Continuous Index:
Within 8" of Joint: **YES**
Remarks:

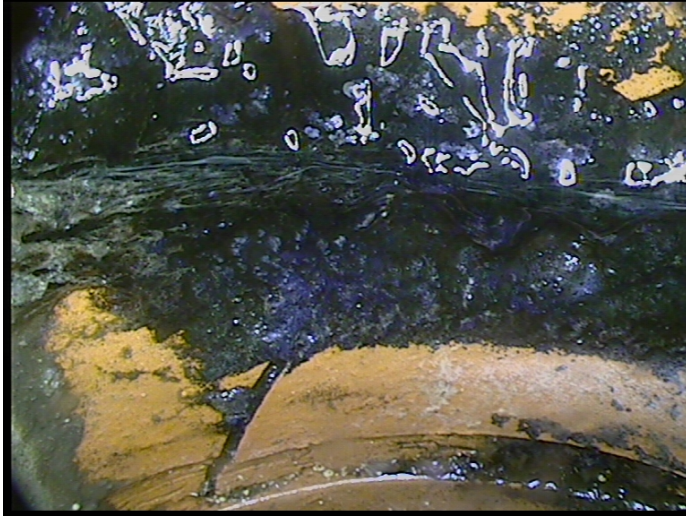
Code:	DAE
Description:	Deposits Attached Encrustation
Distance (ft):	17.6
Structural Grade:	0
O&M Grade:	2
Clock Start/From:	7
Clock To:	5
1st Value:	
2nd Value:	
Value Percent:	5.000
Continuous Index:	
Within 8" of Joint:	YES
Remarks:

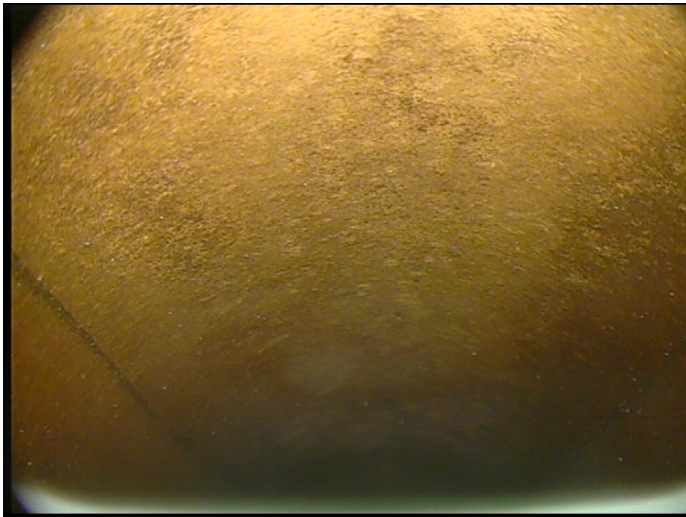
Code:	MWL
Description:	Water Level
Distance (ft):	28.2
Structural Grade:	0
O&M Grade:	0
Clock Start/From:	
Clock To:	
1st Value:	
2nd Value:	
Value Percent:	45.000
Continuous Index:	
Within 8" of Joint:	NO
Remarks:

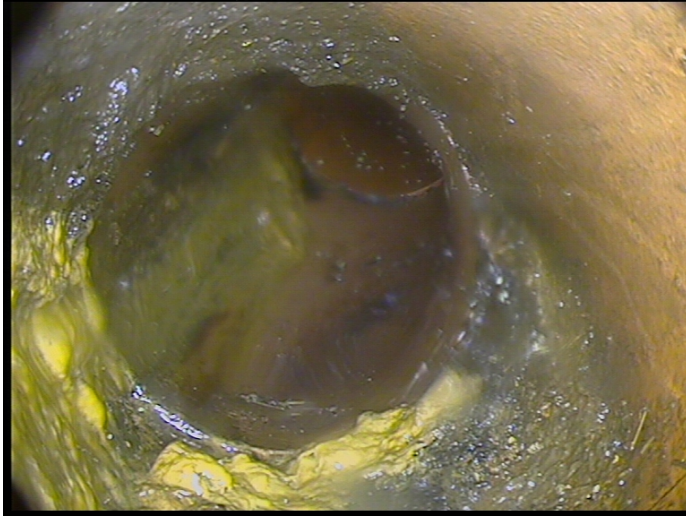
Code: **TF**
Description: **Tap Factory**

Distance (ft): **146.2**
Structural Grade: **0**
O&M Grade: **0**
Clock Start/From: **10**
Clock To:
1st Value: **4.000**
2nd Value:
Value Percent:
Continuous Index:
Within 8" of Joint: **NO**
Remarks:

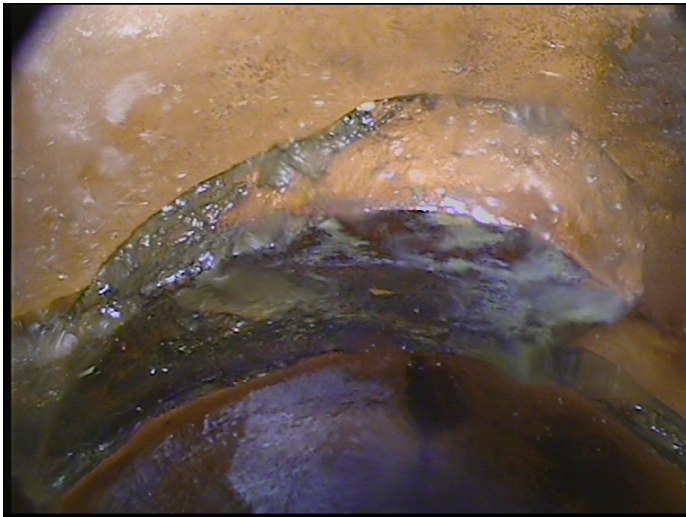
Code: **B**
Description: **Broken**

Distance (ft): **196.8**
Structural Grade: **5**
O&M Grade: **0**
Clock Start/From: **9**
Clock To: **12**
1st Value:
2nd Value:
Value Percent:
Continuous Index:
Within 8" of Joint: **YES**
Remarks:

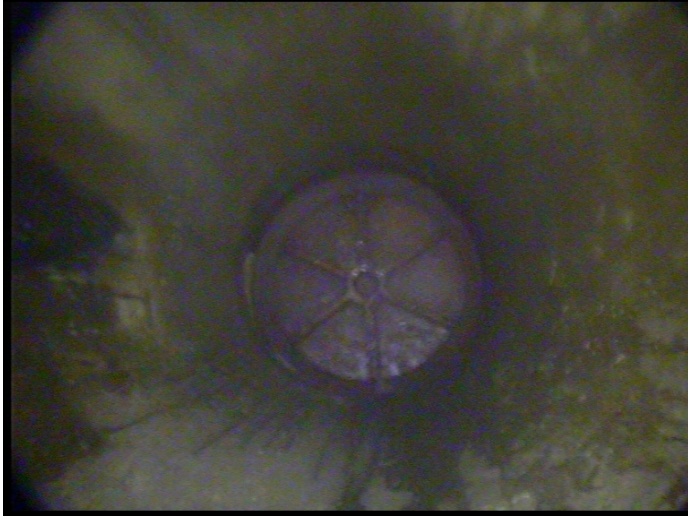
Code:	AMH
Description:	Manhole
Distance (ft):	332.8
Structural Grade:	0
O&M Grade:	0
Clock Start/From:	
Clock To:	
1st Value:	
2nd Value:	
Value Percent:	
Continuous Index:	
Within 8" of Joint:	NO
Remarks:	M-503-67
