Profile/Photo Observation Report

Date:	04/15/2018	Weather:		Coding:	PACP 6.0
Pipe Length (ft):	203.0	Owner:	NA	Pre Clean:	Not Known
P.O.#:		Surveyor:	Selasie Honu	PSR:	P-503-070-069
Customer:		Clean Date:	01/01/1900	Shape:	C

Street:	W 40th ave	Flow Control:	Not Controlled
City:	Hobart, IN	Year Renewed:	
Location:	Other	Tape/Media #:	
Purpose:	Not Known	Dia/Height:	8"
Use:	Sanitary	Material:	VCP
Drain Area:	NA	Lining:	
Category:	NA		
Comment:

Location Details:		Direction of Survey:	Downstream
US MH:	M-503-069	DS MH:	M-503-070
		Total Length Surveyed (ft):	66.7

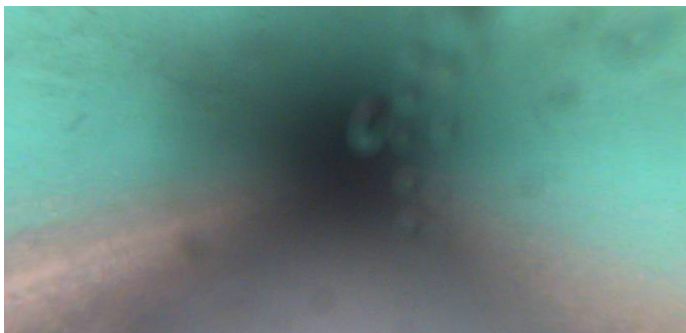
Code: **AMH**
Description: **Manhole**

Distance (ft): **.0**
Structural Grade: **0**
O&M Grade: **0**
Clock Start/From:
Clock To:
1st Value:
2nd Value:
Value Percent:
Continuous Index:
Within 8" of Joint: **NO**
Remarks: **M-503-069**

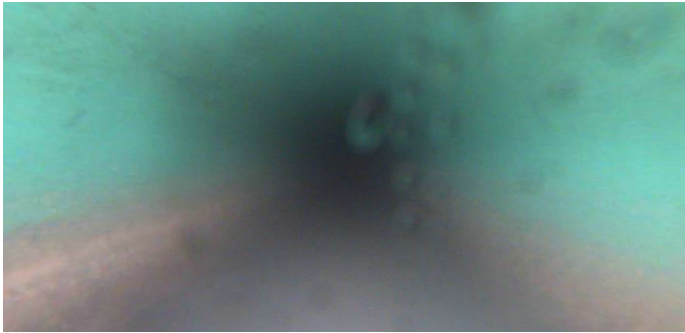
Code:	MWL
Description:	Water Level

Distance (ft):	.0
Structural Grade:	0
O&M Grade:	0
Clock Start/From:	
Clock To:	
1st Value:	
2nd Value:	
Value Percent:	5.000
Continuous Index:	
Within 8" of Joint:	NO
Remarks:

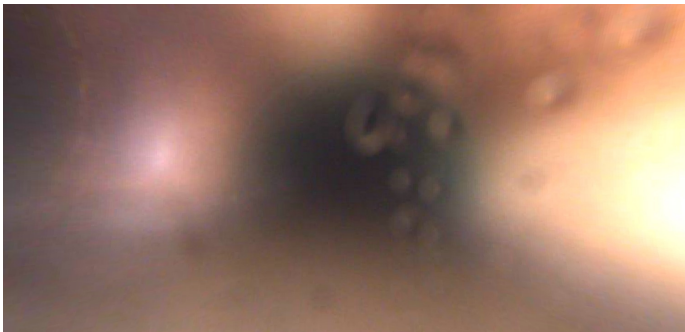
Code:	TF
Description:	Tap Factory

Distance (ft):	64.2
Structural Grade:	0
O&M Grade:	0
Clock Start/From:	9
Clock To:	
1st Value:	4.000
2nd Value:	
Value Percent:	
Continuous Index:	
Within 8" of Joint:	
Remarks:

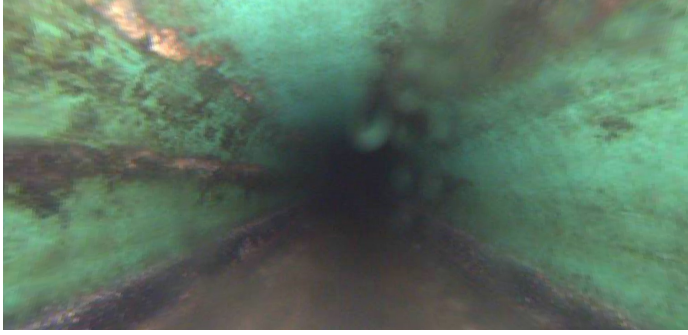
Code:	MSA
Description:	Abandoned Survey
Distance (ft):	66.7
Structural Grade:	0
O&M Grade:	0
Clock Start/From:	
Clock To:	
1st Value:	
2nd Value:	
Value Percent:	
Continuous Index:	
Within 8" of Joint:	NO
Remarks:	camera stopped
