Profile/Photo Observation Report

Street:	W 38TH AVE	Flow Control:	Not Controlled
City:	Hobart, IN	Year Renewed:	
Location:	Other	Tape/Media #:	
Purpose:	Not Known	Dia/Height:	12"
Use:	Sanitary	Material:	VCP
Drain Area:	NA	Lining:	
Category:	NA		
Comment:

Location Details:		Direction of Survey:	Downstream
US MH:	M-503-071	DS MH:	M-503-063
		Total Length Surveyed (ft):	33.2

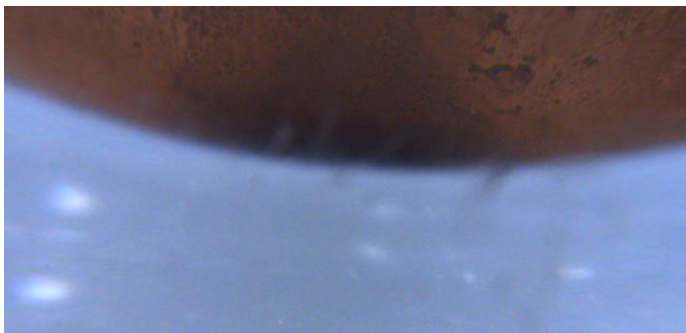
Code: **AMH**
Description: **Manhole**

Distance (ft): **.0**
Structural Grade: **0**
O&M Grade: **0**
Clock Start/From:
Clock To:
1st Value:
2nd Value:
Value Percent:
Continuous Index:
Within 8" of Joint: **NO**
Remarks: **M-503-071**

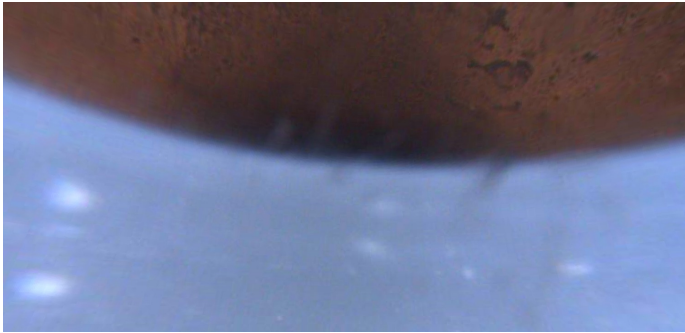
Code:	MWL
Description:	Water Level

Distance (ft):	.0
Structural Grade:	0
O&M Grade:	0
Clock Start/From:	
Clock To:	
1st Value:	
2nd Value:	
Value Percent:	40.000
Continuous Index:	
Within 8" of Joint:	NO
Remarks:

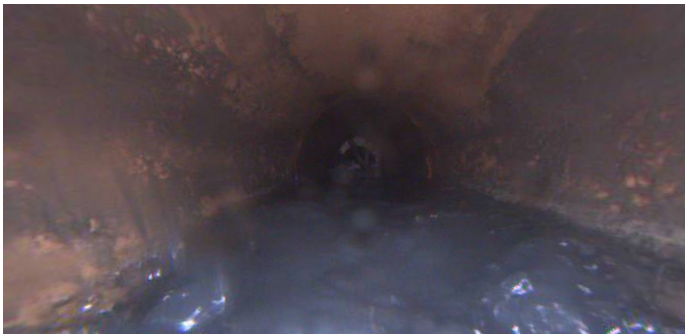
Code:	MGO
Description:	General Observation

Distance (ft):	5.6
Structural Grade:	0
O&M Grade:	0
Clock Start/From:	
Clock To:	
1st Value:	
2nd Value:	
Value Percent:	
Continuous Index:	
Within 8" of Joint:	NO
Remarks:	REAR CAMERA

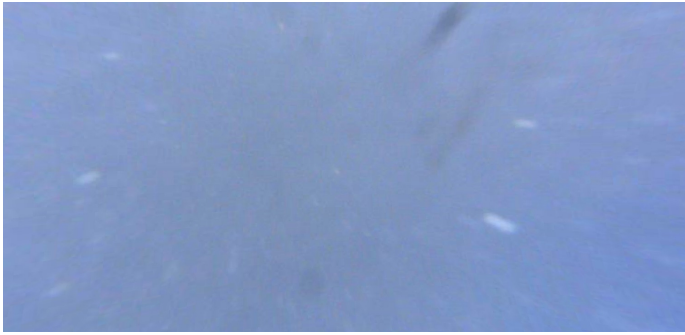
Code: **MCU**
Description: **Camera Underwater**

Distance (ft): **28.6**
Structural Grade: **0**
O&M Grade: **4**
Clock Start/From:
Clock To:
1st Value:
2nd Value:
Value Percent:
Continuous Index:
Within 8" of Joint: **NO**
Remarks:

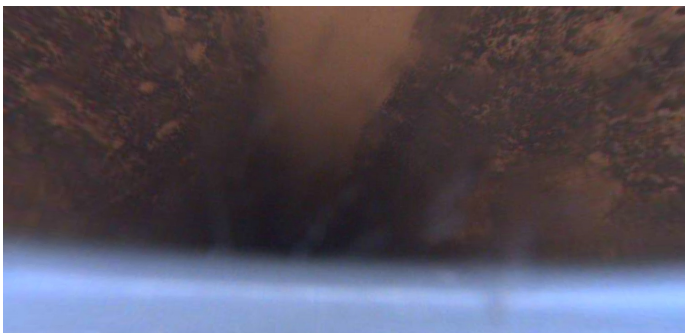
Code: **MSA**
Description: **Abandoned Survey**

Distance (ft): **33.2**
Structural Grade: **0**
O&M Grade: **0**
Clock Start/From:
Clock To:
1st Value:
2nd Value:
Value Percent:
Continuous Index:
Within 8" of Joint: **NO**
Remarks: **UNDER WATER**
