## Profile/Photo Observation Report

Date:	<b>04/14/2018</b>	Weather:		Coding:	<b>PACP 6.0</b>
Pipe Length (ft):	<b>176.2</b>	Owner:	<b>NA</b>	Pre Clean:	<b>Not Known</b>
P.O.#:		Surveyor:	<b>Jen Costello</b>	PSR:	<b>P-503-071-063</b>
Customer:		Clean Date:	<b>01/01/1900</b>	Shape:	<b>C</b>

Street:	<b>W 40th ave</b>	Flow Control:	<b>Not Controlled</b>
City:	<b>Hobart, IN</b>	Year Renewed:	
Location:	<b>Other</b>	Tape/Media #:	
Purpose:	<b>Not Known</b>	Dia/Height:	<b>12"</b>
Use:	<b>Sanitary</b>	Material:	<b>VCP</b>
Drain Area:	<b>NA</b>	Lining:	
Category:	<b>NA</b>		
Comment:

Location Details:		Direction of Survey:	<b>Downstream</b>
US MH:	<b>M-503-071</b>	DS MH:	<b>M-503-063</b>
		Total Length Surveyed (ft):	<b>33.2</b>

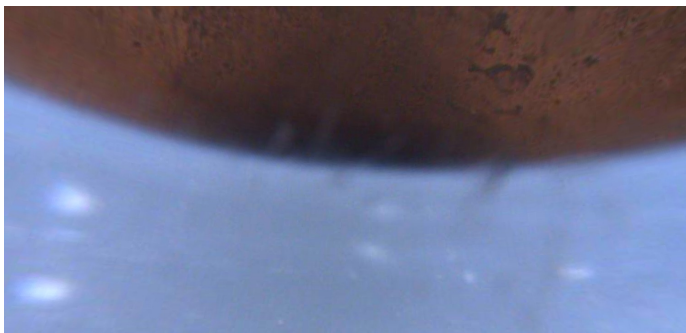
Code: **AMH**  
Description: **Manhole**

Distance (ft): **.0**  
Structural Grade: **0**  
O&M Grade: **0**  
Clock Start/From:  
Clock To:  
1st Value:  
2nd Value:  
Value Percent:  
Continuous Index:  
Within 8" of Joint: **NO**  
Remarks: **M-503-071**

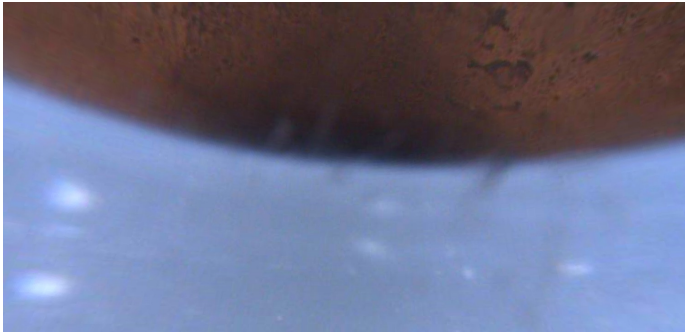
Code:	<b>MWL</b>
Description:	<b>Water Level</b>

Distance (ft):	<b>.0</b>
Structural Grade:	<b>0</b>
O&M Grade:	<b>0</b>
Clock Start/From:	
Clock To:	
1st Value:	
2nd Value:	
Value Percent:	<b>40.000</b>
Continuous Index:	
Within 8" of Joint:	<b>NO</b>
Remarks:

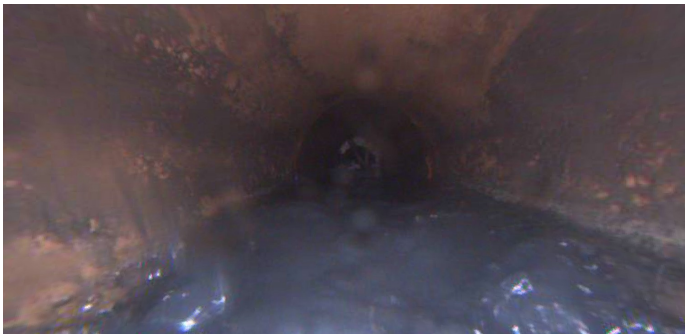
Code:	<b>MGO</b>
Description:	<b>General Observation</b>

Distance (ft):	<b>5.6</b>
Structural Grade:	<b>0</b>
O&M Grade:	<b>0</b>
Clock Start/From:	
Clock To:	
1st Value:	
2nd Value:	
Value Percent:	
Continuous Index:	
Within 8" of Joint:	<b>NO</b>
Remarks:	<b>REAR CAMERA</b>

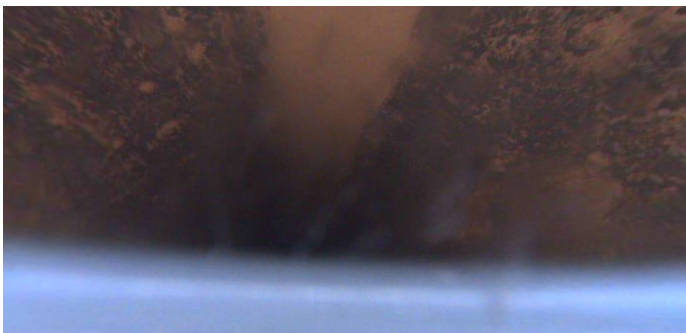
Code: **MSA**  
Description: **Abandoned Survey**

Distance (ft): **33.2**  
Structural Grade: **0**  
O&M Grade: **0**  
Clock Start/From:  
Clock To:  
1st Value:  
2nd Value:  
Value Percent:  
Continuous Index:  
Within 8" of Joint: **NO**  
Remarks: **UNDER WATER**
