Profile/Photo Observation Report

Date:	04/14/2018	Weather:		Coding:	PACP 6.0
Pipe Length (ft):	176.2	Owner:	NA	Pre Clean:	Not Known
P.O.#:		Surveyor:	Jen Costello	PSR:	P-503-071-063
Customer:		Clean Date:	01/01/1900	Shape:	C

Street:	W 40th ave	Flow Control:	Not Controlled
City:	Hobart, IN	Year Renewed:	
Location:	Other	Tape/Media #:	
Purpose:	Not Known	Dia/Height:	10"
Use:	Sanitary	Material:	VCP
Drain Area:	NA	Lining:	
Category:	NA		
Comment:

Location Details:		Direction of Survey:	Downstream
US MH:	M-503-071	DS MH:	M-503-063
		Total Length Surveyed (ft):	307.9

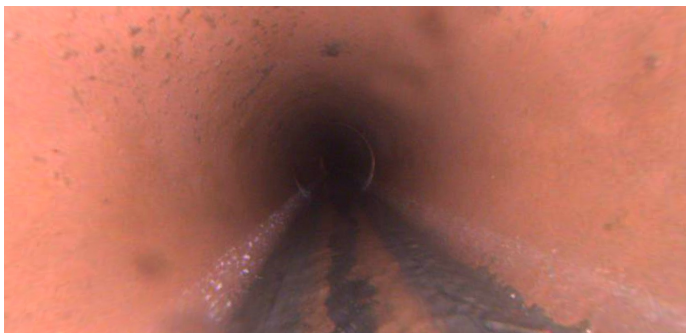
Code: **AMH**
Description: **Manhole**

Distance (ft): **.0**
Structural Grade: **0**
O&M Grade: **0**
Clock Start/From:
Clock To:
1st Value:
2nd Value:
Value Percent:
Continuous Index:
Within 8" of Joint: **NO**
Remarks: **M-503-071**

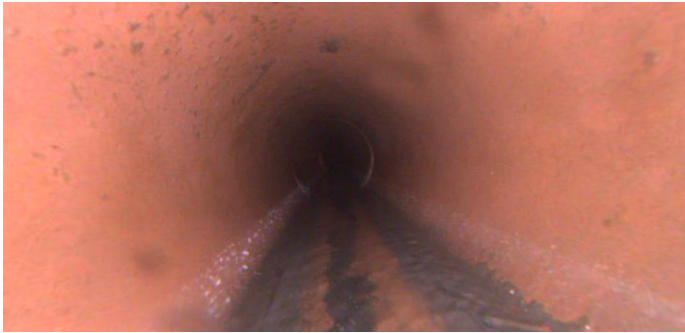
Code:	MWL
Description:	Water Level

Distance (ft):	.0
Structural Grade:	0
O&M Grade:	0
Clock Start/From:	
Clock To:	
1st Value:	
2nd Value:	
Value Percent:	5.000
Continuous Index:	
Within 8" of Joint:	NO
Remarks:

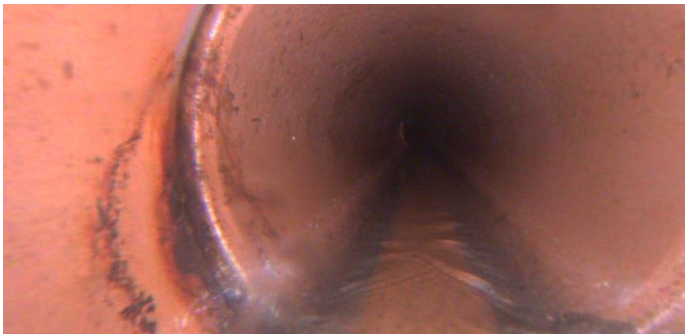
Code:	IS
Description:	Infil Stain

Distance (ft):	3.7
Structural Grade:	0
O&M Grade:	0
Clock Start/From:	8
Clock To:	11
1st Value:	
2nd Value:	
Value Percent:	
Continuous Index:	
Within 8" of Joint:	YES
Remarks:

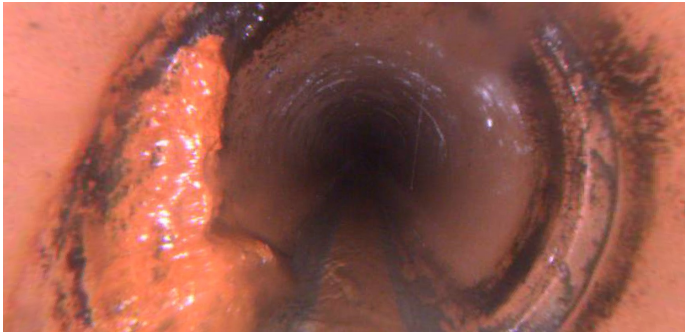
Code: **DAE**
Description: **Deposits Attached Encrustation**

Distance (ft): **8.8**
Structural Grade: **0**
O&M Grade: **2**
Clock Start/From: **7**
Clock To: **11**
1st Value:
2nd Value:
Value Percent: **10.000**
Continuous Index:
Within 8" of Joint: **YES**
Remarks:

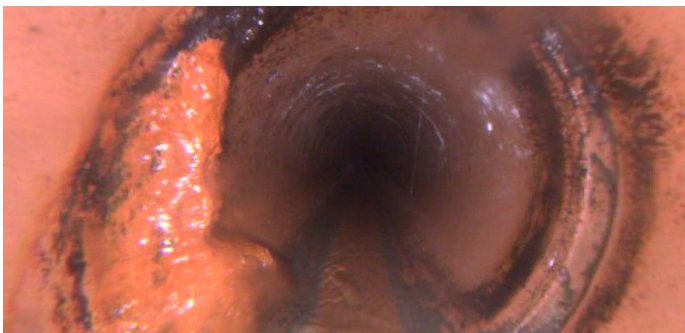
Code: **IW**
Description: **Infil Weeper**

Distance (ft): **8.8**
Structural Grade: **0**
O&M Grade: **2**
Clock Start/From: **8**
Clock To: **4**
1st Value:
2nd Value:
Value Percent:
Continuous Index:
Within 8" of Joint: **YES**
Remarks:

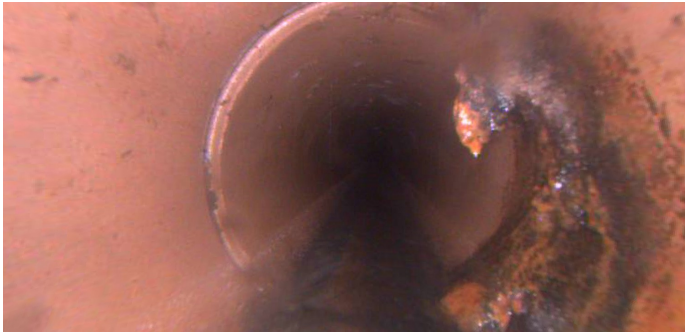
Code: **ID**
Description: **Infil Dripper**

Distance (ft): **19.0**
Structural Grade: **0**
O&M Grade: **3**
Clock Start/From: **1**
Clock To:
1st Value:
2nd Value:
Value Percent:
Continuous Index:
Within 8" of Joint: **YES**
Remarks:

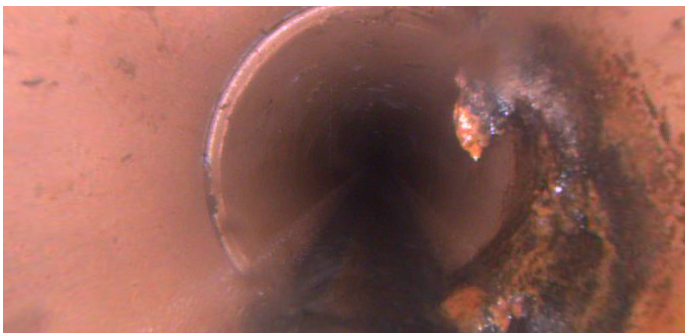
Code: **DAE**
Description: **Deposits Attached Encrustation**

Distance (ft): **19.0**
Structural Grade: **0**
O&M Grade: **2**
Clock Start/From: **1**
Clock To: **4**
1st Value:
2nd Value:
Value Percent: **10.000**
Continuous Index:
Within 8" of Joint: **YES**
Remarks:

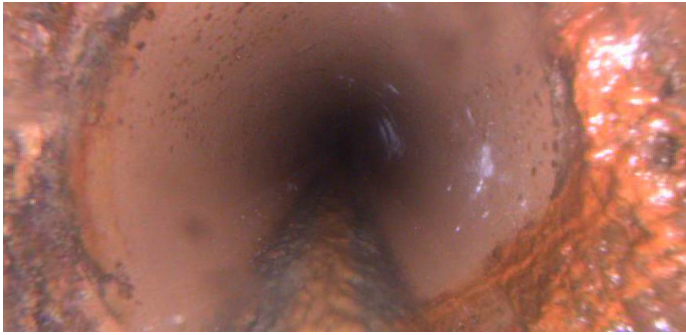
Code: **DAE**
Description: **Deposits Attached Encrustation**

Distance (ft): **35.1**
Structural Grade: **0**
O&M Grade: **2**
Clock Start/From: **8**
Clock To: **4**
1st Value:
2nd Value:
Value Percent: **5.000**
Continuous Index: **S01**
Within 8" of Joint: **YES**
Remarks:

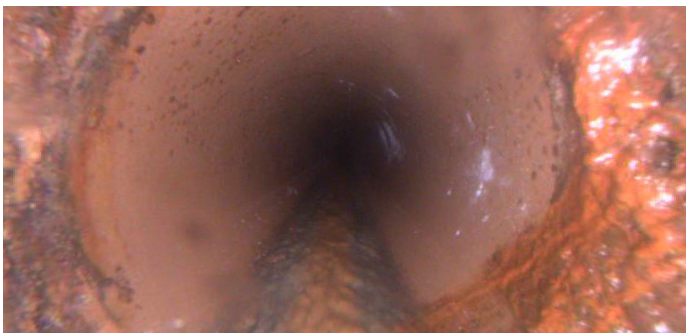
Code: **IW**
Description: **Infil Weeper**

Distance (ft): **35.1**
Structural Grade: **0**
O&M Grade: **2**
Clock Start/From: **8**
Clock To: **4**
1st Value:
2nd Value:
Value Percent:
Continuous Index: **S02**
Within 8" of Joint: **YES**
Remarks:

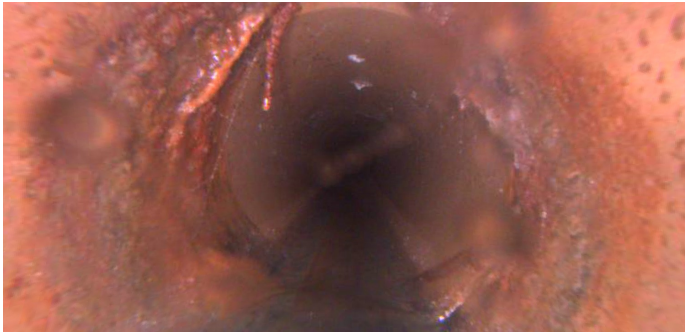
Code: ID
Description: Infil Dripper

Distance (ft): 50.4
Structural Grade: 0
O&M Grade: 3
Clock Start/From: 11
Clock To:
1st Value:
2nd Value:
Value Percent:
Continuous Index:
Within 8" of Joint: YES
Remarks:

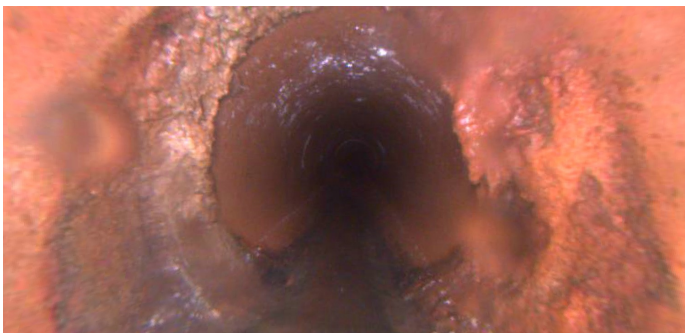
Code: ID
Description: Infil Dripper

Distance (ft): 123.8
Structural Grade: 0
O&M Grade: 3
Clock Start/From: 1
Clock To:
1st Value:
2nd Value:
Value Percent:
Continuous Index:
Within 8" of Joint: YES
Remarks:

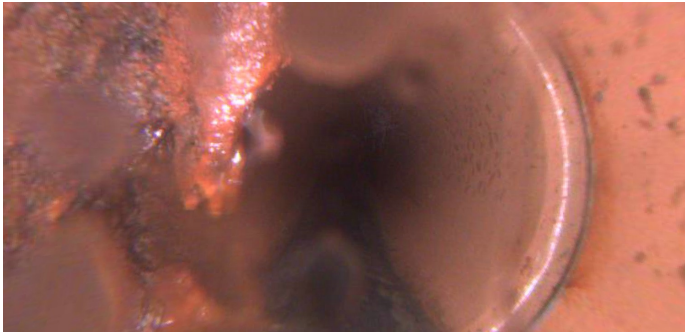
Code: ID
Description: Infil Dripper

Distance (ft): 259.9
Structural Grade: 0
O&M Grade: 3
Clock Start/From: 11
Clock To:
1st Value:
2nd Value:
Value Percent:
Continuous Index:
Within 8" of Joint: YES
Remarks:

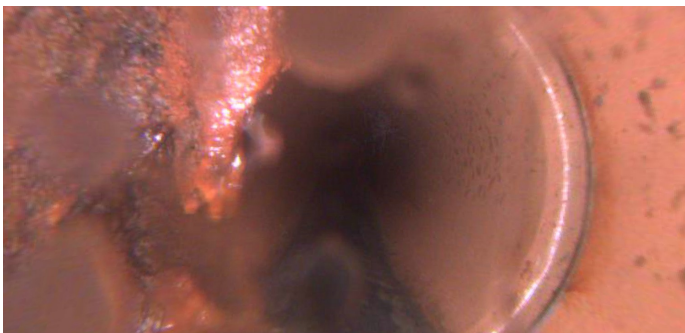
Code: DAE
Description: Deposits Attached Encrustation

Distance (ft): 259.9
Structural Grade: 0
O&M Grade: 3
Clock Start/From: 7
Clock To: 11
1st Value:
2nd Value:
Value Percent: 20.000
Continuous Index:
Within 8" of Joint: YES
Remarks:

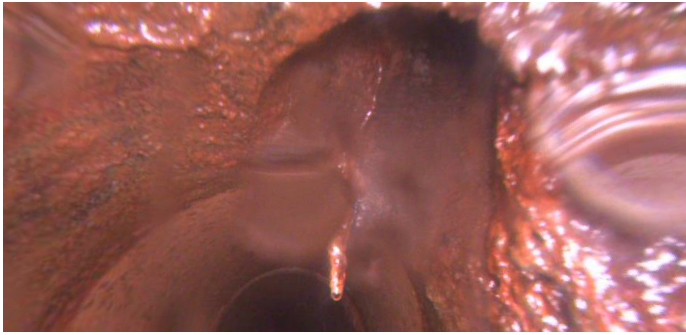
Code: **TFD**
Description: **Tap Factory Defective**

Distance (ft): **266.1**
Structural Grade: **0**
O&M Grade: **2**
Clock Start/From: **1**
Clock To:
1st Value: **4.000**
2nd Value:
Value Percent:
Continuous Index:
Within 8" of Joint:
Remarks: **DAE**

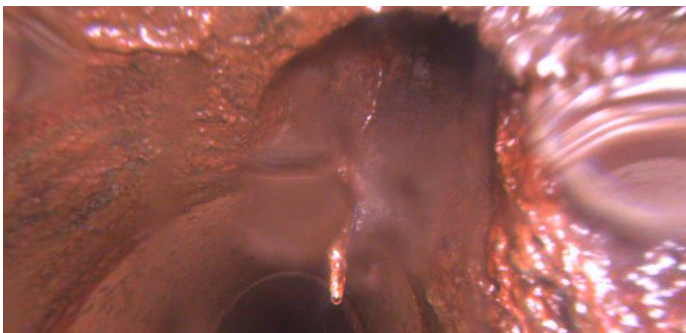
Code: **DAE**
Description: **Deposits Attached Encrustation**

Distance (ft): **266.1**
Structural Grade: **0**
O&M Grade: **2**
Clock Start/From: **8**
Clock To: **4**
1st Value:
2nd Value:
Value Percent: **10.000**
Continuous Index:
Within 8" of Joint: **NO**
Remarks:

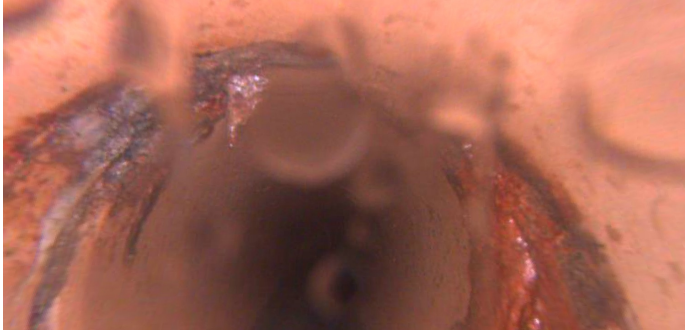
Code: ID
Description: Infil Dripper

Distance (ft): 277.8
Structural Grade: 0
O&M Grade: 3
Clock Start/From: 12
Clock To:
1st Value:
2nd Value:
Value Percent:
Continuous Index:
Within 8" of Joint: YES
Remarks:

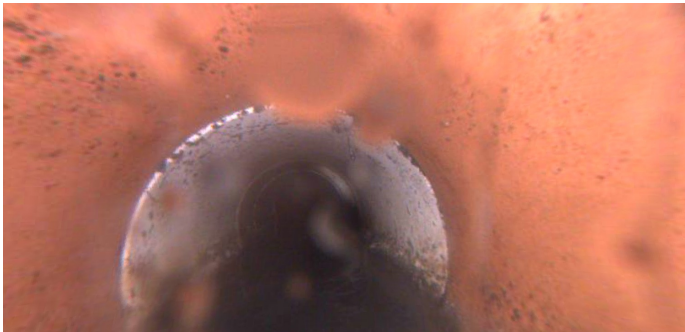
Code: IW
Description: Infil Weeper

Distance (ft): 298.6
Structural Grade: 0
O&M Grade: 2
Clock Start/From: 8
Clock To: 4
1st Value:
2nd Value:
Value Percent:
Continuous Index: F02
Within 8" of Joint: YES
Remarks:

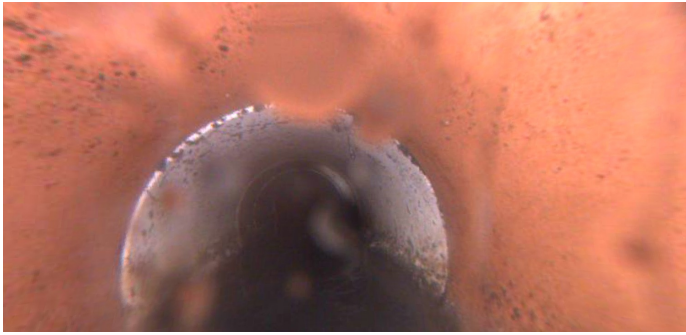
Code: **DAE**
Description: **Deposits Attached Encrustation**

Distance (ft): **298.6**
Structural Grade: **0**
O&M Grade: **2**
Clock Start/From: **8**
Clock To: **4**
1st Value:
2nd Value:
Value Percent: **5.000**
Continuous Index: **F01**
Within 8" of Joint: **YES**
Remarks:

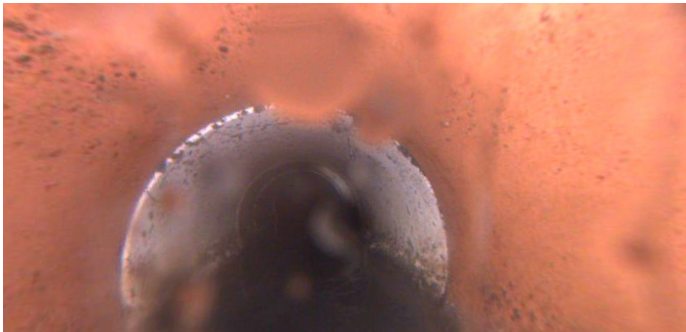
Code: **MMC**
Description: **Material Change**

Distance (ft): **298.6**
Structural Grade: **0**
O&M Grade: **0**
Clock Start/From:
Clock To:
1st Value:
2nd Value:
Value Percent:
Continuous Index:
Within 8" of Joint: **NO**
Remarks: **pvc**

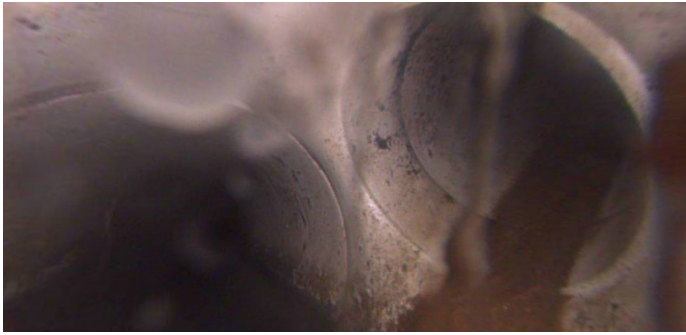
Code: **TFA**
Description: **Tap Factory Active**

Distance (ft): **300.6**
Structural Grade: **0**
O&M Grade: **0**
Clock Start/From: **2**
Clock To:
1st Value: **4.000**
2nd Value:
Value Percent:
Continuous Index:
Within 8" of Joint:
Remarks:

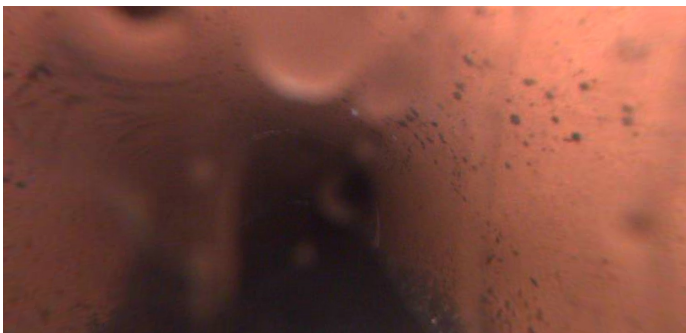
Code: **MMC**
Description: **Material Change**

Distance (ft): **303.2**
Structural Grade: **0**
O&M Grade: **0**
Clock Start/From:
Clock To:
1st Value:
2nd Value:
Value Percent:
Continuous Index:
Within 8" of Joint: **NO**
Remarks: **dae**

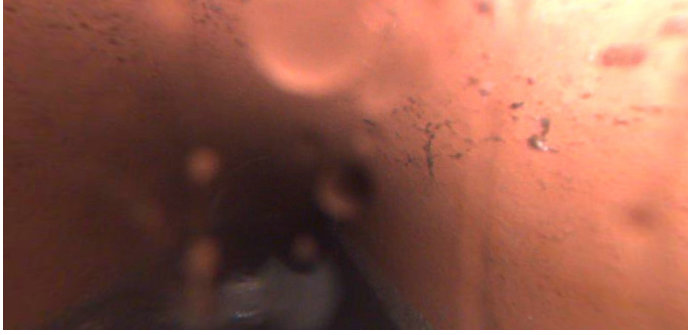
Code:	MSA
Description:	Abandoned Survey
Distance (ft):	307.9
Structural Grade:	0
O&M Grade:	0
Clock Start/From:	
Clock To:	
1st Value:	
2nd Value:	
Value Percent:	
Continuous Index:	
Within 8" of Joint:	NO
Remarks:	debris under water
