Profile/Photo Observation Report

Street:	West 38th Avenue	Flow Control:	Not Controlled
City:	Hobart, IN	Year Renewed:	
Location:	Ditch	Tape/Media #:	
Purpose:	Routine Assessment	Dia/Height:	12"
Use:	Sanitary Sewage Pipe	Material:	VCP
Drain Area:		Lining:	None
Category:	NA		
Comment:

Location Details:		Direction of Survey:	Downstream
US MH:	M-503-071	DS MH:	M-503-063
		Total Length Surveyed (ft):	75.2

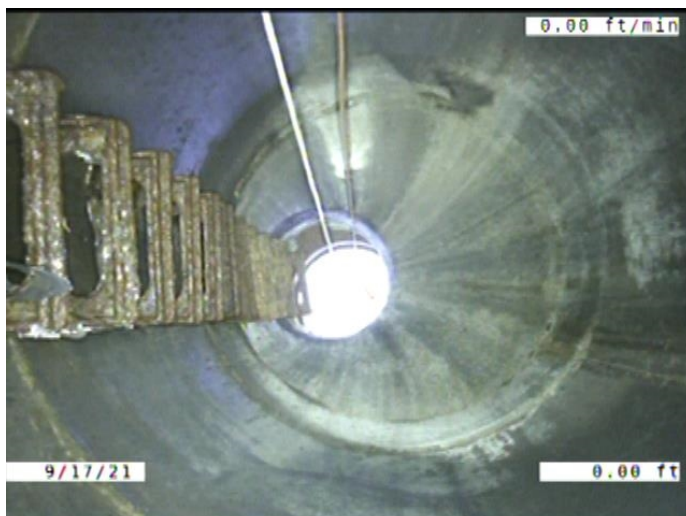
Code: **AMH**
 Description: **Manhole**

Distance (ft): **.0**
 Structural Grade: **0**
 O&M Grade: **0**
 Clock Start/From:
 Clock To:
 1st Value:
 2nd Value:
 Value Percent:
 Continuous Index:
 Within 8" of Joint: **NO**
 Remarks: **M-503-071**

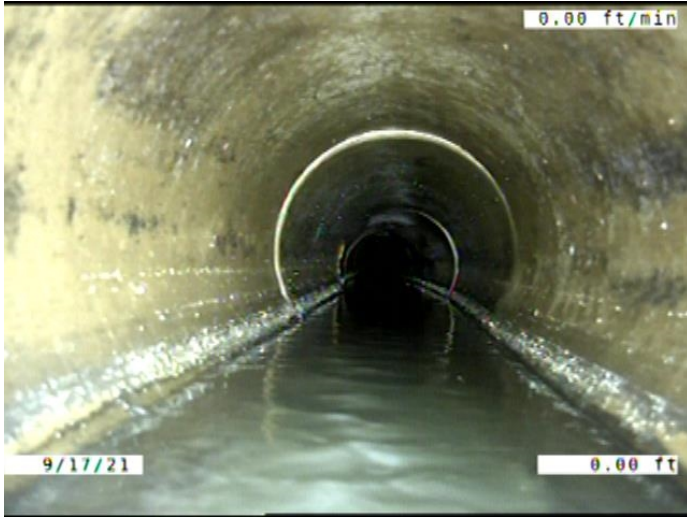
Code: **MWL**
Description: **Miscellaneous Water Level**

Distance (ft): **.0**
Structural Grade: **0**
O&M Grade: **0**
Clock Start/From:
Clock To:
1st Value:
2nd Value:
Value Percent: **10.000**
Continuous Index:
Within 8" of Joint: **NO**
Remarks:

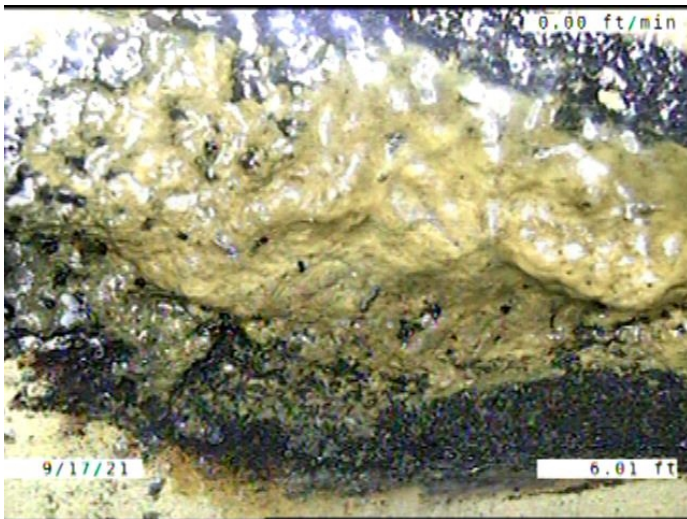
Code: **DAE**
Description: **Deposits Attached Encrustation**

Distance (ft): **6.0**
Structural Grade: **0**
O&M Grade: **2**
Clock Start/From: **8**
Clock To: **4**
1st Value:
2nd Value:
Value Percent: **5.000**
Continuous Index:
Within 8" of Joint: **YES**
Remarks:

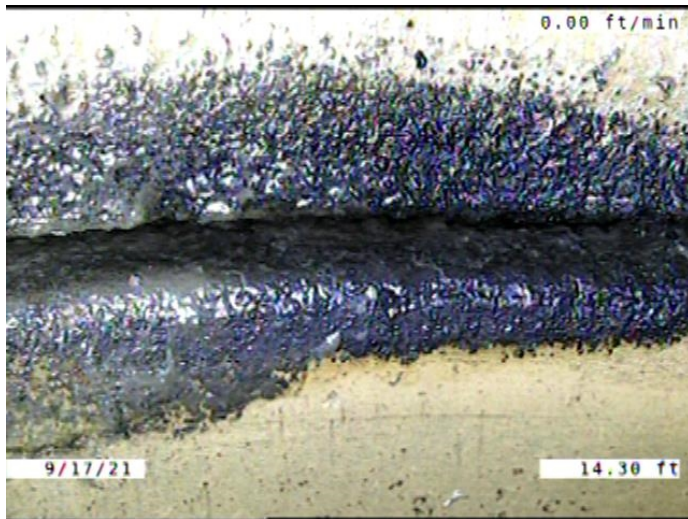
Code: **DAE**
 Description: **Deposits Attached Encrustation**

Distance (ft): **14.3**
 Structural Grade: **0**
 O&M Grade: **2**
 Clock Start/From: **9**
 Clock To: **11**
 1st Value:
 2nd Value:
 Value Percent: **5.000**
 Continuous Index:
 Within 8" of Joint: **YES**
 Remarks:

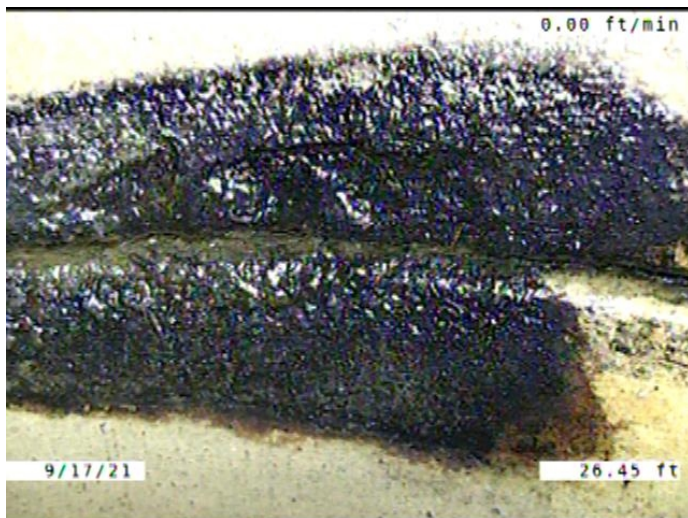
Code: **DAE**
 Description: **Deposits Attached Encrustation**

Distance (ft): **26.4**
 Structural Grade: **0**
 O&M Grade: **2**
 Clock Start/From: **9**
 Clock To: **3**
 1st Value:
 2nd Value:
 Value Percent: **5.000**
 Continuous Index: **S01**
 Within 8" of Joint: **YES**
 Remarks:

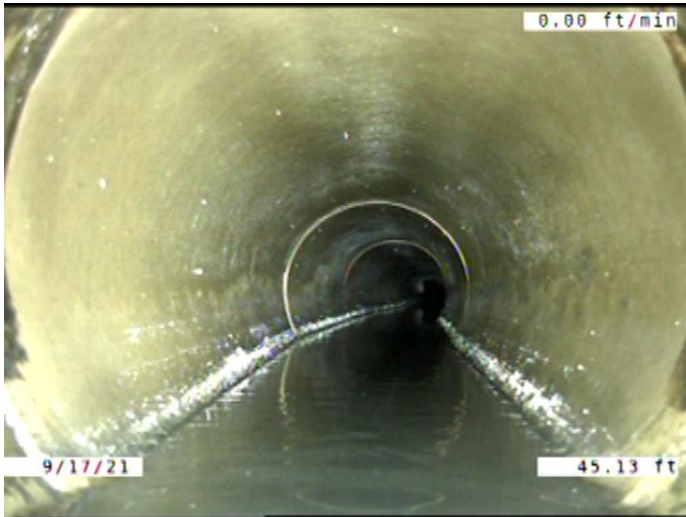
Code: **LR**
 Description: **Line Right**

Distance (ft): **45.1**
 Structural Grade: **0**
 O&M Grade: **1**
 Clock Start/From:
 Clock To:
 1st Value:
 2nd Value:
 Value Percent: **5.000**
 Continuous Index:
 Within 8" of Joint: **NO**
 Remarks:

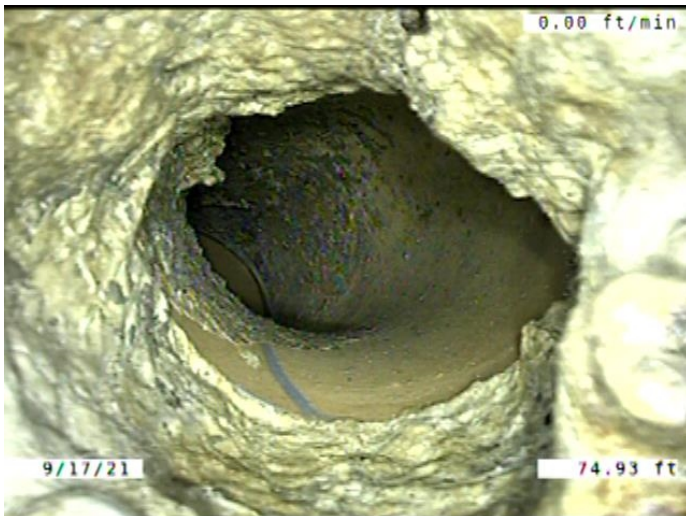
Code: **TFD**
 Description: **Tap Factory Defective**

Distance (ft): **74.9**
 Structural Grade: **0**
 O&M Grade: **3**
 Clock Start/From: **12**
 Clock To:
 1st Value: **4.000**
 2nd Value:
 Value Percent:
 Continuous Index:
 Within 8" of Joint: **YES**
 Remarks: **Defective**

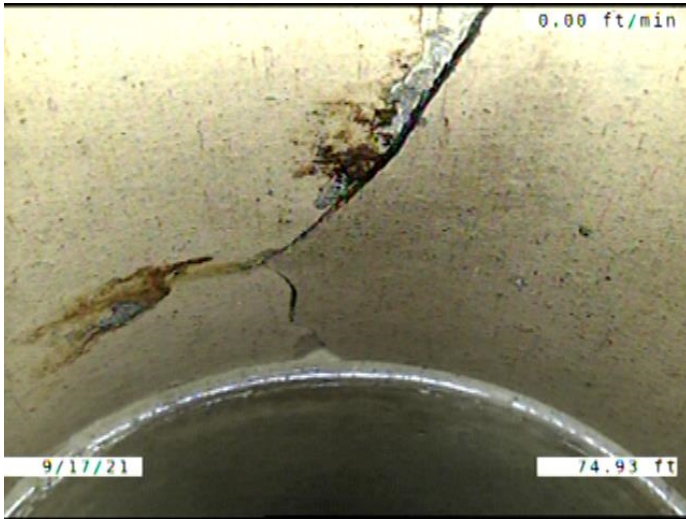
Code: **FM**
Description: **Fracture Multiple**

Distance (ft): **74.9**
Structural Grade: **4**
O&M Grade: **0**
Clock Start/From: **8**
Clock To: **12**
1st Value:
2nd Value:
Value Percent:
Continuous Index:
Within 8" of Joint: **YES**
Remarks:

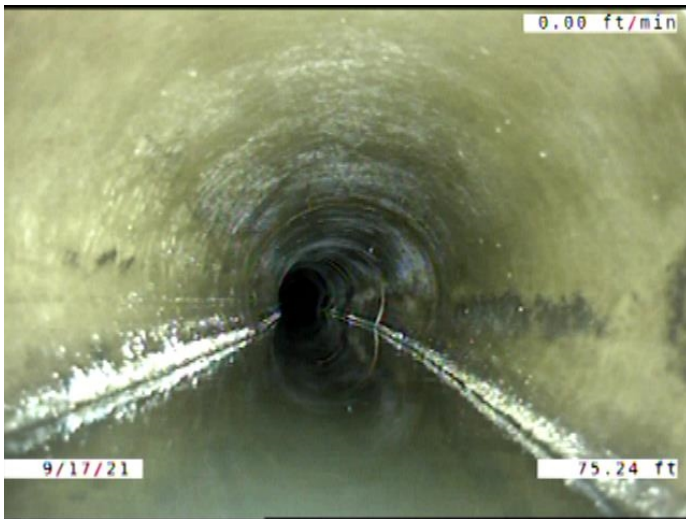
Code: **DAE**
Description: **Deposits Attached Encrustation**

Distance (ft): **75.2**
Structural Grade: **0**
O&M Grade: **2**
Clock Start/From: **9**
Clock To: **3**
1st Value:
2nd Value:
Value Percent: **5.000**
Continuous Index: **F01**
Within 8" of Joint: **YES**
Remarks:

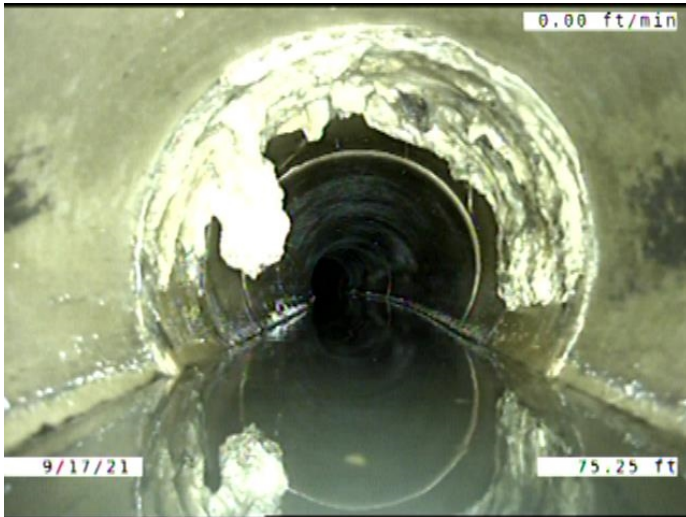
Code:	MSA
Description:	Miscellaneous Survey Abandoned
Distance (ft):	75.2
Structural Grade:	0
O&M Grade:	0
Clock Start/From:	
Clock To:	
1st Value:	
2nd Value:	
Value Percent:	
Continuous Index:	
Within 8" of Joint:	NO
Remarks:	CAMERA CANT MAKE IT PAST ENCRUSTATION
