Profile/Photo Observation Report

Date:	09/18/2021	Weather:		Coding:	PACP 7.0
Pipe Length (ft):	176.0	Owner:	City of Hobart	Pre Clean:	Light Cleaning
P.O.#:	YES502259	Surveyor:	S. Bucklin	PSR:	P-503-071-063
Customer:	City of Hobart	Clean Date:	08/24/2021	Shape:	C

Street:	West 38th Avenue	Flow Control:	Not Controlled
City:	Hobart, IN	Year Renewed:	
Location:	Ditch	Tape/Media #:	
Purpose:	Routine Assessment	Dia/Height:	12"
Use:	Sanitary Sewage Pipe	Material:	VCP
Drain Area:		Lining:	None
Category:	NA		
Comment:			
Location Details:		Direction of Survey:	Upstream
US MH:	M-503-071	DS MH:	M-503-063
		Total Length Surveyed (ft):	98.5

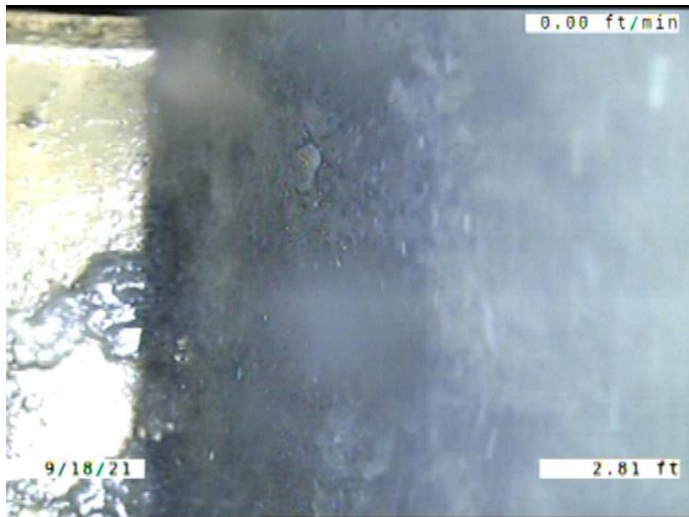
Code: **DSF**
 Description: **Deposits Settled Fine**

Distance (ft): **2.8**
 Structural Grade: **0**
 O&M Grade: **2**
 Clock Start/From: **5**
 Clock To: **7**
 1st Value:
 2nd Value:
 Value Percent: **5.000**
 Continuous Index: **S02**
 Within 8" of Joint: **YES**
 Remarks:

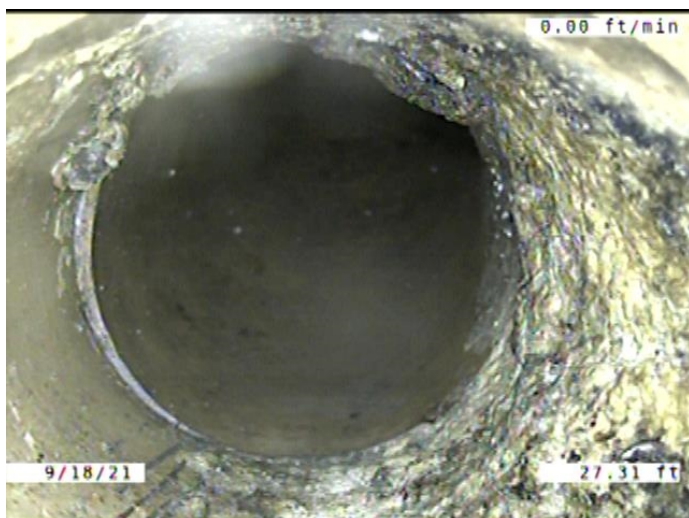
Code: **TF**
 Description: **Tap Factory**

Distance (ft): **27.3**
 Structural Grade: **0**
 O&M Grade: **0**
 Clock Start/From: **12**
 Clock To:
 1st Value: **4.000**
 2nd Value:
 Value Percent:
 Continuous Index:
 Within 8" of Joint: **YES**
 Remarks:

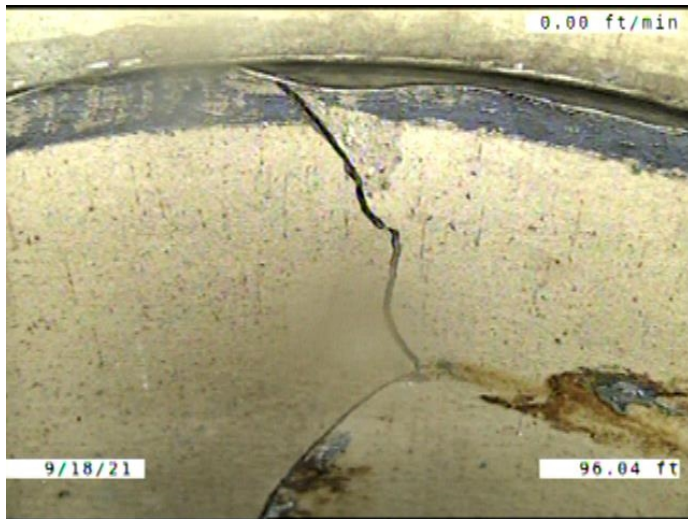
Code: **FM**
 Description: **Fracture Multiple**

Distance (ft): **96.0**
 Structural Grade: **4**
 O&M Grade: **0**
 Clock Start/From: **12**
 Clock To: **4**
 1st Value:
 2nd Value:
 Value Percent:
 Continuous Index:
 Within 8" of Joint: **YES**
 Remarks:

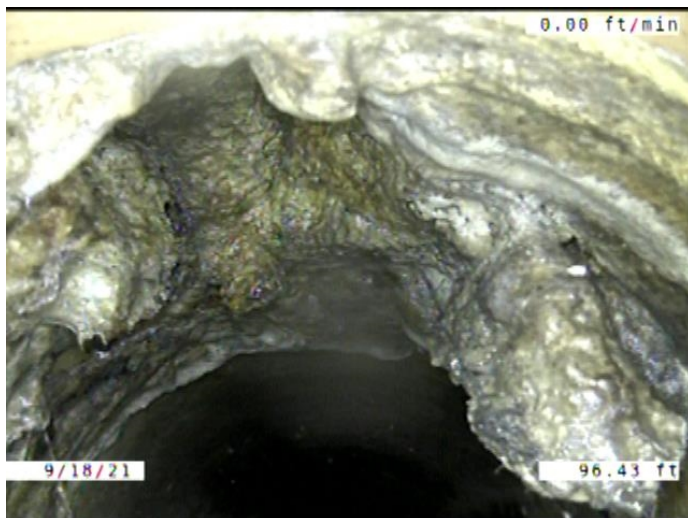
Code: **DAE**
 Description: **Deposits Attached Encrustation**

Distance (ft): **96.4**
 Structural Grade: **0**
 O&M Grade: **2**
 Clock Start/From: **8**
 Clock To: **4**
 1st Value:
 2nd Value:
 Value Percent: **5.000**
 Continuous Index:
 Within 8" of Joint: **YES**
 Remarks:

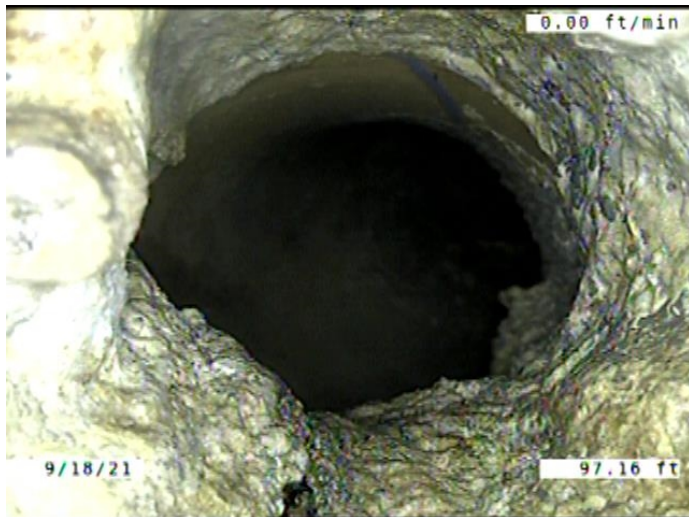
Code:	TFD
Description:	Tap Factory Defective
Distance (ft):	97.2
Structural Grade:	0
O&M Grade:	3
Clock Start/From:	12
Clock To:	
1st Value:	4.000
2nd Value:	
Value Percent:	
Continuous Index:	
Within 8" of Joint:	YES
Remarks:	ENCrustATION ALL AROUND THE TAP CONNECTION

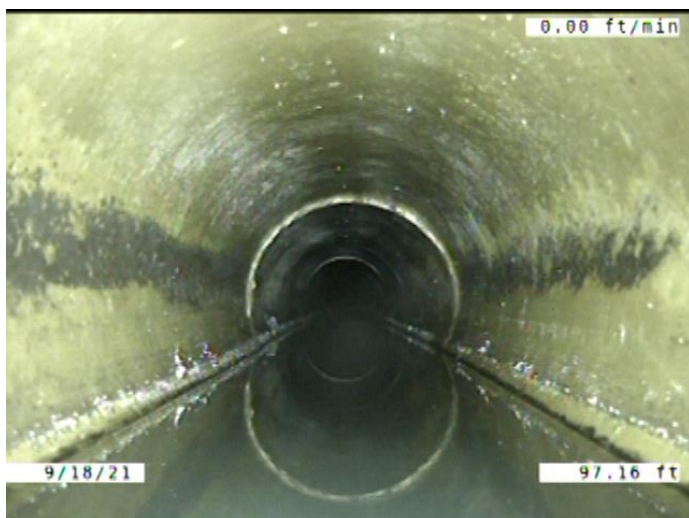
Code:	DSF
Description:	Deposits Settled Fine
Distance (ft):	97.2
Structural Grade:	0
O&M Grade:	2
Clock Start/From:	5
Clock To:	7
1st Value:	
2nd Value:	
Value Percent:	5.000
Continuous Index:	F02
Within 8" of Joint:	YES
Remarks:
