## Profile/Photo Observation Report

Date:	<b>09/18/2021</b>	Weather:		Coding:	<b>PACP 7.0</b>
Pipe Length (ft):	<b>176.0</b>	Owner:	<b>City of Hobart</b>	Pre Clean:	<b>Light Cleaning</b>
P.O.#:	<b>YES502259</b>	Surveyor:	<b>S. Bucklin</b>	PSR:	<b>P-503-071-063</b>
Customer:	<b>City of Hobart</b>	Clean Date:	<b>08/24/2021</b>	Shape:	<b>C</b>

Street:	<b>West 38th Avenue</b>	Flow Control:	<b>Not Controlled</b>
City:	<b>Hobart, IN</b>	Year Renewed:	
Location:	<b>Ditch</b>	Tape/Media #:	
Purpose:	<b>Routine Assessment</b>	Dia/Height:	<b>12"</b>
Use:	<b>Sanitary Sewage Pipe</b>	Material:	<b>VCP</b>
Drain Area:		Lining:	<b>None</b>
Category:	<b>NA</b>		
Comment:			
Location Details:		Direction of Survey:	<b>Upstream</b>
US MH:	<b>M-503-071</b>	DS MH:	<b>M-503-063</b>
		Total Length Surveyed (ft):	<b>98.5</b>

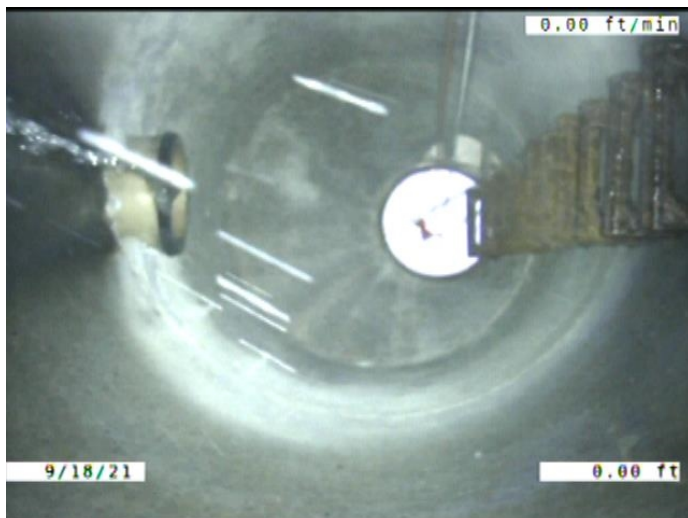
Code: **AMH**  
 Description: **Manhole**

Distance (ft): **.0**  
 Structural Grade: **0**  
 O&M Grade: **0**  
 Clock Start/From:  
 Clock To:  
 1st Value:  
 2nd Value:  
 Value Percent:  
 Continuous Index:  
 Within 8" of Joint: **NO**  
 Remarks: **M-503-063**

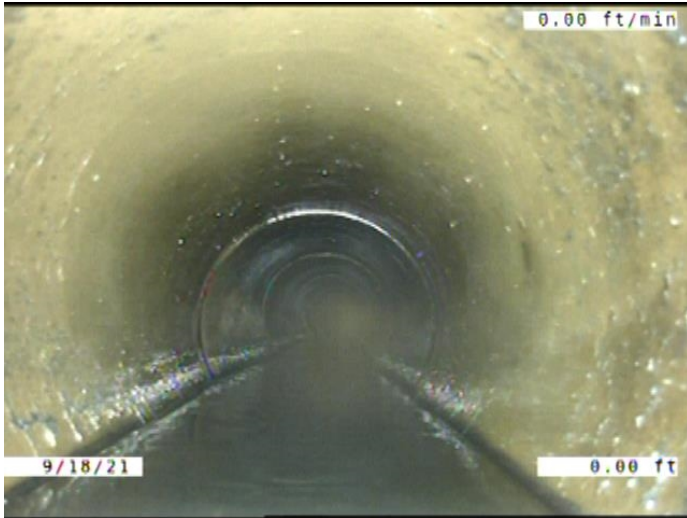
Code: **MWL**  
Description: **Miscellaneous Water Level**

Distance (ft): **.0**  
Structural Grade: **0**  
O&M Grade: **0**  
Clock Start/From:  
Clock To:  
1st Value:  
2nd Value:  
Value Percent: **5.000**  
Continuous Index:  
Within 8" of Joint: **NO**  
Remarks:

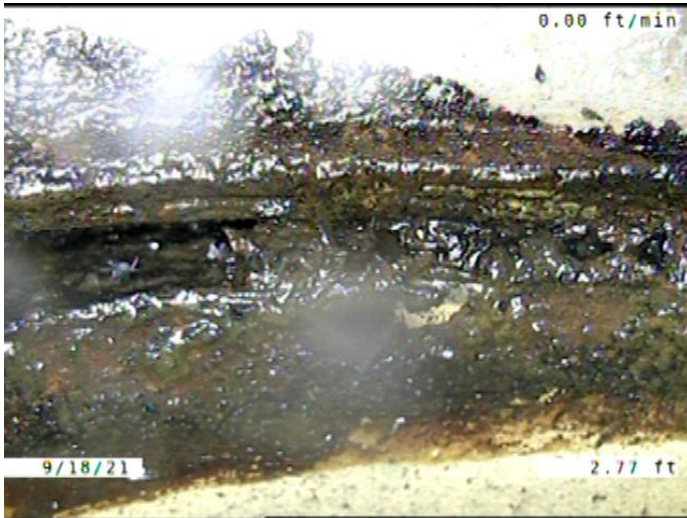
Code: **DAE**  
Description: **Deposits Attached Encrustation**

Distance (ft): **2.8**  
Structural Grade: **0**  
O&M Grade: **2**  
Clock Start/From: **8**  
Clock To: **4**  
1st Value:  
2nd Value:  
Value Percent: **5.000**  
Continuous Index: **S01**  
Within 8" of Joint: **YES**  
Remarks:

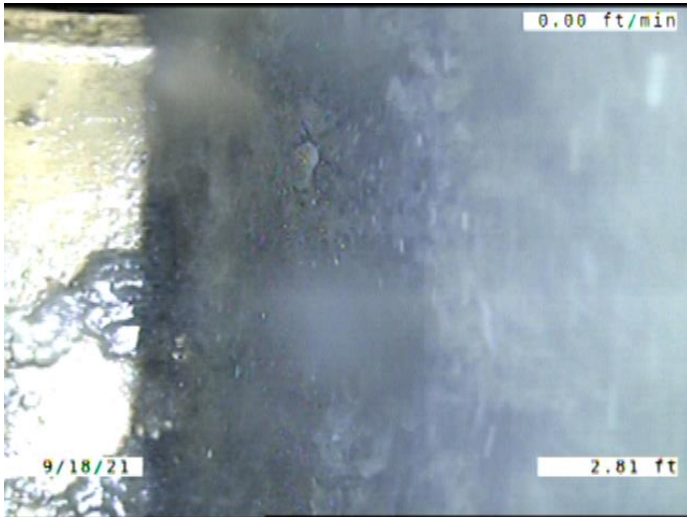
Code: **DSF**  
Description: **Deposits Settled Fine**

Distance (ft): **2.8**  
Structural Grade: **0**  
O&M Grade: **2**  
Clock Start/From: **5**  
Clock To: **7**  
1st Value:  
2nd Value:  
Value Percent: **5.000**  
Continuous Index: **S02**  
Within 8" of Joint: **YES**  
Remarks:

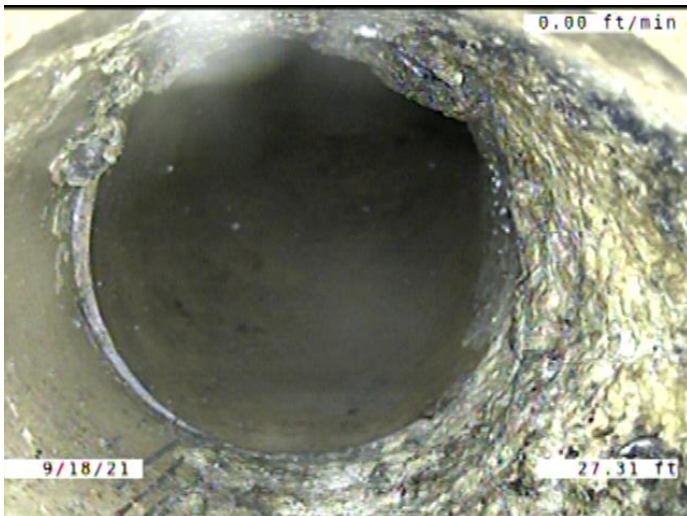
Code: **TF**  
Description: **Tap Factory**

Distance (ft): **27.3**  
Structural Grade: **0**  
O&M Grade: **0**  
Clock Start/From: **12**  
Clock To:  
1st Value: **4.000**  
2nd Value:  
Value Percent:  
Continuous Index:  
Within 8" of Joint: **YES**  
Remarks:

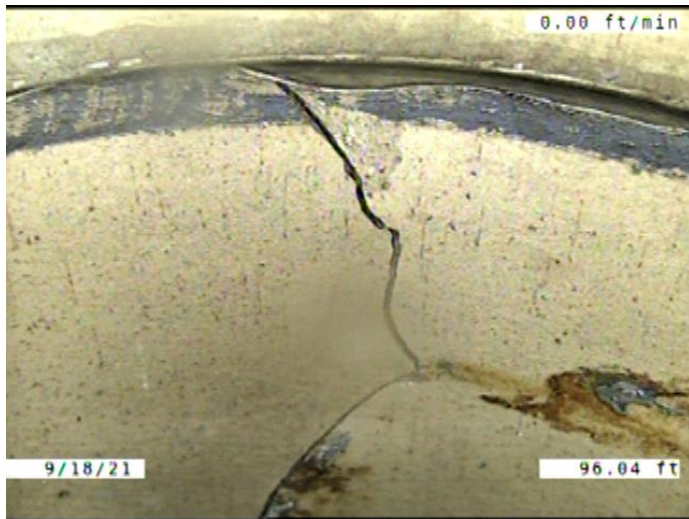
Code: **FM**  
 Description: **Fracture Multiple**

Distance (ft): **96.0**  
 Structural Grade: **4**  
 O&M Grade: **0**  
 Clock Start/From: **12**  
 Clock To: **4**  
 1st Value:  
 2nd Value:  
 Value Percent:  
 Continuous Index:  
 Within 8" of Joint: **YES**  
 Remarks:

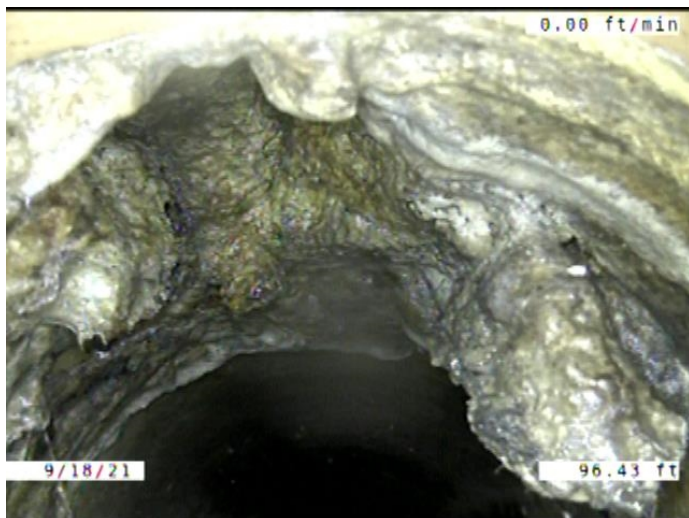
Code: **DAE**  
 Description: **Deposits Attached Encrustation**

Distance (ft): **96.4**  
 Structural Grade: **0**  
 O&M Grade: **2**  
 Clock Start/From: **8**  
 Clock To: **4**  
 1st Value:  
 2nd Value:  
 Value Percent: **5.000**  
 Continuous Index:  
 Within 8" of Joint: **YES**  
 Remarks:

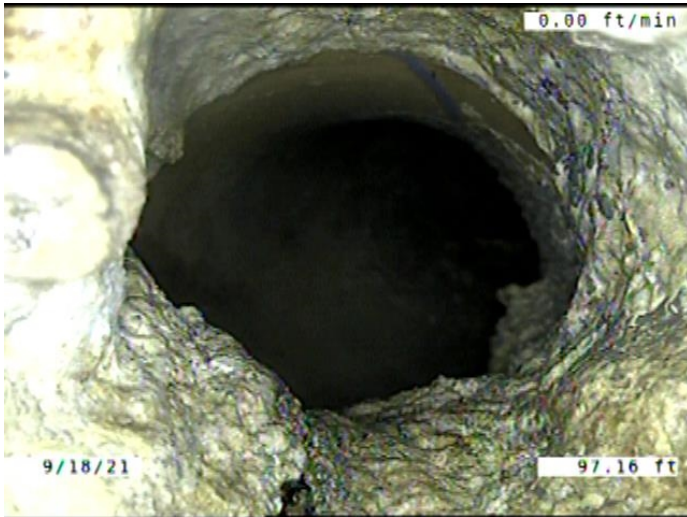
Code:	<b>TFD</b>
Description:	<b>Tap Factory Defective</b>
Distance (ft):	<b>97.2</b>
Structural Grade:	<b>0</b>
O&M Grade:	<b>3</b>
Clock Start/From:	<b>12</b>
Clock To:	
1st Value:	<b>4.000</b>
2nd Value:	
Value Percent:	
Continuous Index:	
Within 8" of Joint:	<b>YES</b>
Remarks:	<b>ENCrustATION ALL AROUND THE TAP CONNECTION</b>

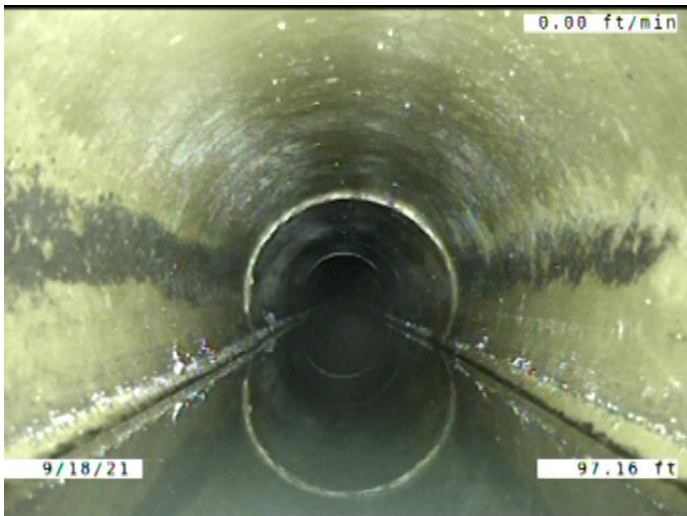
Code:	<b>DSF</b>
Description:	<b>Deposits Settled Fine</b>
Distance (ft):	<b>97.2</b>
Structural Grade:	<b>0</b>
O&M Grade:	<b>2</b>
Clock Start/From:	<b>5</b>
Clock To:	<b>7</b>
1st Value:	
2nd Value:	
Value Percent:	<b>5.000</b>
Continuous Index:	<b>F02</b>
Within 8" of Joint:	<b>YES</b>
Remarks:

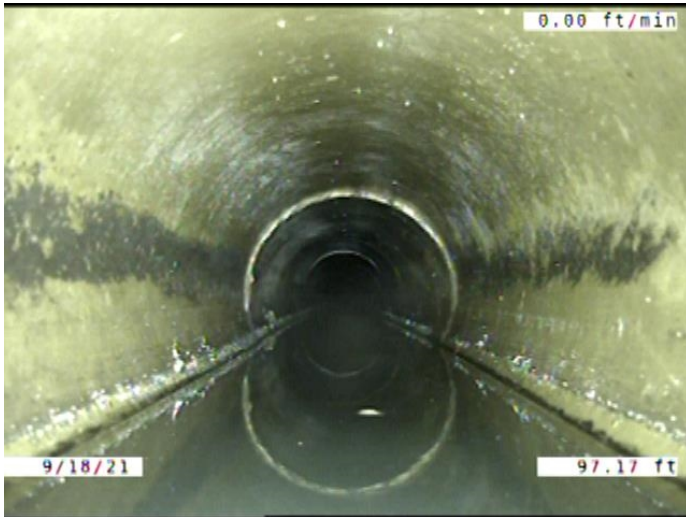
Code: **DAE**  
 Description: **Deposits Attached Encrustation**

Distance (ft): **97.2**  
 Structural Grade: **0**  
 O&M Grade: **2**  
 Clock Start/From: **8**  
 Clock To: **4**  
 1st Value:  
 2nd Value:  
 Value Percent: **5.000**  
 Continuous Index: **F01**  
 Within 8" of Joint: **YES**  
 Remarks:

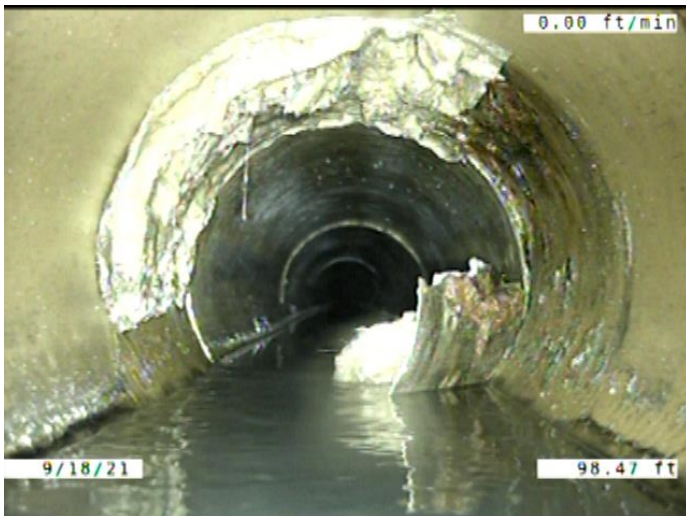
Code: **MSA**  
 Description: **Miscellaneous Survey Abandoned**

Distance (ft): **98.5**  
 Structural Grade: **0**  
 O&M Grade: **0**  
 Clock Start/From:  
 Clock To:  
 1st Value:  
 2nd Value:  
 Value Percent:  
 Continuous Index:  
 Within 8" of Joint: **NO**  
 Remarks: **MADE IT TO THE POINT OF OVERLAP.  
 REVERSAL COMPLETE**
