Profile/Photo Observation Report

| P.O.#: | | Surveyor: | Jen Costello | PSR: | P-503-072.1-072 |

| Street: | W 38TH AVE | Flow Control: | Not Controlled |

| US MH: | M-503-072 | DS MH: | M-503-072.1 |

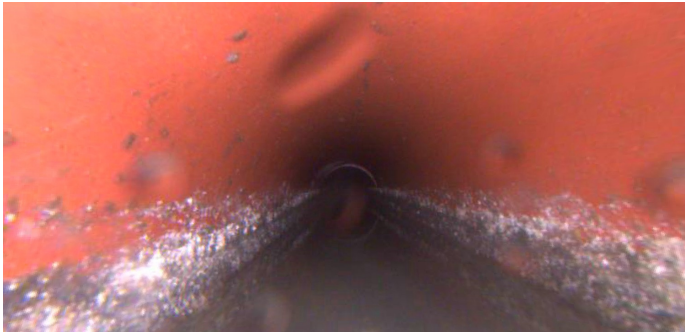
| Code: | MWL |
| Description: | Water Level |

| Value Percent: | 20.000 |

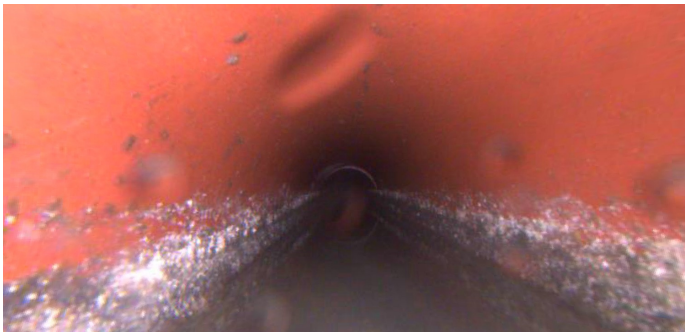
| Code: | DAGS |
| Description: | Deposits Attached Grease |

| O&M Grade: | 2 |
| Clock Start/From: | 8 |
| Clock To: | 4 |
| Value Percent: | 5.000 |

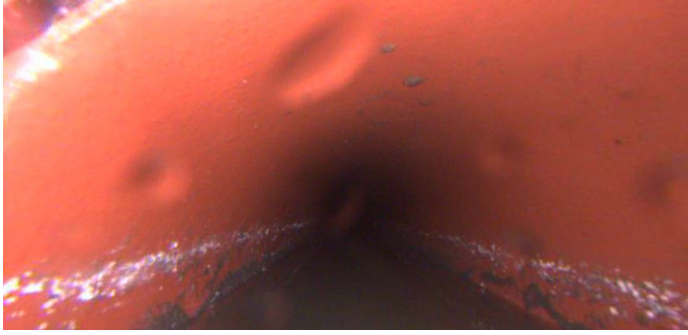
| Code: | MSA |
| Description: | Abandoned Survey |
| Distance (ft): | 4.5 |
| Remarks: | debris under water |
